Llyn Tegid Reservoir Safety Project

Access Audit

Version: 3.0

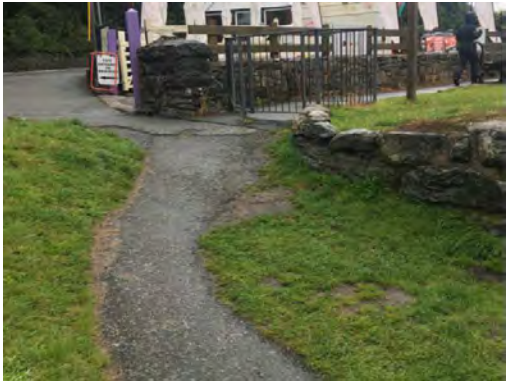
<p>Surface material: Tarmac and some stone paving (around pay machine and at base of ramp). Inconsistent tarmac surfacing at top of ramp, and uneven transition between tarmac and stone paving surfaces creates step levels >15mm along route.</p> <p>Parking payment machine along route (before steep section of ramp) accessible from the foreshore car park via tarmac footpath.</p> <p>See above (R1/04) for seating, litter bins and signage information.</p>		<p>Llyn Tegid Reservoir Safety project to provide the localised improvement of addressing the uneven transition between tarmac and stone paving surfaces.</p>
R4/03

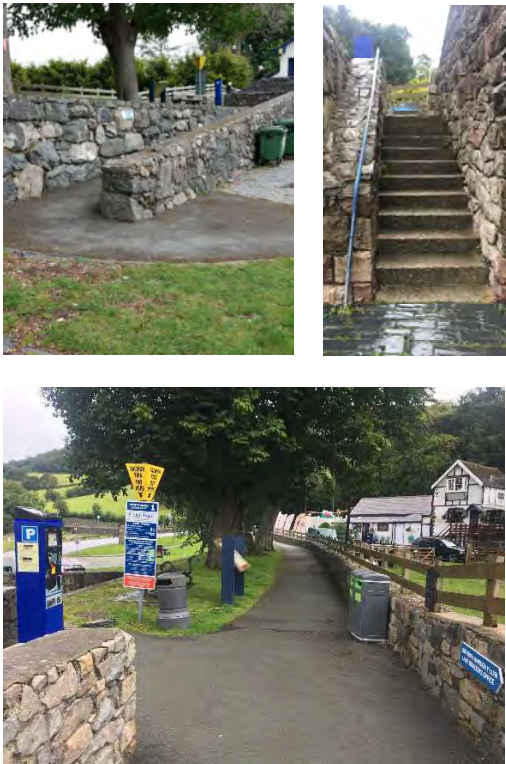
<p>Ramp and stepped access from Y Bala Rhif 4 to lakeside car park at western side of Bala Adventure & Watersports building / public toilets (provides access from the lakeside car park to another parking payment machine)</p> <p>No access control barriers</p> <p>Ramp gradient: c. 1:15 (length c. 24m; Rise c. 1.7m; Width 1.4m – 1.6m). No handrails. No level landings.</p> <p>Step dimensions: Total rise c. 1.8m, width c. 1m. (individual step rise c. 180mm; tread c. 300mm). One handrail provided. Steps leading up to public toilets do not have any handrails.</p> <p>Seating provided (final of a set of three resting places along this stretch of Y Bala Rhif 4 between Pensarn Road entrance and Watersports Centre). All on raised stone paving within grass, not accessible. This is the last bench for app. 150m along Y Bala Rhif 4 (heading west to east) – next is located within leisure centre outdoor area.</p> <p>Litter bin and recycling bins provided. All accessible, recycling bins are within boundary of access route.</p> <p>Interpretation signage provided.</p>	<p>The ramp does not comply with recommendations of BS 8300 as the maximum recommended gradient for this rise is 1:20. Ramps require a handrail at either side, and level landings for every 500mm rise / 10m going. BARM guidance recommends a maximum ramp gradient of 1:10.</p> <p>Steps not compliant with recommendations of BS 8300, lacking corduroy tactile paving top and bottom and contrasting nosings. Dimensional ranges for the steps should be between 150-180mm for the rise and between 300-450mm for the going, steps fall within these dimensions. A handrail should be provided on each side of the ramp or stair, stairs only have one handrail, some have none.</p> <p>BS 8300 recommends litter bins, amongst other street furniture, should wherever possible be located at or beyond the boundaries of an access route.</p>	<p>Re-grading the ramp and adding in level landings here is likely to be costly and disruptive, and is outside the scope of the Llyn Tegid Reservoir Safety project.</p> <p>Llyn Tegid Reservoir Safety project to provide a handrail to one side of the ramp and additional signage from the lakeshore car park, to improve compliance with BARM guidance.</p> <p>Opportunities to improve access standards here would be beyond the working area, and therefore outside the scope of the Llyn Tegid Reservoir Safety project.</p> <p>The Llyn Tegid Reservoir Safety project will move the recycling bins so that they do not sit within the boundary of the access route, which will improve compliance with BS 8300 (there is plenty of room not within the footpath that they can be located).</p>

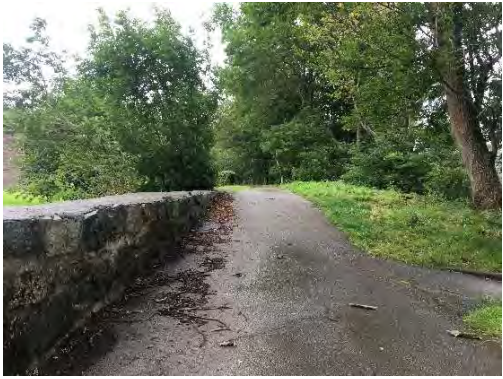
<p>Ramp on Y Bala Rhif 4 leading up to leisure centre</p> <p>Ramp gradient: c. 1:20, likely to be steeper as not a steady incline (length c. 19m, rise c. 0.9m, width 1.7m – 2.0m). No handrails. No level landings.</p> <p>Crossfall gradient is as steep as c. 1:25 at some parts of this section of footpath, particularly steep at the top of the concrete ramp leading down to the lake foreshore, greatly reducing.</p> <p>Surface material: Tarmac</p>	<p>The ramp does not comply with recommendations of BS 8300, maximum recommended gradient for this rise is 1:20. Ramps require level landings for every 500mm rise / 10m going, two handrails, and a minimum width of 1.5m. BARM recommends a maximum ramp gradient of 1:10, no preferred width is given, but minimum path width is 1m.</p> <p>According to BS 8300 where an access route has a gradient steeper than 1:60, but not as steep as 1:20, it should usually have a level landing for each 500mm rise of the access route. On access routes with a gradient not steeper than 1:30, a level resting place adjacent to the route may be provided as an exception.</p>	<p>Opportunities to improve access standards here (e.g. reducing gradients, providing resting places) would be beyond the scope of the Llyn Tegid Reservoir Safety project.</p>

<p>BS 8300 recommends cross-fall gradient across a level access route should not exceed 1:50, except when associated with a dropped kerb or access route.</p>	<p>Llyn Tegid Reservoir Safety project to address cross-fall issue only if reinstatement is required here.</p>
R4/10

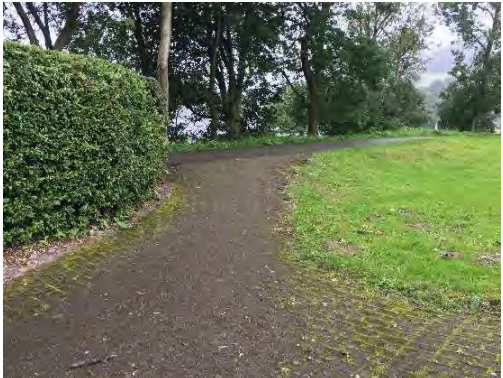
<p>Ramp between Y Bala Rhif 4 and Leisure Centre frontage</p> <p>Access control barrier: None.</p> <p>Ramp gradient: c. 1:10 (length c. 6m; rise c. 0.6m; width 1.8m – 3.0m). No handrails. No level landings.</p> <p>Surface material: Brick setts. Even and smooth surface. Not slip resistant when wet due to moss build up, likely worsened by area being heavily shaded by vegetation on embankment.</p>	<p>The ramp does not comply with recommendations of BS 8300 as maximum recommended gradient for this rise is 1:20). Ramps require level landings for every 500mm rise / 10m going, and two handrails. BARM recommends maximum gradient is 1:10 for a ramp.</p>	<p>Llyn Tegid Reservoir Safety project to provide a reduced gradient (no steeper than 1:20) access path as part of Leisure Centre enhancement works.</p>

<p>This is one of the access points onto Y Bala Rhif 4 that is uncontrolled, being directly connected to one of the well-used car parks in the area. Currently there is no known issue with unauthorised access from this connection.</p>	<p>Retain the open access at this location, no access control would be proposed along the replacement footpath.</p>

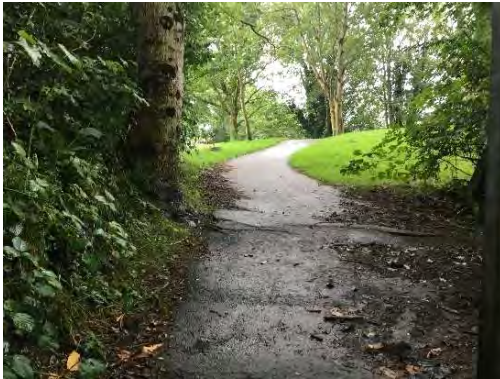
<p>Surface material: Tarmac. Exposed roots have created breaks and an uneven surface with a step level >15mm. Area is shaded, lots of leaf litter and debris build up behind the gate makes the surface slippery.</p> <p>No seating.</p> <p>No litter bins.</p> <p>No directional signage indicating this route is also a public right of way. It would be useful here as there is also a gate leading down into the rugby club (not PRow).</p>	<p>BARM recommends path surfaces be level, step levels should not exceed 15mm.</p>	<p>Llyn Tegid Reservoir Safety project to ensure removal of any step levels greater than 15mm will increase compliance, as other than these areas of raised tarmac, surfacing appears compliant.</p>
R4/19

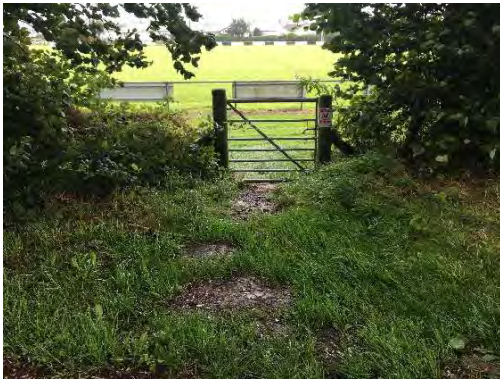
<p>Ramped connection from Y Bala Rhif 4 to the rugby club grounds (not PRow)</p> <p>Access control barrier: Steel field gate, 1.2m wide, one-way opening. Gate not normally used for public access, however is used to go and fetch balls when kicked out of Rugby ground. Also used as an access to the embankments generally when the rugby club grounds are used for parking/ camping during big events (e.g. Bala Big Bash).</p> <p>Ramp gradient: c. 1:10; length c. 4m; rise c. 0.4m; width c. 0.5m – 1.0m. No handrails. No level landings.</p> <p>Surface material: Unsurfaced, combination of grass and bare earth.</p> <p>No seating. No litter bins. No signage.</p>	<p>BARM recommends path surfaces be 'hard and firm with very few loose stones (no bigger than 10mm)' and that 'the ideal is non-slip, well-drained, level path'. BS 8300 recommends 'an access route should have a firm, slip-resistant and reasonably smooth surface. Cobbles, bare earth, sand and unbonded gravel should not be used'.</p> <p>Access control barrier does not comply with recommendations set out in BS 8300 (2-way self-closing gates may be used, but not revolving gates, turnstiles, kissing gates or A-frame barriers) or BARM (no steps, or stiles or other physical barriers restricting access).</p>	<p>Retain gate, but no access improvements proposed, as gate is rarely used and normally locked.</p>

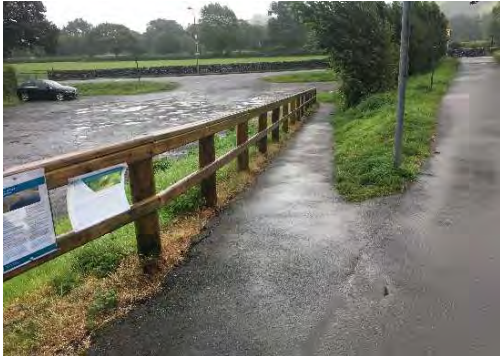
<p>Ramped footpath connection between Y Bala Rhif 4 and rugby club car park.</p> <p>No access control barrier.</p> <p>Ramp gradient: c. 1:13; length c. 25m; rise c. 1.9m; width: 1.0m – 1.1m. One handrail provided, no level landings.</p> <p>Surface material: Tarmac. No step levels >15mm noted. Evidence of path edging remains in parts but has disintegrated for much of the route and is</p>	<p>Ramp does not comply with recommendations of BS 8300 (maximum recommended gradient 1:20 for this rise). Ramp requires level landings for every 500mm rise / 10m going, two handrails, and a minimum width of 1.5m.</p> <p>This is one of the access points onto Y Bala Rhif 4 that is uncontrolled, being directly connected to one of the well-used car parks in the area. Currently there is no known issue with unauthorised access from this</p>	<p>Review need for this access to car park. Either reinstate like for like or consider removal of this access.</p>

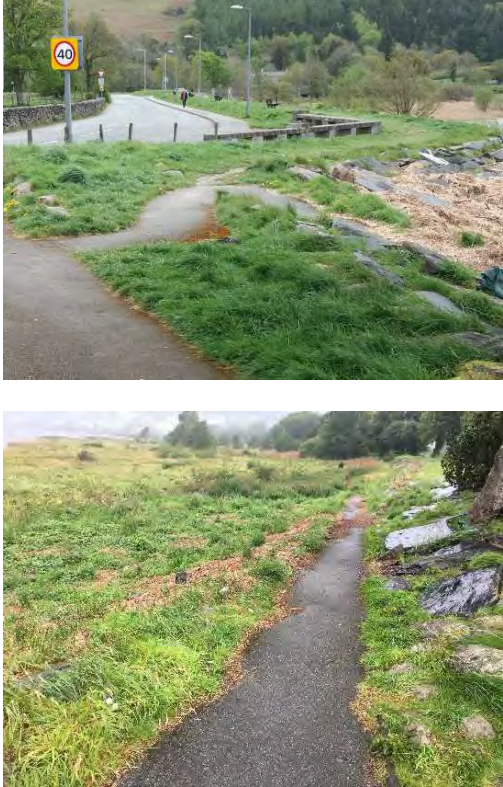
<p>Ramped footpath connection between Y Bala Rhif 4 and lake foreshore path leading back to the lakeside car park.</p> <p>Ramp gradient: At steepest c. 1:10 (gradient varies along ramp); total length c. 55m; total rise c. 2.5m; width 0.5m– 1.2m. No level landings. No handrails.</p> <p>Surface material: Tarmac. Evidence of path edging remains in parts but has disintegrated for much of the route and is therefore inconsistent. Tarmac surfacing ends at base of ramp leading onto exposed earth path. Path is undulating and uneven, no step levels >15mm noted.</p> <p>No seating.</p> <p>No litter bins.</p> <p>No directional signage.</p> <p>Ramp apparently used during Bala Triathlon.</p>	<p>Ramp does not comply with recommendations of BS 8300. Ramp gradient varies over the full length but much of the fall takes place over 10m (it is approx. 1:13 here) making it steeper than the recommended gradient of 1:20 for this rise. Ramp also requires level landings for every 500mm rise / 10m going, two handrails and a minimum width of 1.5m.</p> <p>BS 8300 recommends pedestrian paths have a detectable demarcation which can be followed by people who are blind or partially sighted, for example a wall, building line, kerb edge, grass verge, barrier, or clearly detectable change in texture.</p>	<p>Llyn Tegid Reservoir Safety project to maintain / re-create access to lake foreshore but relocated slightly to the west, so that the Bala railway crosses just one path here rather than two. Aim retain or improve on ramp gradient and width if possible, but full handrailing/ landings/ slack gradients etc are not justified in context of linked paths.</p> <p>Construct all tarmac paths with consistent edging (with no upstands) to ensure robust construction; contrast between grass and tarmac is sufficient for demarcation</p>

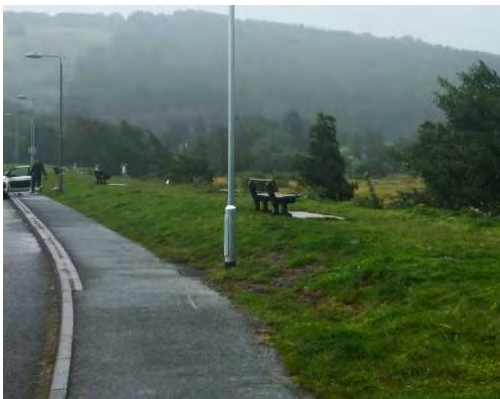
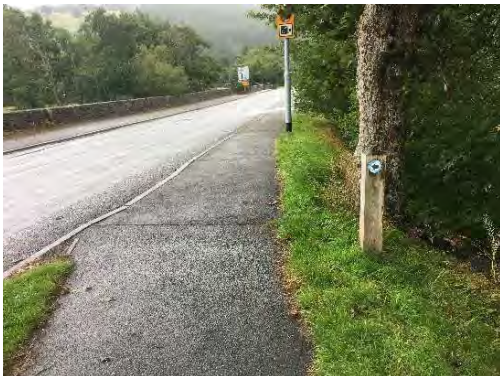
<p>Tegid street and B4391 footpath (connecting route between Y Bala Rhif 4 and Y Bala Rhif 1)</p> <p>Path gradient: >1:60 for most, if not all of route.</p> <p>Path width: 1.2m – 1.5m</p> <p>Embankment gradient: c. 1:4 (no path provided to access seating located on here).</p> <p>Surface material: Tarmac footpath. Embankment is unsurfaced (grass and in some cases bare earth), uneven and inaccessible.</p> <p>Set of 4 benches on top of the embankment crest give picturesque views across Llyn Tegid but they are not accessible. Seating sits on concrete platforms within the embankment crest.</p> <p>No litter bins.</p> <p>There is directional signage at the bottom of Tegid Street, where it meets B4391, directing users to Y Bala Rhif 1 (and towards Y Bala Rhif 4 if approaching from the other direction).</p>	<p>BS 8300 recommends minimum path width be 1.8m (although a minimum of 2m is preferred). Where the surface width of an access route is less than 1.8m, passing places should be provided to allow two wheelchair users to pass each other. BARM recommends at least 1.2m path width for urban / formal landscapes.</p> <p>BS 8300 recommends that appropriate accessible space should be allowed for wheelchair users to be integrated within the general seating provision, and a choice of seating options should be provided for a variety of users.</p> <p>Future extension of Bala Railway along this embankment crest will remove opportunity for seating; the Reservoir Safety Project will install some of track bed here which will have some visual impact but not affect access.</p>	<p>Opportunity to widen the footpath to 1.8m is not a feasible option as it is located on a highway; no scope for increasing width as would impact on embankment .</p> <p>Existing benches not to be replaced here due to Bala railway project, and risk of damage to railway channel if seats needed to be removed in the future. Loss of seating here mitigated by creation of new high quality seating area (as TS/01), option to relocate these benches elsewhere within the community.</p>

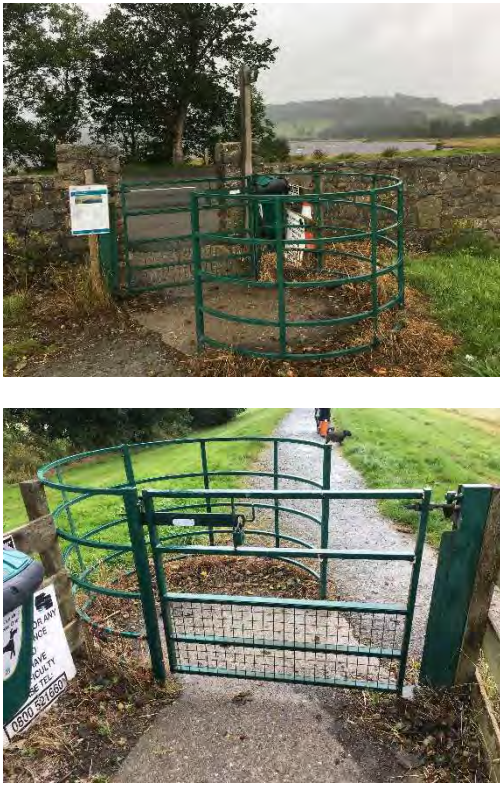
<p>Ramped access and access control (entrance from B4391).</p> <p>Access control barrier: Curved metal 'kissing gate' with RADAR bypass. Self-closing, opens both ways, has 'radar key' padlock system to allow wheelchair users to open fully outwards from either side and move straight through. c. 1.2m wide.</p> <p>Path gradient (footpath to barrier): c. 1:7; length c. 1.4m; rise c. 0.18m; width c. 1.2m.</p> <p>Surface material: Tarmac, concrete and bound stone. Tarmac footpath to concrete is a smooth, even surface, no step level. Stone path behind gate sits slightly lower than the concrete foundation for gate, step level >15mm where two surfaces meet.</p> <p>No seating.</p> <p>Dog waste bin provided. Accessible, not within boundary of access route.</p> <p>Timber finger post sign and dog litter bin provided here.</p> <p>Footpath on crest of embankment was surfaced with unbound stone approx. 15 years ago (formerly grass), to improve DDA standards.</p>	<p>BARM recommends path surfaces have very few loose stones, and none bigger than 10mm. BS 8300 recommends unbonded gravel should not be used.</p> <p>BARM recommends that any changes in surface should not result in step levels greater than 15mm to avoid creating a trip hazard.</p> <p>Ramp does not comply with recommendations of BS 8300, in which the maximum recommended gradient for this rise is 1:12, requiring level landings for every 500mm rise and 10m going, two handrails, and a minimum width of 1.5m. BARM guidance recommends that the steepest gradient be 1:10, no preferred width is given, but minimum path width recommended is 1m.</p>	<p>Llyn Tegid Reservoir Safety project to resurface this footpath in tarmac.</p> <p>Also remove RADAR by-pass curved kissing gate and replace with 2-way opening self-closing gate set into the footpath sufficiently to avoid it opening across the footway of the B4391 – idea supported by GCC PROW.</p> <p>Llyn Tegid Reservoir Safety project to remove step level during resurfacing (above) by ensuring joint where surface materials meet is flush.</p> <p>Llyn Tegid Reservoir Safety project to regrade this ramp, to increase compliance with BS 8300 at this location.</p>

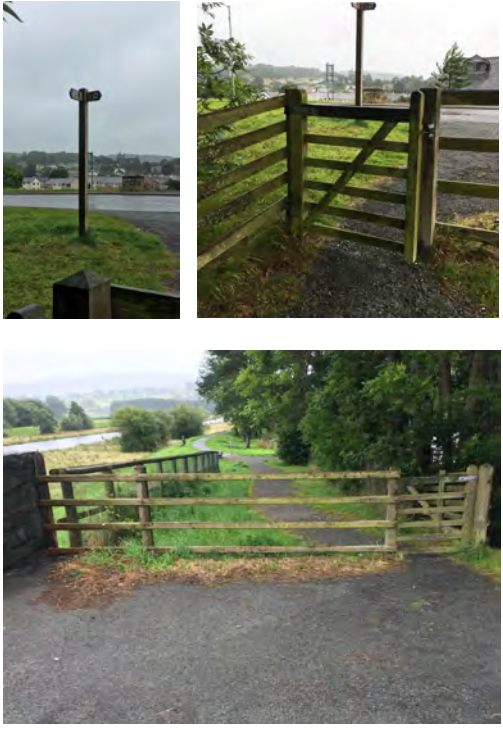
<p>Ramped footpath and access control (Station Road to Y Bala Rhif 1)</p> <p>Access Control Barrier: Timber field gate (broken, closing mechanism missing), 1.0m wide, not self-closing; one-way opening.</p> <p>Path gradient: Varies. c. 1:10 – 1:12, total length c. 40m; total rise c. 3.2; width 1.0m – 6.0m (steepest from Station Road to field gate).</p> <p>Surface material: Tarmac (Station Road to field gate) and bound stone surface with loose stones >10mm below gate. Worn tarmac at top of ramp creates an uneven surface and step level changes >15mm.</p> <p>See R1/06 for seating and litter bin information</p> <p>Directional signage on Station Road (and at base of ramp as described in R1/06).</p>	<p>Access control barrier does not comply with recommendations set out in BS 8300 (2-way self-closing gates may be used, but not revolving gates, turnstiles, kissing gates or A-frame barriers) or BARM (no steps, or stiles or other physical barriers restricting access).</p> <p>BARM recommends path surfaces should have very few loose stones (none greater than 10mm). BS 8300 recommends cobbles, bare earth, sand and unbonded gravel should not be used.</p>	<p>Llyn Tegid Reservoir Safety project to replace existing access gate with 2-way opening self-closing gate (not RADAR kissing gate - on suggestion from GCC PROW officer).</p> <p>Llyn Tegid Reservoir Safety project to resurface this footpath in tarmac.</p>

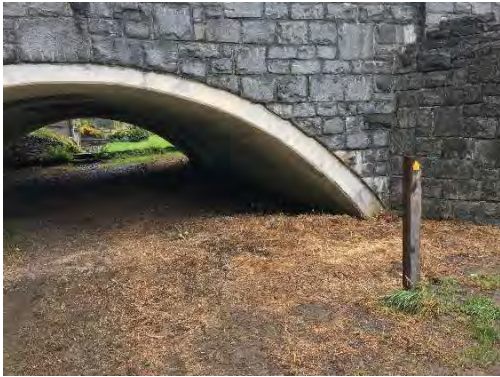
<p>Y Bala Rhif 11 (base of ramp to Tryweryn Terrace)</p> <p>Access control barrier: None.</p> <p>Path gradient: c. 1:20. No clear level landings.</p> <p>Surface material: Unsurfaced, bare earth footpath. Loose stone surface (>10m) under bridge arch. Footpath informal and uneven, no step level >15mm noted. Bridge arch restricts clear walking tunnel to less than 2.1m (vertically) clear of footpath. Nettles reduce clear walking tunnel to less than 1m (horizontally) at field gate.</p> <p>No seating provided.</p> <p>No litter bins.</p> <p>Directional waymarker signage is present throughout.</p>	<p>BARM recommends path surfaces be 'hard and firm with very few loose stones (no bigger than 10mm)' and that 'the ideal is non-slip, well-drained, level path'. BS 8300 recommends 'an access route should have a firm, slip-resistant and reasonably smooth surface. Cobbles, bare earth, sand and unbonded gravel should not be used'.</p> <p>BS 8300 recommends that where an access route has a gradient steeper than 1:60, but not as steep as 1:20, it should usually have a level landing for each 500 mm rise of the access route. On access routes with a gradient not steeper than 1:30, a level resting place adjacent to the route may be provided as an exception'</p>	<p>Opportunities for widening and resurfacing of this path considered outside the scope of the Llyn Tegid Reservoir Safety project.</p> <p>Opportunities to improve gradient / provide level landings considered outside the scope of the Llyn Tegid Reservoir Safety project</p>

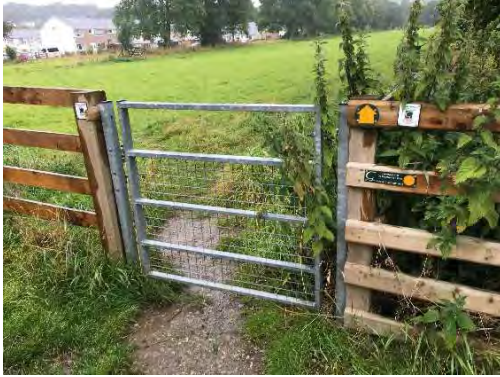
<p>Y Bala Rhif 11 access control</p> <p>Access control barrier (adjacent to Tryweryn Terrace): Steel field gate. 1.0m wide; self-closing; one way opening.</p> <p>Path gradient: c. 1:20. No clear level landings.</p> <p>Surface material: Unsurfaced, bare earth footpath.</p> <p>No seating provided.</p> <p>No litter bins.</p> <p>Directional waymarker signage present.</p>	<p>Access control barrier does not comply with recommendations set out in BS 8300 (2-way self-closing gates may be used, but not revolving gates, turnstiles, kissing gates or A-frame barriers) or BARM (no steps, or stiles or other physical barriers restricting access).</p>	<p>Removal of the access barrier altogether is unlikely to be an option in this area as the PRow runs through farmland; replacing the gate is considered outside the scope of the Llyn Tegid Reservoir Safety project.</p>

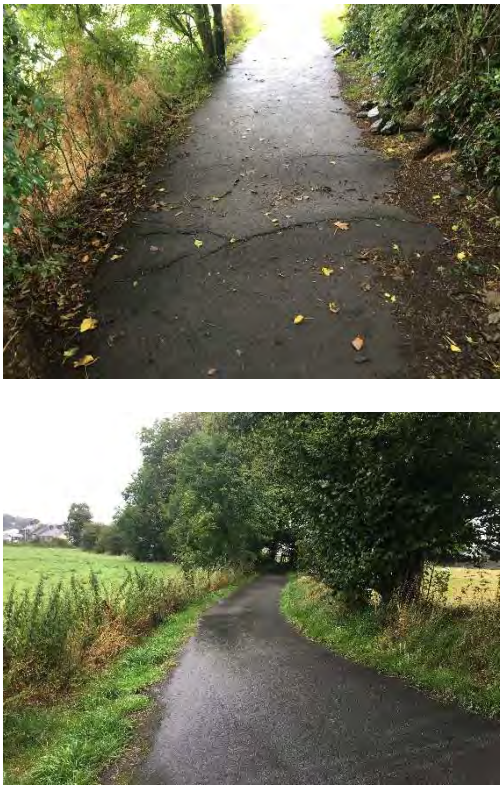
<p>Surface material: Tarmac surfaced. Uneven tarmac caused by root disturbance has led to step level changes >15mm at some points.</p> <p>No access control until the end of the footpath, path is wide enough in parts for a small vehicle to drive down.</p> <p>No seating along this route (or within 150m either side of the starting points of this route).</p> <p>No litter bins.</p> <p>No signage noted along the route. There are two spurs off the route, one is also Y Bala Rhif 5 and one is not (see R5/03 and R5/04). Signage would be useful at these points to clarify direction of PRoW.</p> <p>Some vegetation hangs low along this footpath (difficult to tell if it falls below 2.1m clear of the footpath).</p>	<p>BARM recommends the maximum distance between resting spaces in 300m. BS 8300 recommends that seating should be located such that it and its users do not reduce the access route width below 1.8m when in use by a variety of people.</p>	<p>This location is quite remote from the Llyn Tegid Reservoir Safety project, therefore no scope to deliver improvements.</p> <p>Suggestions below may be considered by GCC/ SNPA/ BTC as future opportunities.</p> <p>Additional seating / resting spaces along this route would improve compliance with BARM, although scope for this may be limited as path widths are relatively restricted, addition of seating along this route may reduce the access route width to below 1.8m in parts, which reduces compliance with BS 8300.</p>

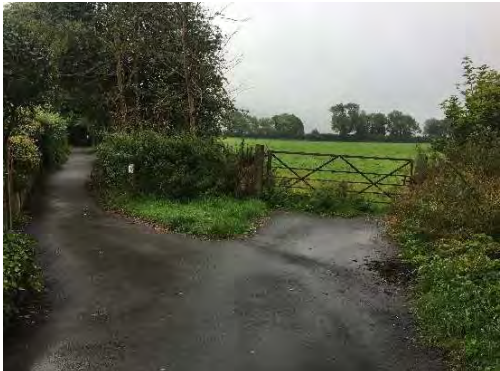
<p>Maintenance access gate off Y Bala Rhif 5. (Gate leads onto farmland, no public access)</p> <p>Access control barrier: Steel field gate. c. 3m wide, presumed vehicular maintenance access gate for farmland.</p> <p>Path gradient: c. 1:20 + (no topographic survey information for this area); length c. 2m; rise c. 0.1m, width c. 3m.</p> <p>Surface material: Path is tarmac surfaced as a continuation of Y Bala Rhif 4. No step level >15mm noted.</p> <p>See R1/06 for seating, litter bin and signage information.</p>	<p><i>Access barrier is not continuation of Y Bala Rhif 5, and therefore not considered.</i></p> <p>BS 8300 recommends that signage reaffirm directions on a route that continues over a long distance or at changes in direction.</p>	<p>This location is quite remote from the Llyn Tegid Reservoir Safety project, therefore no scope to deliver improvements.</p> <p>Suggestions below may be considered by GCC/ SNPA/ BTC as future opportunities.</p> <p>Given that some Y Bala Rhif 5 does run through farmland, a directional waymarker sign would be useful here to confirm that the PRoW continues to the left, and that there is no public access through this gate.</p>

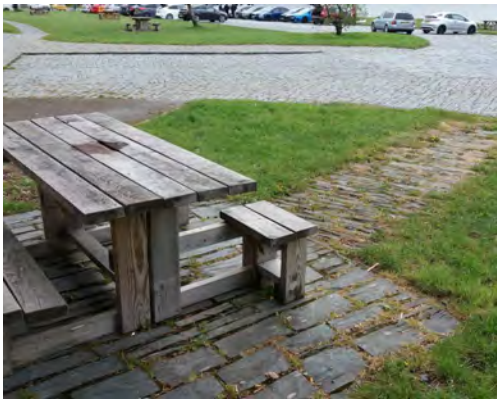
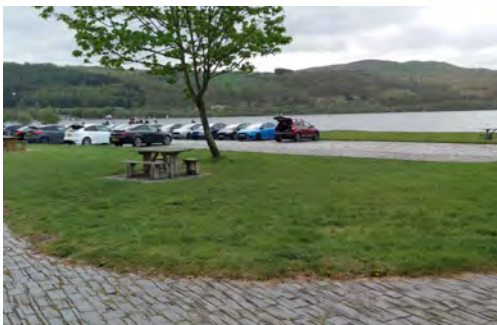
<p>Foreshore car park seating</p> <p>Nine benches noted in total, two are connected to the footpaths via small stone paved paths. Two dropped kerbs noted. Ramped access to both seating areas (c. 1:30 and >1:60), width c. 1.8m.</p> <p>Grass between stone pavers and uneven slabs mean the surface isn't 'level' in parts, paving joints don't appear to comply with recommendations set out in guidance.</p> <p>Others sit on stone paved bases within the grass, despite being level to the ground and on relatively flat areas of grass, lack of hard surfacing connecting benches to footpaths means benches are not accessible.</p> <p>Several benches leave a gap in between seating, presumably to enable wheelchairs and other mobility vehicles to sit at the table comfortably, so ensuring the benches are accessible would improve this area.</p>	<p>Access to seating is not compliant with BS 8300, 'where joints are filled but recessed below the surface, the difference in level between adjacent units should not be greater than 2mm, with joints not wider than 10mm and recess not deeper than 5mm'. BARM recommends path surfaces be 'hard and firm with very few loose stones' and that 'the ideal is non-slip, well-drained, level path'.</p> <p>BARM recommends that the ideal path surface is non-slip and well-drained. BS 8300 recommends an access route should have a slip-resistant and reasonably smooth surface. Bare earth should not be used.</p> <p>Access for all acknowledges mown grass as an acceptable surface material, provided it is appropriate to the location and local landscape character.</p>	<p>Opportunities to improve surfacing considered outside the scope of the Llyn Tegid Reservoir Safety project.</p> <p>Opportunities to improve surfacing considered outside the scope of the Llyn Tegid Reservoir Safety project.</p>

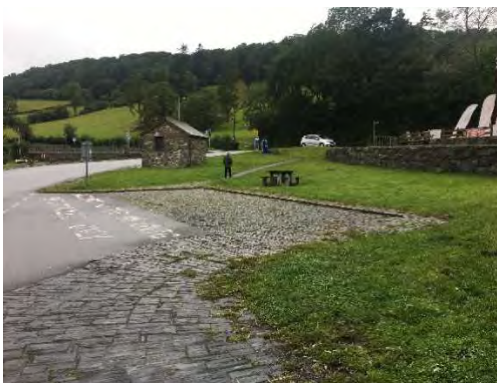
<p>Foreshore car park (formal)</p> <p>Surface materials: Tarmac and paved stone. All car parking spaces are stone paved, tarmac used purely for road surfacing.</p> <p>Access: Two dropped kerbs noted connecting the car park to surrounding raised, both at the west side (one connects motorcycle bay to footpath, another to a small area, possibly a loading bay or coach parking for 2 coaches). No tactile paving noted.</p> <p>No designated disabled car parking spaces noted.</p> <p>No bicycle parking noted.</p>	<p>Access is not compliant with BS 8300, 'where joints are filled but recessed below the surface, the difference in level between adjacent units should not be greater than 2mm, with joints not wider than 10mm and recess not deeper than 5mm'. BARM recommends path surfaces be 'hard and firm with very few loose stones' and that 'the ideal is non-slip, well-drained, level path'.</p> <p>There is an opportunity to provide cycle parking in the area, in accordance with recommendations for cycle parking set out in BS 8300, to improve overall parking provision in the area. Consider provision of accessible litter bins for people using picnic benches.</p>	<p>Opportunities to improve surfacing considered outside the scope of the Llyn Tegid Reservoir Safety project.</p>

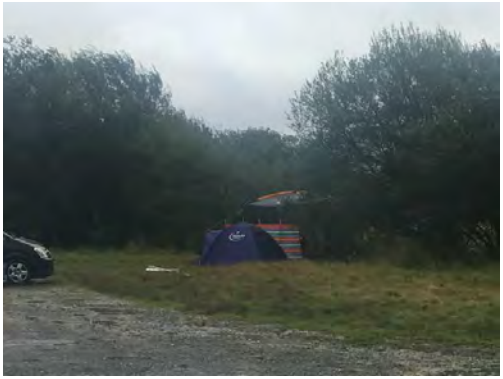
<p>No seating. No signage. No litter bins.</p>
