Dee Conservancy Statutory Harbour Authority

Fatal Accident Investigation Report

Fatality of a Licensed Cockler within the Dee Estuary Fishery 28th August
2020

Report compiled by the Dee Conservancy Harbour Master

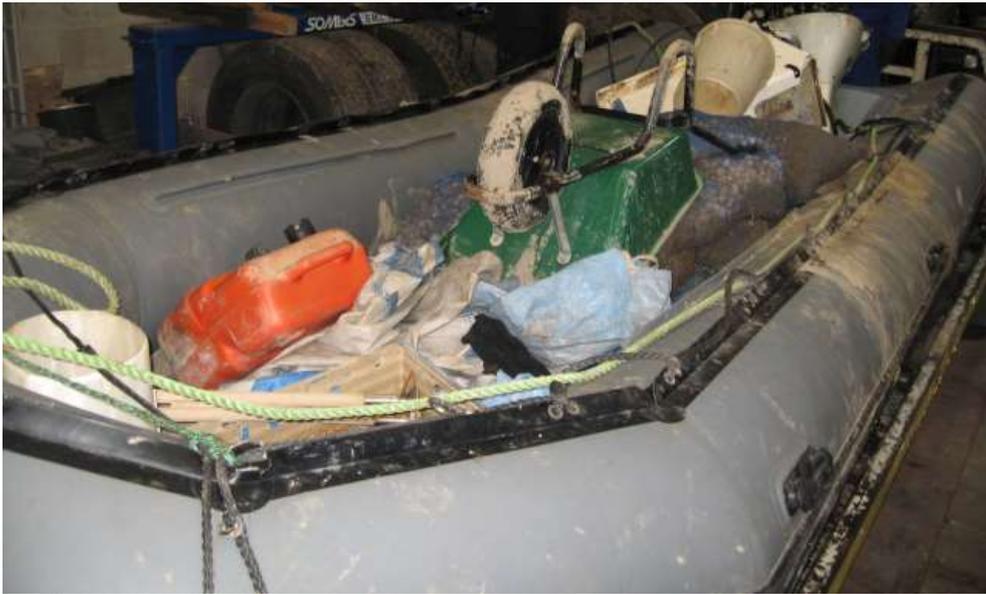
Image One

- 1) The vessel had not capsized as had been stated in some early reports, as the boat was still filled with cockle sacks and equipment. (Images 1 and 2)
- 2) Items in the boat had at some point previously been moved from their initial position as some of the cockle sacks were laying on top of the control console and engine. It was reported the cockle sacks had been removed from the boat during recovery ashore to lighten it and make man handling possible. (Image 3)

Boat in police secure storage as recovered ashore, bow view, gear onboard.

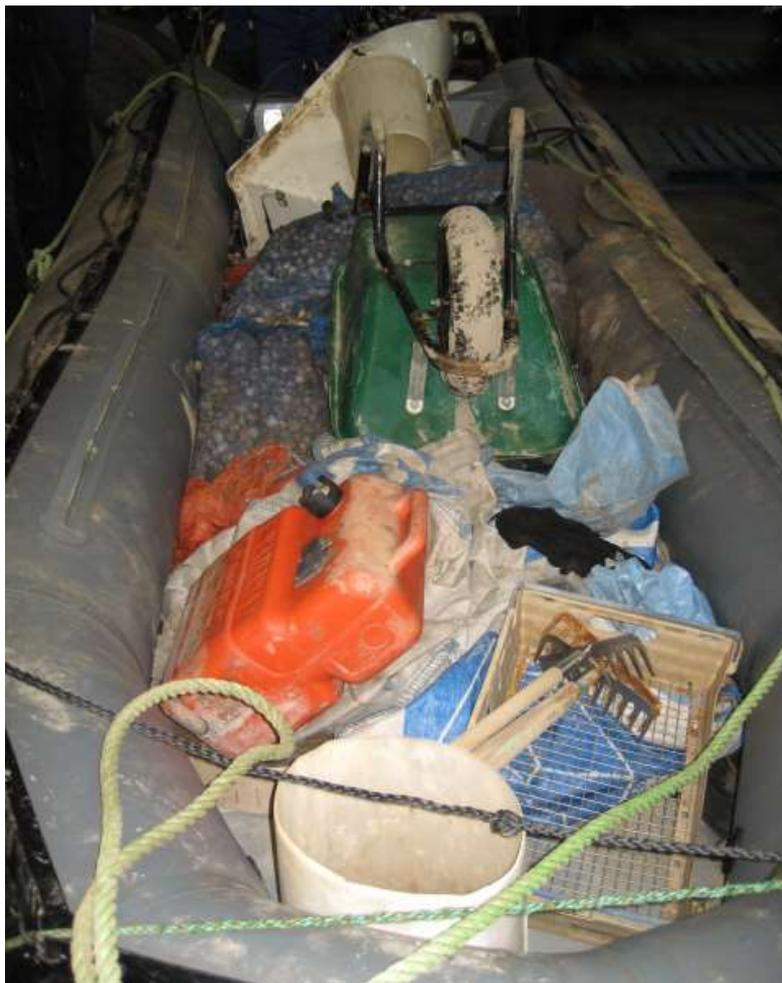
Image Two

Boat in police secure storage as recovered ashore, head on view, gear onboard.

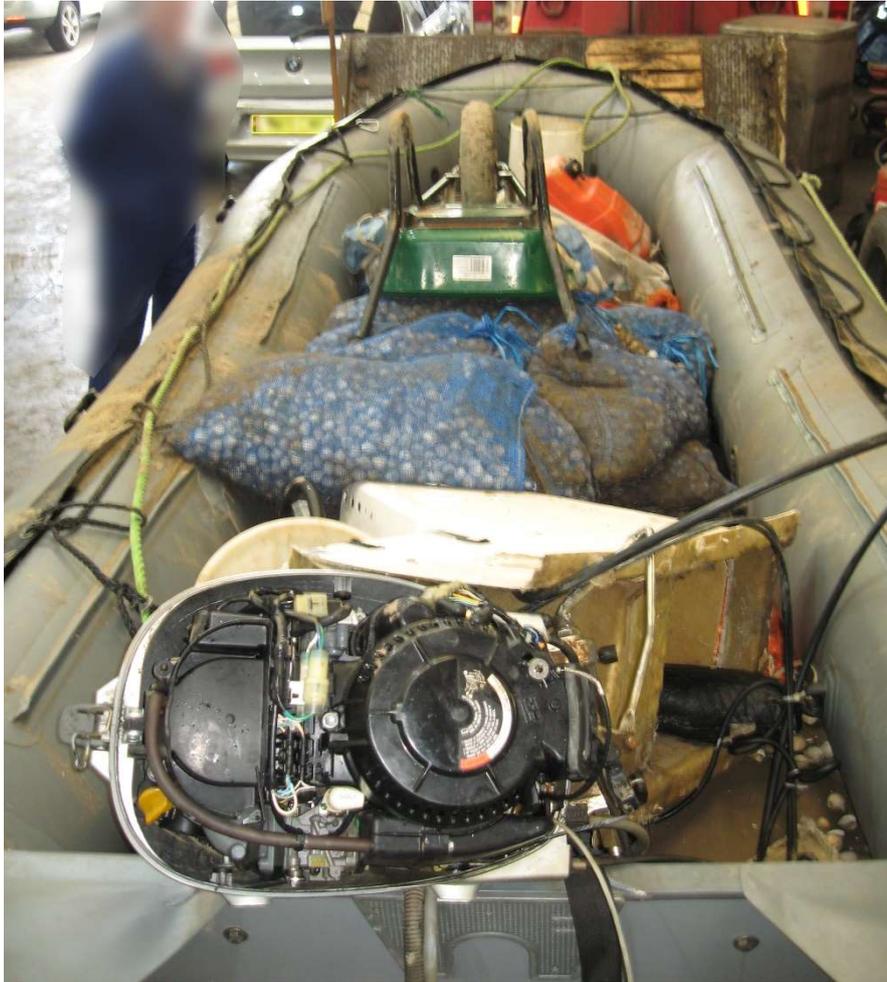
Image Three

Boat in police secure storage as recovered ashore, stern view. Engine and consul position on the floor, gear onboard.

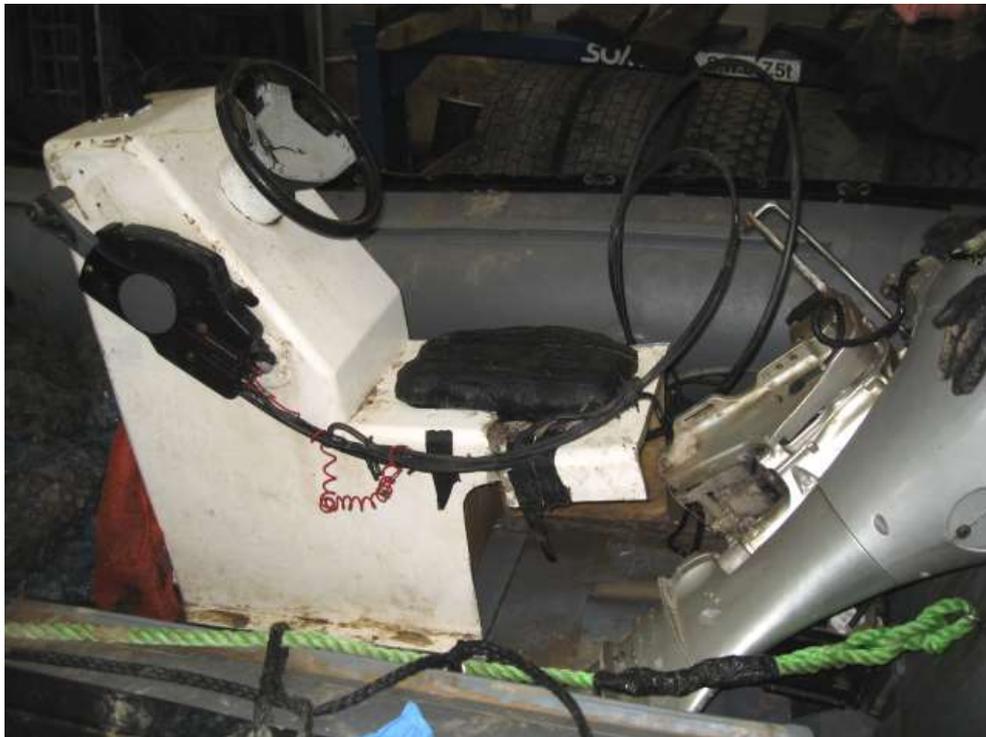
Image Four

- There were no apparent signs of impact to bow, stern or the visible part of lower hull
- The throttle was in the full ahead position.
- The kill cord (engine stop) was in position but wrapped around throttle cables. (Image 4 & 5)

- The ignition was off.
- Damage to steering wheel centre noted but it was not evident when this occurred.
- Consul seat was broken and had some evidence that this had been repaired with duct tape. It also appeared to have been cut smaller to fit. Stbd side appeared to have old damage, port side damage appeared recent, possibly as result of the incident.

The retrofitted consul was in poor condition and the nature of the boat's floor meant securing arrangements were weak and ineffective. The seating position was in close proximity to the engine power head. (Image 4)

Control consul stood up in position. Note poor condition of the consul; cracked between black tape and cut short to fit leaving no support on the left side.

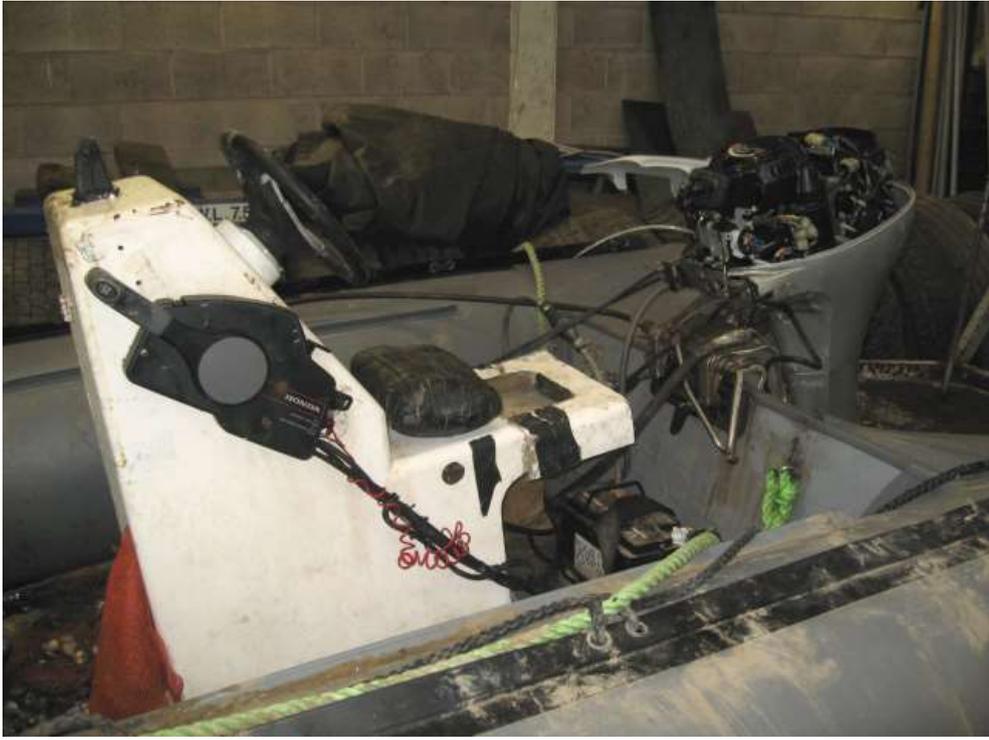
Image Five

- There was no evidence of impact damage to front of the 'leg' of gear box at the bottom.
- The steering arm mechanism was bent forwards and slightly down.

Control consul stood up in position and engine loosely refitted onto the transom board. Note engine throttle in full ahead position, kill cord fitted but helm end wrapped around control cables and heavily bent steering control arm.
