# **Flood Investigation Report**

## **St Asaph and Elwy Communities**

Storm Ciara  
9<sup>th</sup> February 2020

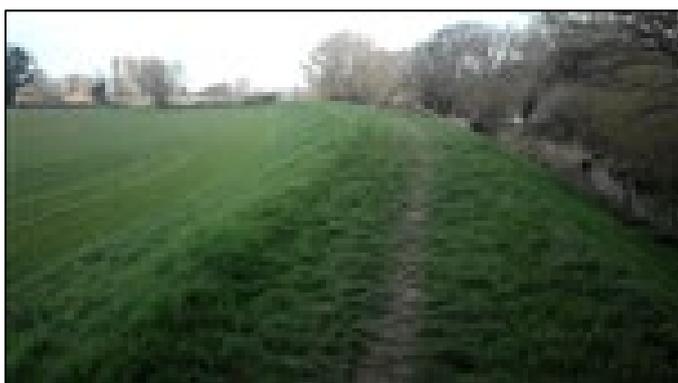
Figure 22: Elwy Fishermans Bridge Embankment (NRW, 2019)

The Elwy Fisherman's Bridge Embankment (Figure 22) was not raised during the scheme as modelling showed the crest levels were sufficient to contain the 0.5% AEP flood. At the time of the last inspection in October 2019 the embankment was in Good condition. Subsequent post-event (February 2020 & February 2021) and (May 2020) routine inspections record the embankment condition as Fair with comments "*is stable and only suffered minor erosion damage*".

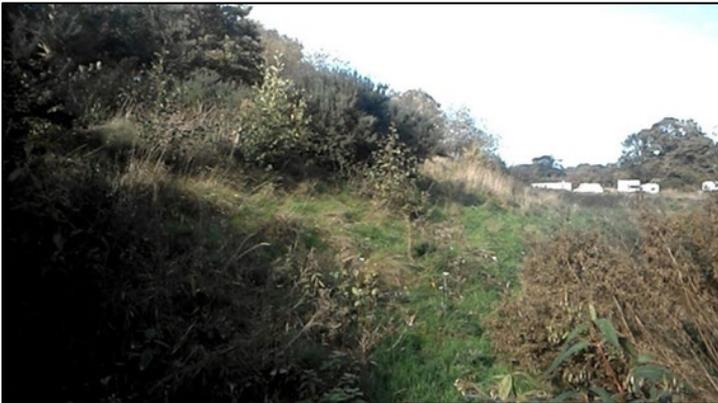
*Figure 23: Elwy Mount Embankment (NRW, 2019)*

A short section of the embankment was in Very Poor condition during the October 2019 asset inspection due to excessive vegetation growth and motorcycle damage. NRW are currently working with landowners in the area to refurbish and maintain flood risk management assets to a good condition.

### **Recommendation 1.2 – NRW – Work with the landowners of Elwy Mount embankment to restore the flood risk management asset back to good condition.**

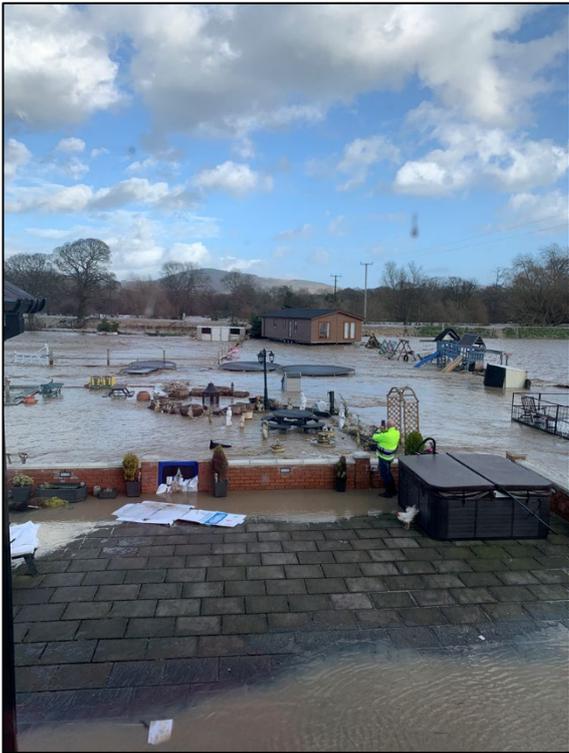
Initial reports from NRW operatives on site stated that flooding began to occur just downstream of Spring Gardens Bridge on the left bank (See Figure 34, Figure 35& Figure 36), but based on observed water levels (Figure 31) it is possible other areas of raised defence in the lower reaches (downstream of Spring Gardens Caravan Park) of the Elwy started to overtop before this. Multiple sources later confirmed that during the event significant lengths of the Elwy Fishermans Bridge Embankment (EMB1500412) experienced overtopping, >200mm for approximately 1.5 hours (see Figure 32 & Figure 33 below).

Figure 32: Extensive embankment overtopping at Dol Afon (Elwy resident, 2020)

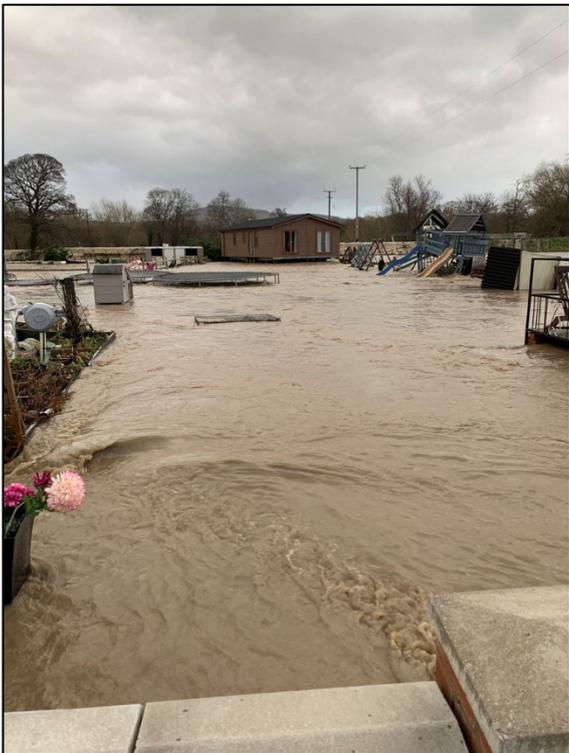
Figure 33: Extensive embankment overtopping at Dol Afon (Elwy resident, 2020)

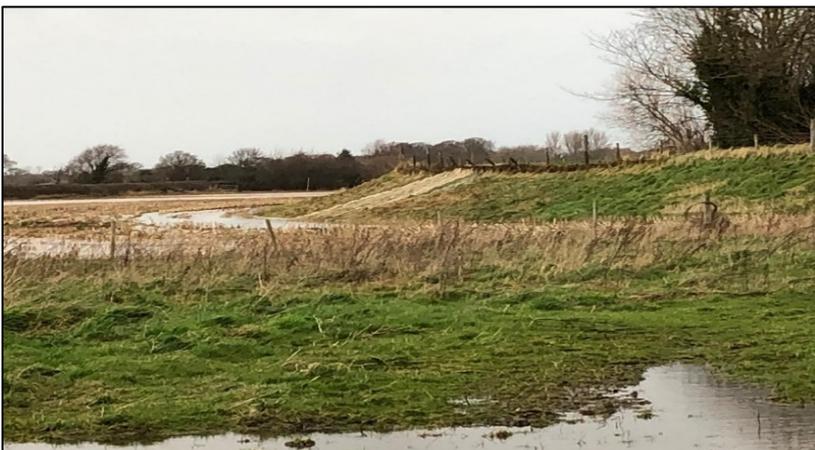
Figure 36: Phase 3 – Minimal overtopping at EMB1500412 (NRW 2020)

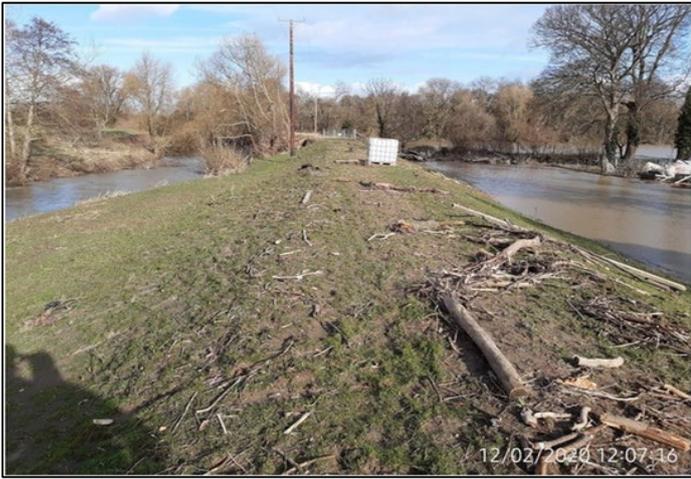
Figure 37: Wrack & debris deposits signifying overtopping location (NRW, 2020)

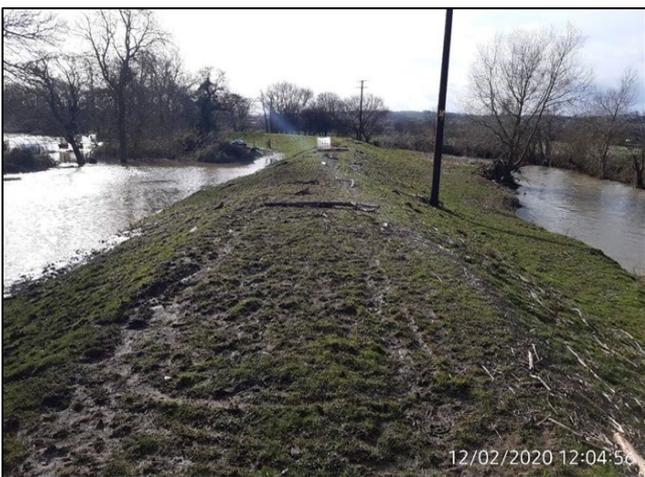
Figure 39: Wrack & debris deposits on the riverside face (NRW, 2020)

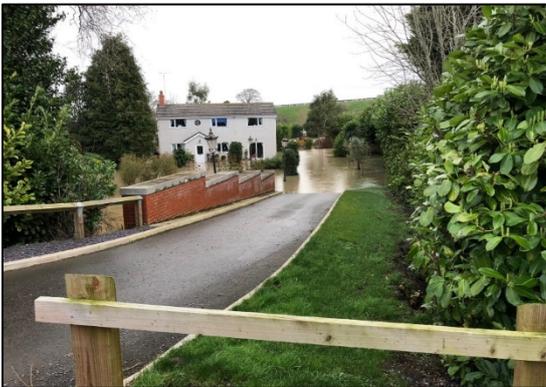
*Figure 41: Residential property flooded on Elwy RB (NRW, 2020)*

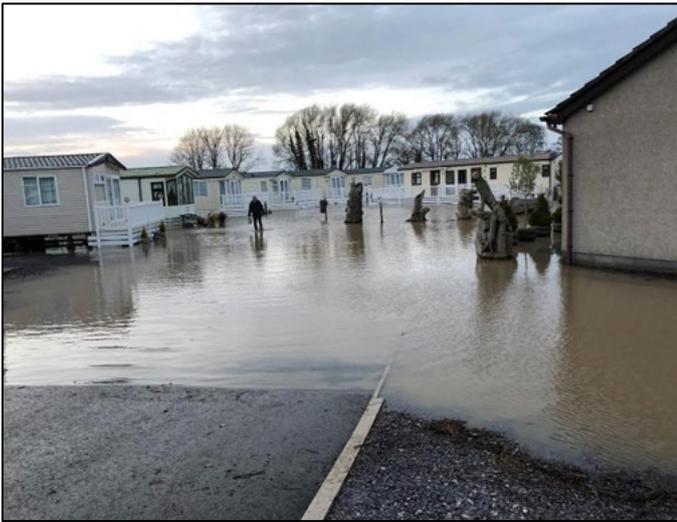
Figure 43: Spring Gardens Caravan Park flooding (NRW, 2020)

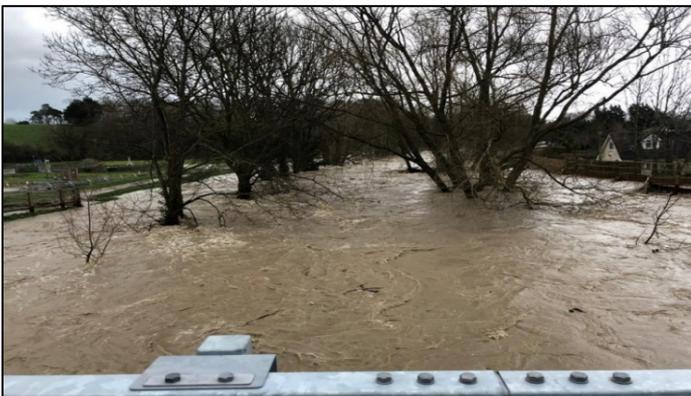
Initial investigations into the factors which caused the overtopping at this location pointed to the main reason being channel exceedance (Figure 44) due to a significant storm event affecting the upper catchment. It is probable that hydraulic afflux (localised raising of water levels) occurred in the immediate vicinity of the STW embankment due to the dense, mature trees on the riverbank berm. Water levels may also have increased locally due to super elevation caused by the volume of water passing around a slight bend in the river channel at this location. A build-up of debris in the channel profile impacting available cross-sectional area and reducing conveyance efficiency may also have exacerbated water levels but it is difficult to ascertain the full impact due to the high debris loading already in the system during high flow events.

Figure 44: Elwy river levels 09-02-2020 (NRW, 2020)

**Recommendation 2.1 – NRW – Undertake a performance review for the 2018 St Asaph Flood Risk Management scheme.**

## **Recommendation 2.2 – NRW – Using the hydraulic model, investigate the flow mechanisms and sensitivity of various parameters which may be impacting water levels at St Asaph STW Embankment.**

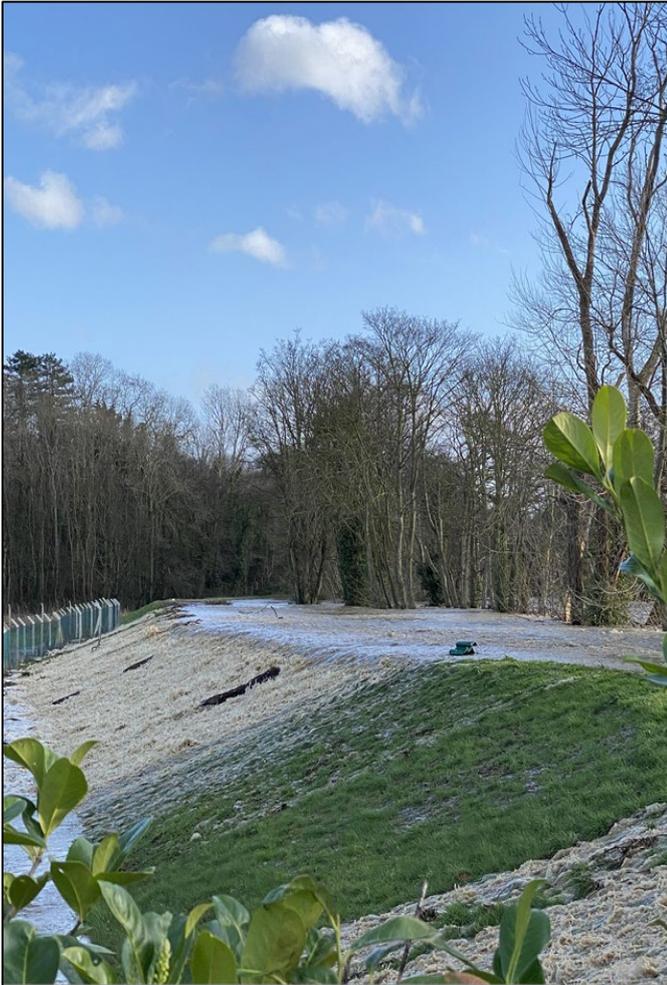
Figure 46: Overtopping of RB EMB1800067 (Resident Photo)

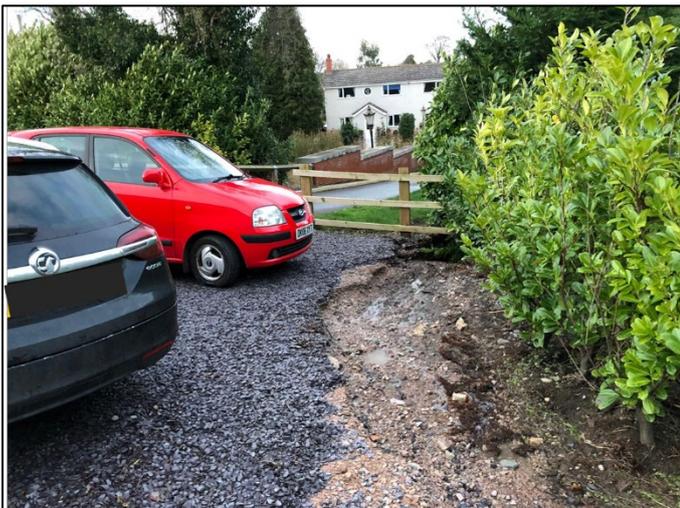
Figure 47: Localised scour caused by overtopping at the discrete low spot (NRW, 2020)

There was one area of minor scour (Figure 47), later observed to be in the approximate location of the low spot. The scour observed only at this specific location and not on the embankments is likely due to a concentrated flow route, turbulence caused at the base of the hedge and lack of grass revetment.

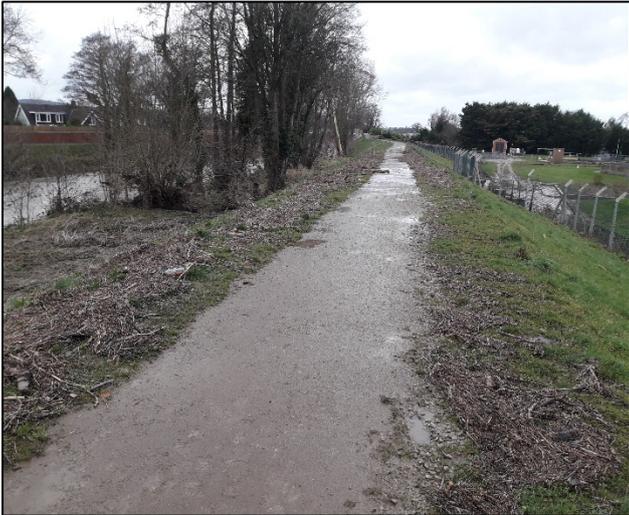
Figure 48: Line of wrack on RB STW emb (NRW, 2020)

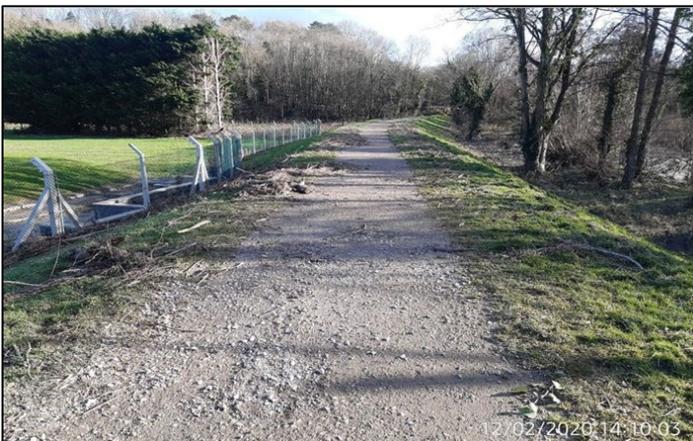
Figure 49: Post Event Inspection RB EMB1800067 (NRW, 2020)

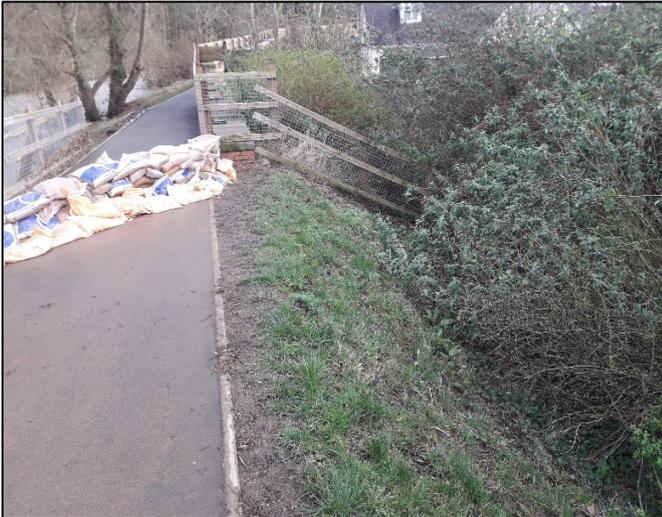
A Roe Parc resident estimated overtopping at the downstream end of Roe Parc Wall started when the manual river gauge located on the A55 bridge was reading 4.6m. Post-event investigation showed that overtopping started downstream of Spring Garden Bridge and was later observed to be pushing up smooth surfaces causing minor overtopping at Roe Parc when the manual river gauge was reading circa 4.8m. The photo below (Figure 58) was taken at the height of the flood when the manual river gauge under the A55 bridge was reading 4.9 metres. Overtopping was observed to be minimal before residents deployed sandbags (Figure 57). The role of flood wardens is highly valued and this incident shows the resilience provided by their presence on site but health, safety and wellbeing must be priority during potentially hazardous situations.

Figure 57: Sandbags placed at Roe Parc wall by residents (NRW, 2020)

### **Recommendation 3.1 – NRW – Review policy and procedure regarding the roles and responsibilities of flood wardens both in an incident and during normal working times.**

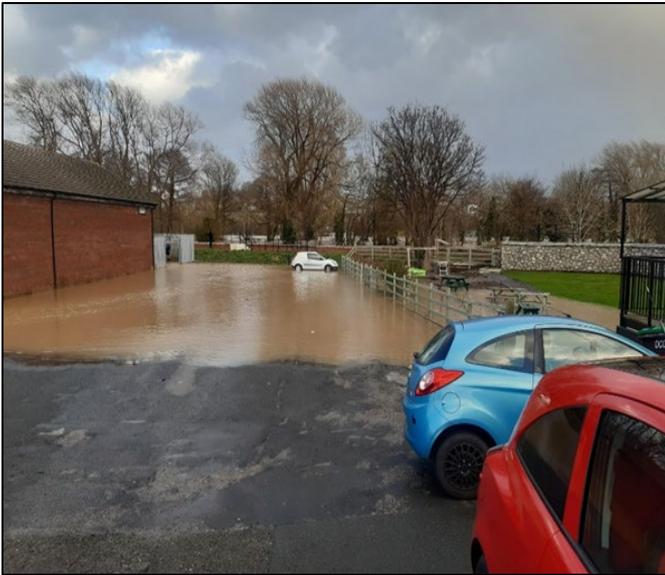
*Figure 60: Water accumulation behind embankment at New Inn (NRW, 2020)*

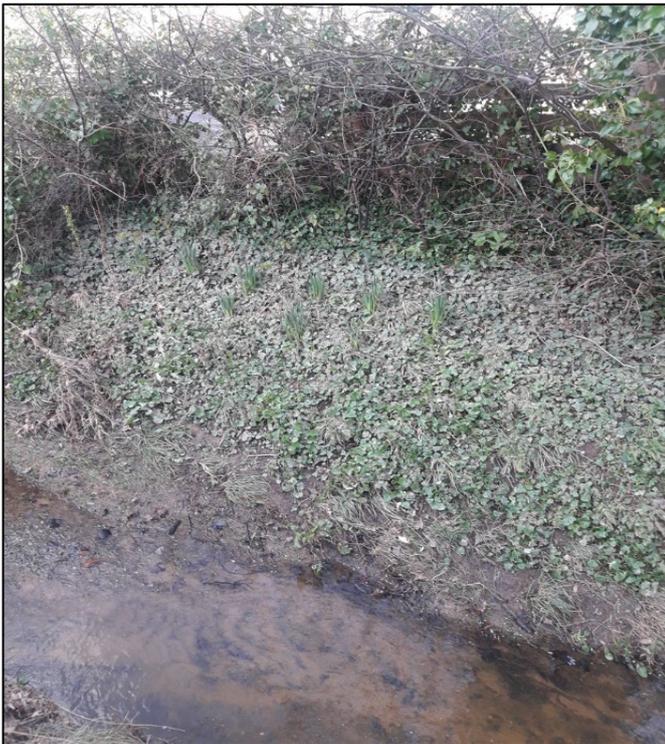
Post event inspection of the Glascoed Stream by representatives of NRW and DCC highlighted the high-water levels (Figure 63). During the event residents utilised available material to divert flood water away from property and into road gulleys and surface water systems (Figure 61 & Figure 62).

Figure 63: Silt mark Glascoed Stream (NRW, 2020)

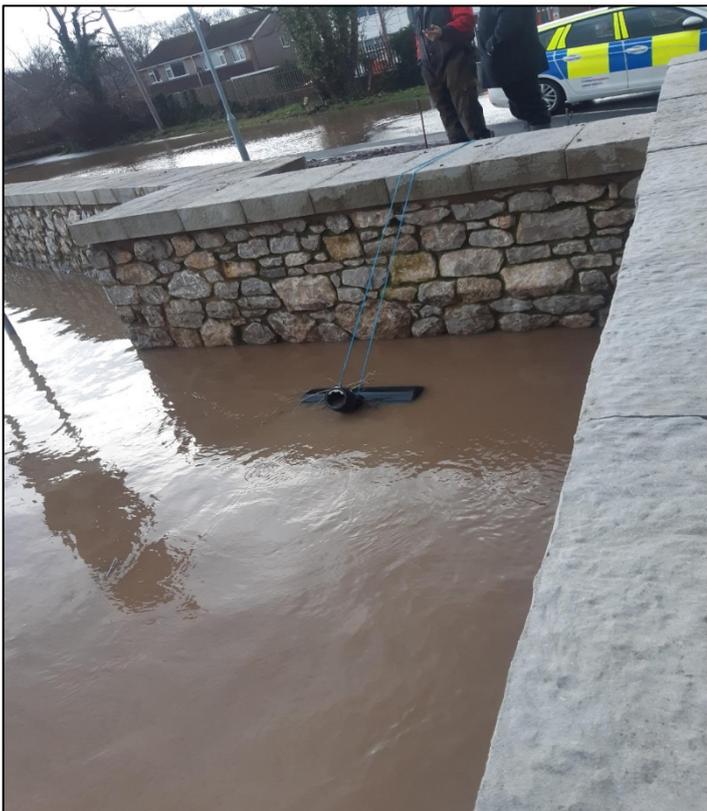
*Figure 64: Unauthorised opening of non-return valve (NRW, 2020)*

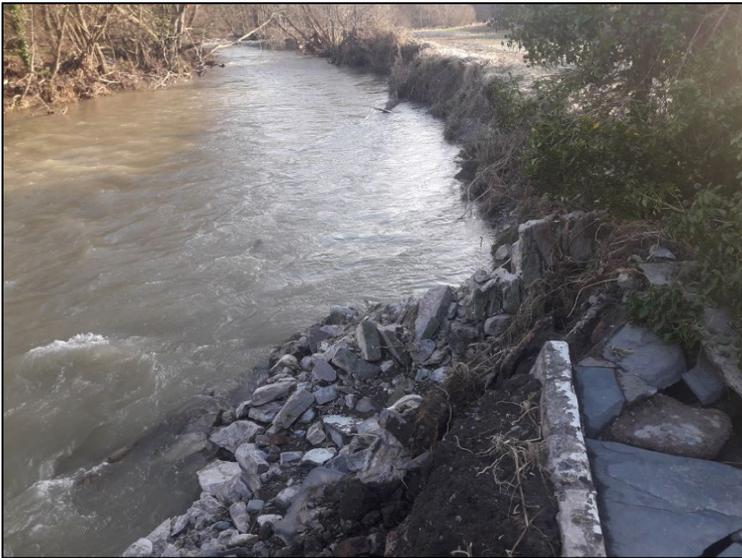
*Figure 69: Erosion to private garden, showing historic riverbank revetment (NRW, 2020)*

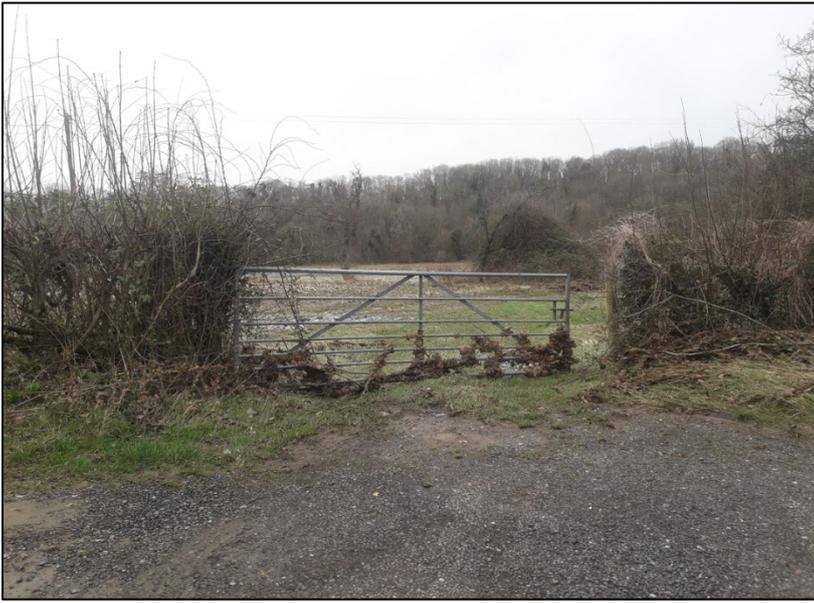
Figure 70: Wrack mark on gate showing height of flood (NRW, 2020)

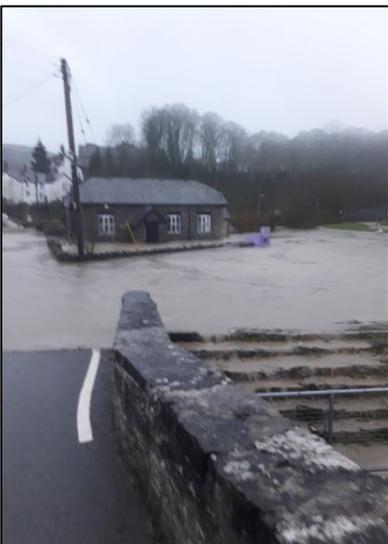
Figure 78: Flooding in Llanfair TH exacerbated by Elwy river levels (Resident photo)

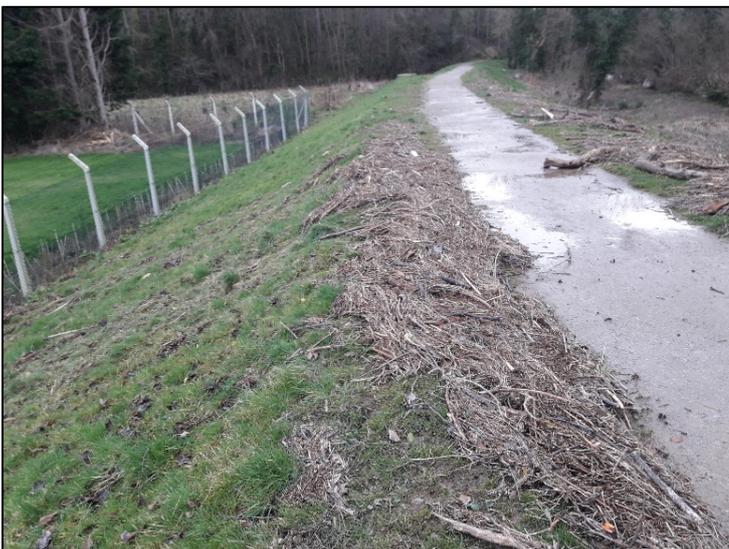
Figure 95: Overtopping location RB STW emb (NRW, 2020)
