Condition Assessments for the Designated Features of Ardal Cadwraeth Arbennig Bae Cemlyn / Cemlyn Bay Special Area of Conservation

Report No: 905

Publication date: June 2025

Title: Condition Assessments for the Designated Features of Ardal Cadwraeth Arbennig Bae Cemlyn/ Cemlyn Bay Special Area of Conservation

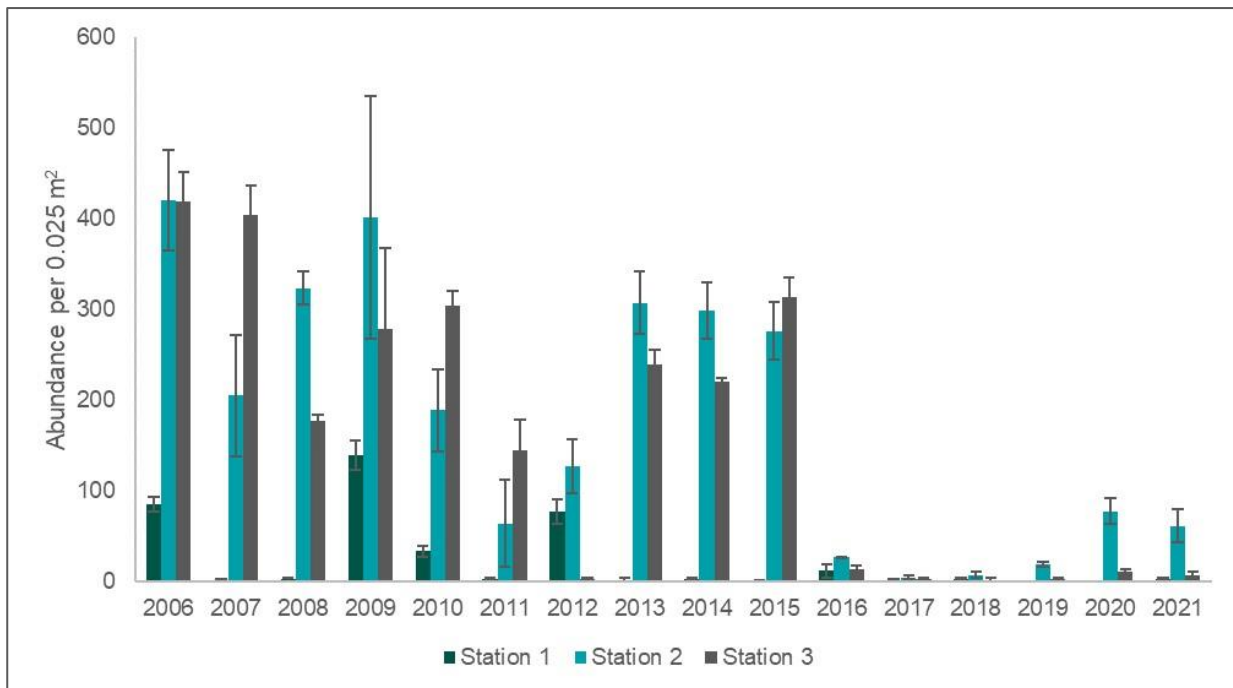
Analysis showed a relatively large shift in community composition since 2016. This shift has been driven by a decline in the Spire snail *Ecrobia ventrosa*, a lagoon specialist, and increases in more opportunistic species (i.e. smaller body sizes and shorter life spans). *E. ventrosa* was the most abundant lagoon specialist at Cemlyn with high densities in the past, before starting to decline in 2016 as seen in Figure 3. Confidence in the fail is high due to the significant shifts toward opportunistic species seen in recent years, which are strongly indicative of environmental disturbance.

Figure 3. Declines of the Spire snail *Ecrobia ventrosa* at Cemlyn lagoon. Mean (\pm Standard Error) abundance of *E. ventrosa* per 0.025 m² from grab surveys between 2006 and 2021 (5 grabs per station).

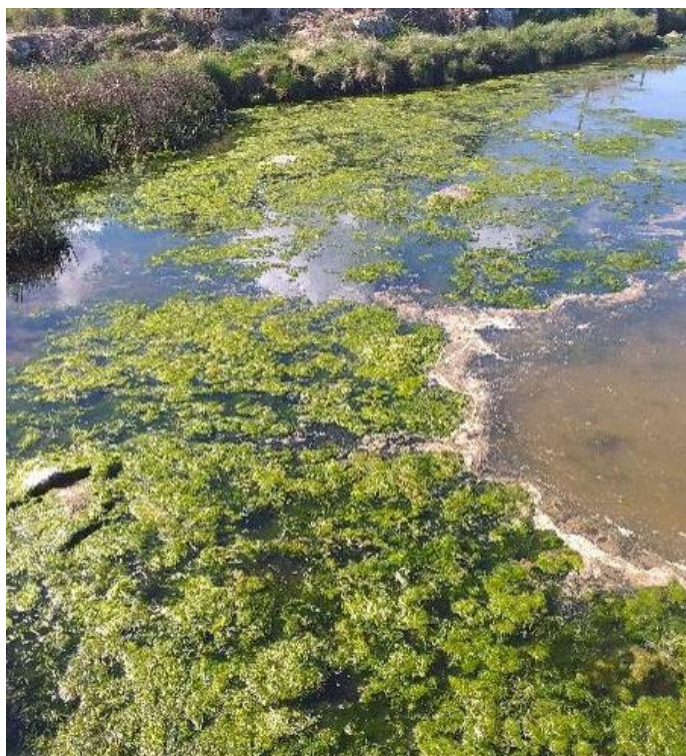
The opportunistic macroalgae indicator was assessed as failing to meet its target with high confidence due to observations of opportunistic macroalgae since 2020 (Figure 4). There were no reports of nuisance algae prior to 2020. This suggests new additional inputs have been increasing levels of nutrients to a point that produces a biological response.

Figure 4. Algal mats at Cemlyn lagoon in 2020.

This indicator failed to meet its secondary target as a large accumulation of green algae has been observed in the lagoon since 2020. The large algae mats present are a result of high levels of nutrients in the lagoon and are now considered to be abundant enough to have a detrimental impact (see above).

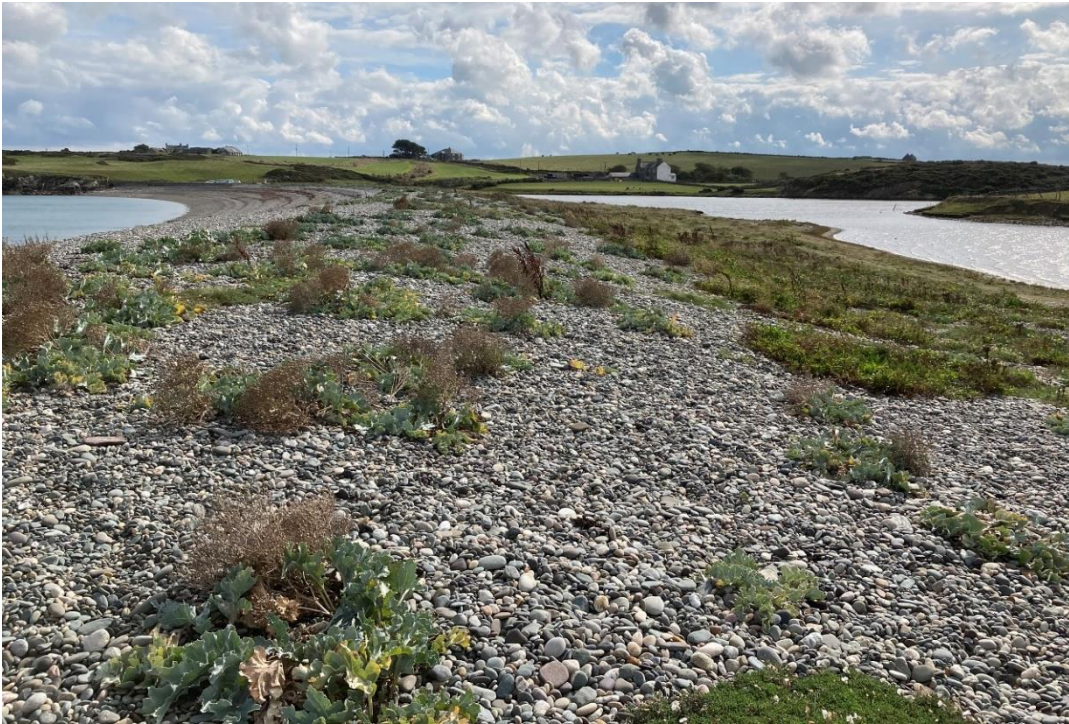
There were also no reports of grass species in the pioneer communities on the ridge when the communities were classified in 2022. Based on this information the habitat quality: shingle ridge indicator passed, but with medium confidence, as the survey did not specifically map the open shingle so no comparison to previous data could be made.

Figure 6. Shingle ridge at Cemlyn. The ridge in 2022 was considered to have sufficient open areas.
