**PROSIECT LIFE+ CORSYDD MÔN A LLŶN
ANGLESEY AND LLŶN FENS LIFE+ PROJECT**

**Restoration of hydrological and hydrochemical
regimes at Cors Hirdre, Corsydd Llyn SAC: results of
water level monitoring and hydrological
investigations 2012-14.**

Final Report of the Anglesey & Llyn Fens LIFE Project: Technical Report No. 1.

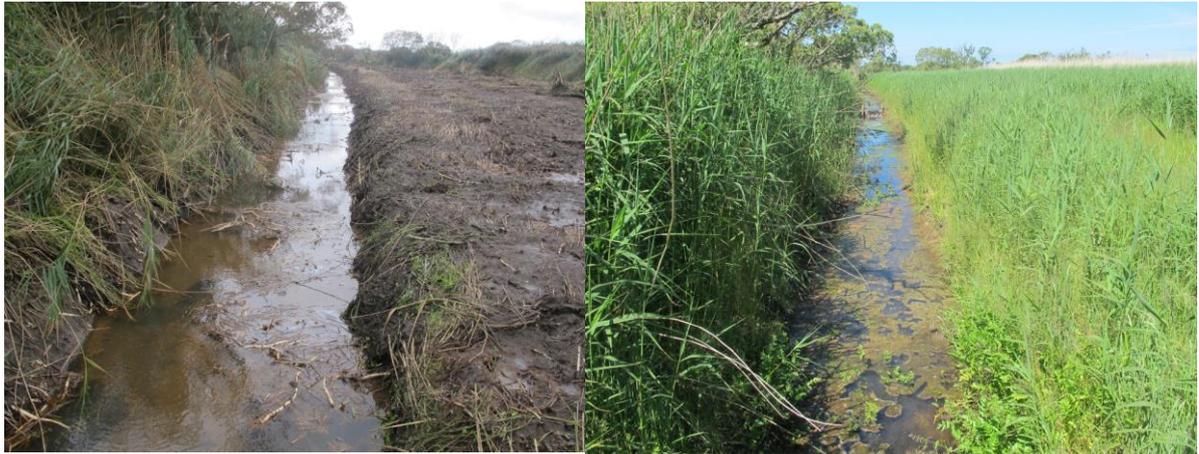
Figure 3. The main ditch at Cors Hirdre upstream (W) of the plank bridge close to dipwell DWM9. The L image (30/8/13) shows the ditch immediately after being cleaned, the R image shows the same location on 16/6/14: note the significant reed growth through the spoil (all of which was deposited on the N bank at this location) and also dam D3 in the distance of the RH image.

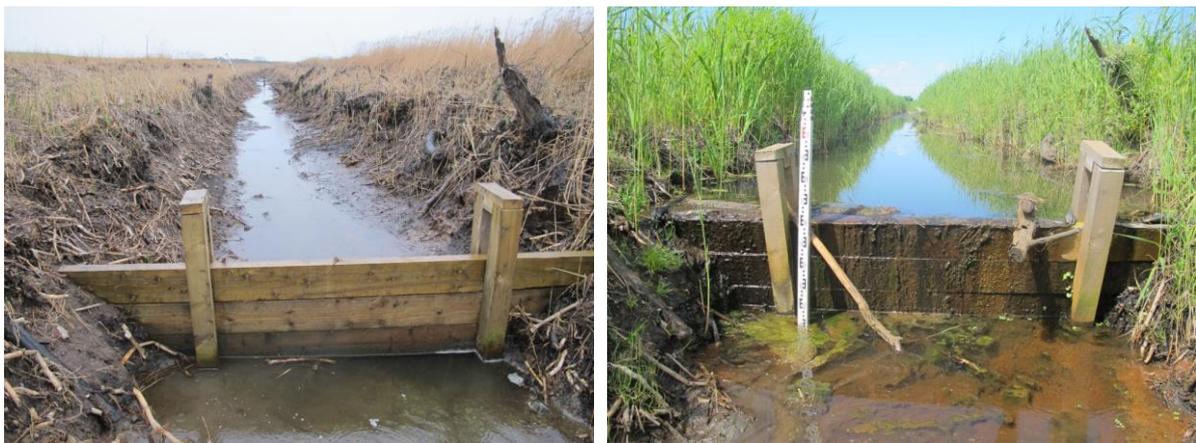
Ditch cleaning reached the position of the main M13 water level transect on 11 September and the point at which water levels dropped in the drain in response to cleaning was recorded by the datalogger at SW1 (see Figure 5 for location) as occurring between 11:00 and 12:00 on the 11th. Unfortunately, the operator had continued to desilt beneath the peat below the top of the till but probably not deeper than the original depth of the ditch. Two timber board dams (D1 and D2) were subsequently installed in the main ditch at locations west and east of the main dipwell transect (Figures 4 & 5) to raise water levels back to a position approximating to the peat/till boundary and to encourage sedimentation. Two further dams (D3 and D4) were installed further to the east in Spring 2014. Unfortunately when first visited after installation (25 November 2013) Dams D1 and 2 were suffering substantial leakage beneath the lowest timber board. On 17 December 2013 the base of both dams was backfilled with peat dug by hand, but this was also ineffective. Plastic sheeting was installed on the upstream side of Dams D1 and D2 on 19th February 2014 and this did prove effective (Figure 4), though this approach has failed to prevent ongoing severe leakage for Dams 3 and 4.

Figure 4. View of dam D2 looking upstream on 6 February 2014 (L) when dam leakage was resulting in similar water levels both up and down-stream, and 13 June 2014 (R) following measures to line the dam. The dam is sustaining a water level difference of 48.2 cm upstream (water level at dam crest) and downstream of the dam in the R hand image.

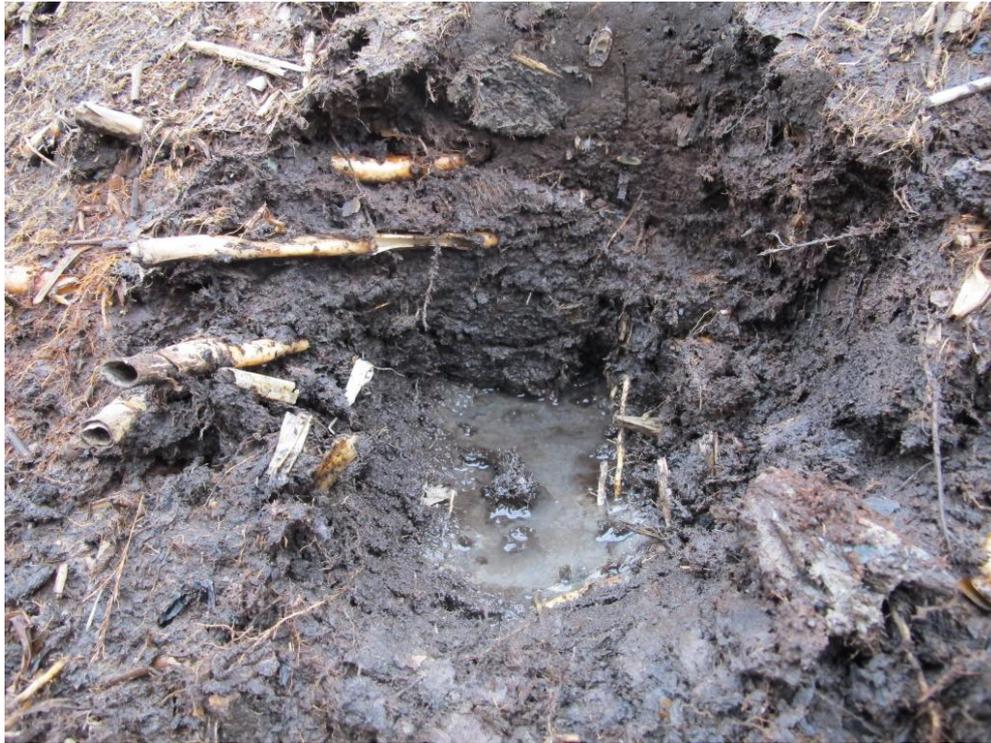
Ponding of seepage water from the overlying peat onto the surface of the clay was noted when a 'step' was cut into the side of the ditch into the overlying peat (Figure 9). The thickness of the clay could not be determined by hand augering due to its stony content, but the base of the ditch appears to have been cut into essentially similar material, suggesting a minimum thickness of 0.41 m (Table 7).

Figure 9. Accumulation of seepage water at the junction between peat and underlying till in the recently cleaned ditch section, Cors Hirdre SSSI. Location of image SH 25741.38323. The top of the till is shown by the shelf cut into the profile. Image reference IMG_3323, 29 November 2013. Image shows S bank of ditch.

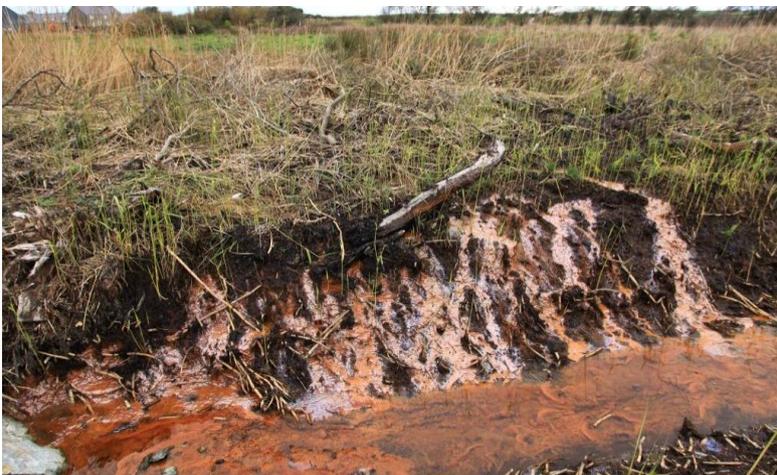
Significant precipitation of ochre was noted in the main drain during the November 2013 site visits (Figure 10), with many iron rich seeps (and oily bacterial films) noted entering the drain from the surface of the peat profile down to (and beyond) its junction with the till. This is likely to be due to oxidation of reduced ferrous iron as groundwater discharges onto the ditch face following years of strongly impeded drainage during which excess water is likely to have ponded on the surface and then gradually dissipated as surface flow along the ditch axis. Whether this is a temporary effect remains to be seen. Raising water levels within the ditch at least to the level of the peat/till interface and then establishing mini linear constructed wetlands in-between dams could be used to trap and treat ochre *in-situ* should it remain an issue. The N side of the ditch face appears to be associated with the most pronounced ochre.

Figure 10. Ochre deposition resulting from seepage onto N face of recently cleaned ditch at Cors Hirdre, 25 November 2013. The boulder just visible to the left is immediately downstream of Dam 1 at SH 25691.38332. View looking NNE with Hirdre Isaf farm visible top left

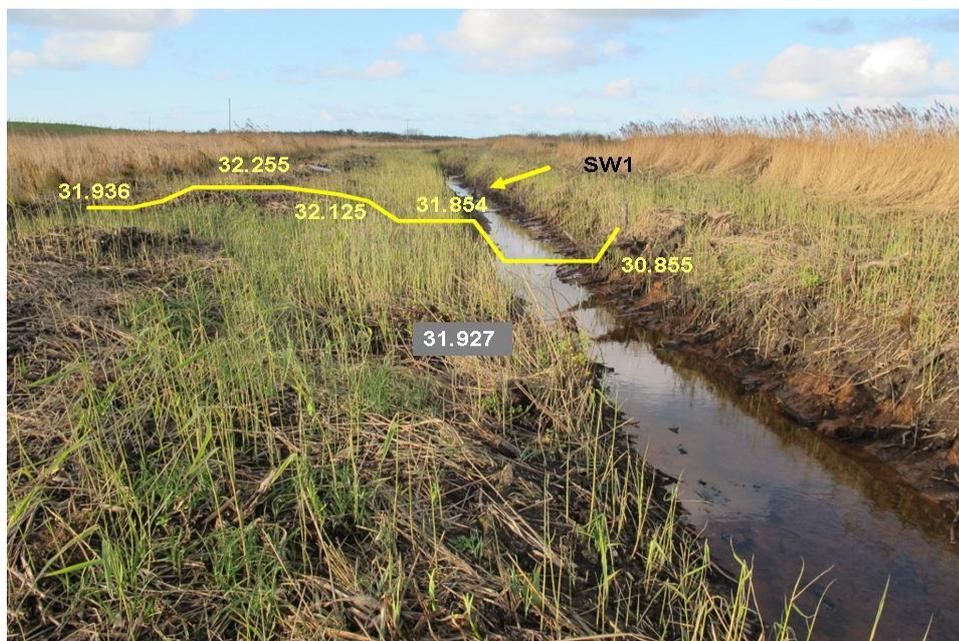
Substantial deposition of ditch arisings has occurred on both sides of the ditch (Figure 17), despite efforts to ensure this was focussed on the opposite (N) side of the ditch to the main stands of alkaline fen vegetation. The predominantly organic nature of the spoil confirms the digger operator generally avoided over-deepening beyond the original drain profile. Removal of at least a proportion of the spoil to the side opposite the alkaline fen would be desirable. The spoil will encourage ponding of water in the alkaline fen (undesirable) but by the same token it will help reduce drainage to the drain should adequate control of drain levels prove difficult. Some of the spoil could be replaced within the ditch profile to aid creation of a ditch floor corresponding to the base of the peat, or even slightly higher.

Figure 17. The main axial ditch looking west from dam D2 at SH25776.38312, 4 December 2013. The yellow profile is diagrammatic and note the ditch cross section and the rising pile of ditch arisings to the left (south of the ditch) with key measured spot elevations (m aOD) shown in yellow. The level in white with the grey background denotes the level of the occasional drainage points left by the digger operator to carry excess water to the drain – see also Figure A.3.5. Location SW1 is a short distance upstream of the conceptual profile. Note young reed growth (still green) to 1 m high through the spoil on both banks, compared with the full seasons (2013) growth (dead material) to the far right. This photograph was taken before work to ensure correct operation of the timber dams.

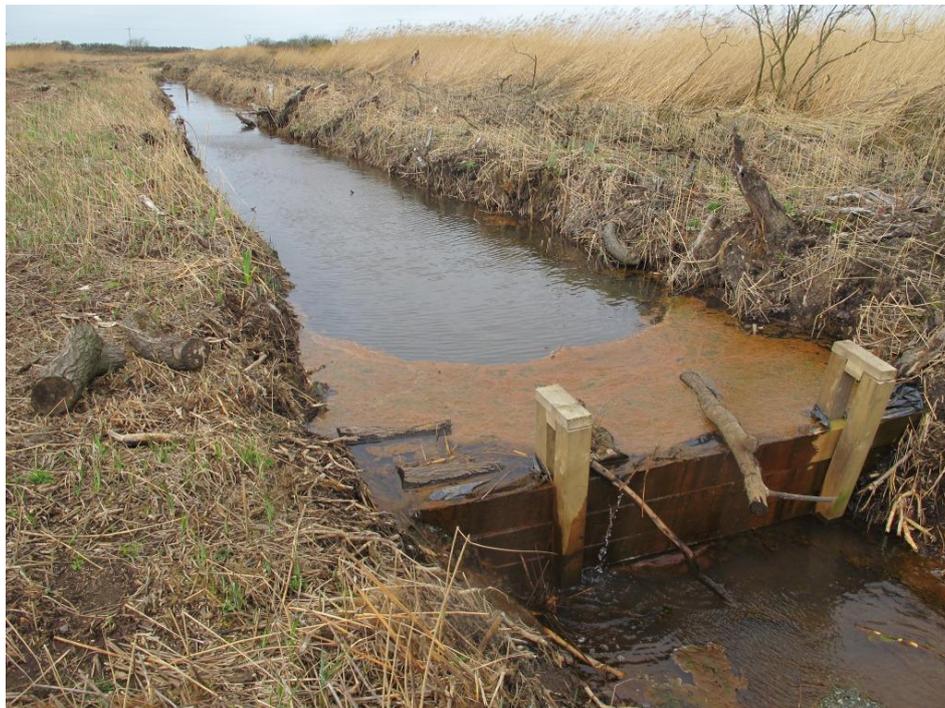
Figure 18. Water levels in the recently cleaned main drain upstream of Dam D2, 19 March 2014. The water level upstream of the dam is probably slightly above the base of the peat in this image, this is the recommended level.

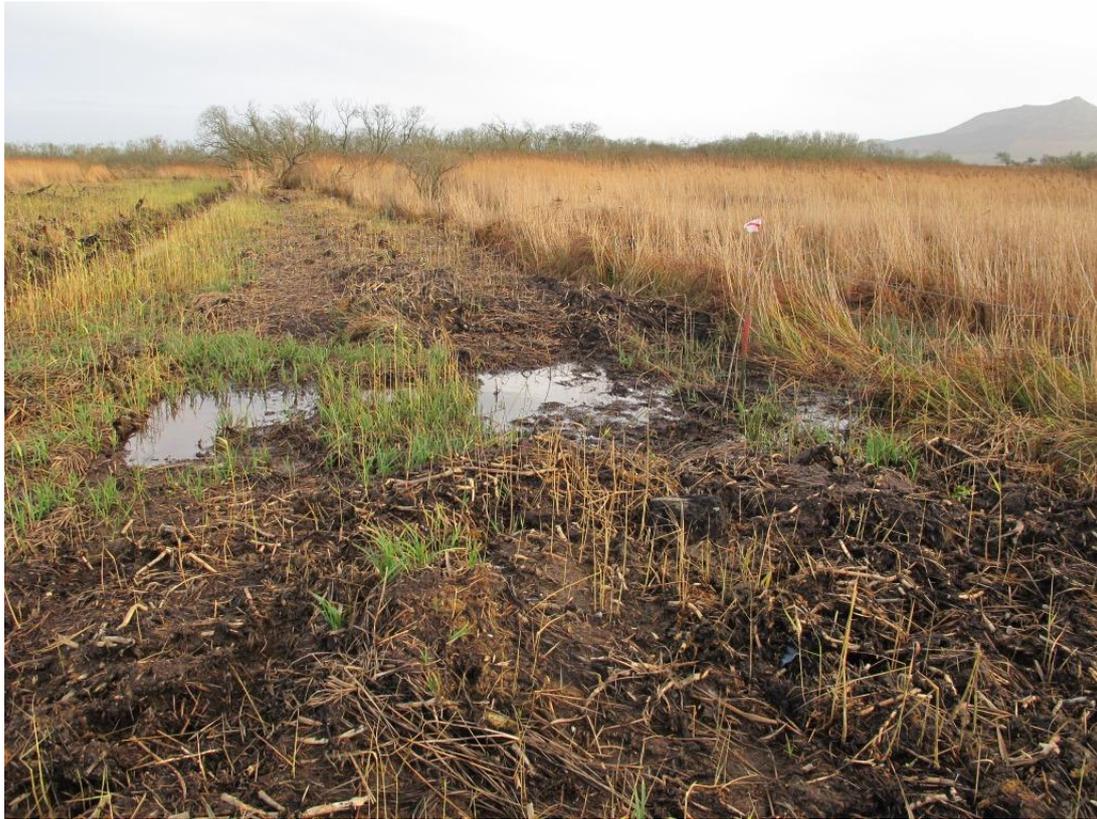
Figure A.3.5. Looking east along S side of recently cleaned ditch with dipwell DW5 flagged to right. A channel (flooded) has been left in the spoil bank by the digger operator.

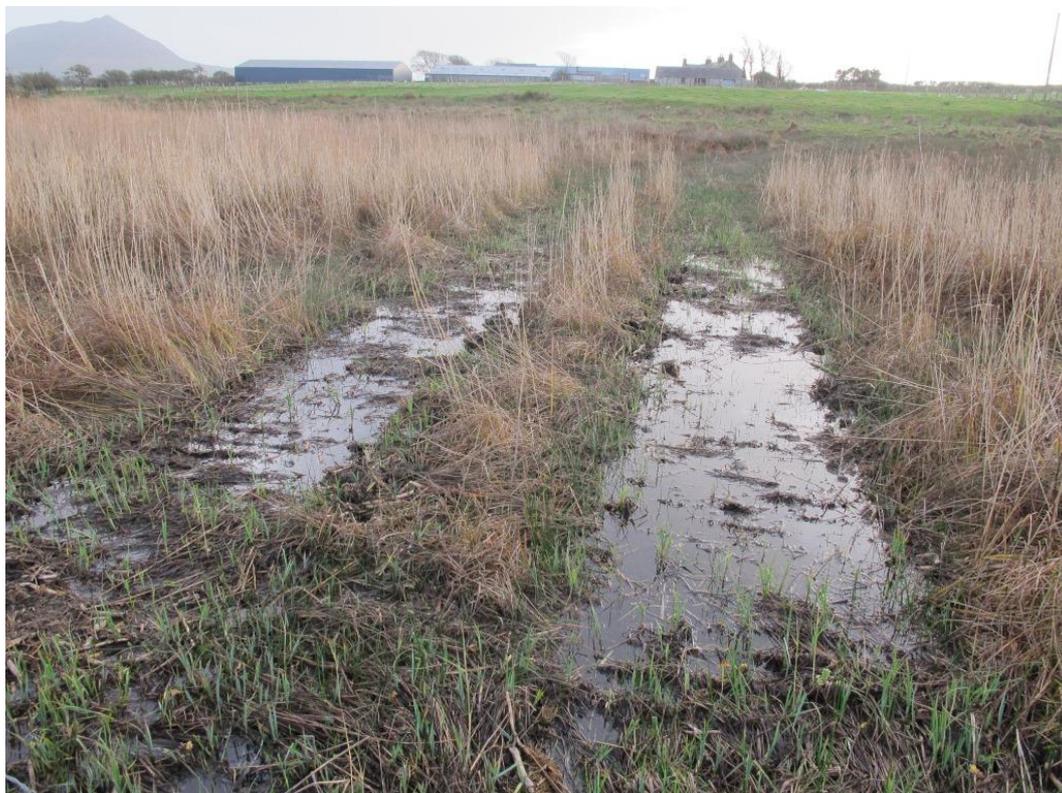
Figure A.3.6. Tracks of 'bog-master' machine on very soft peat. Photo taken from S side of axial ditch looking towards Hirdre Uchaf, December 2013. The vegetation has been flattened but the vegetation raft remains unbroken.

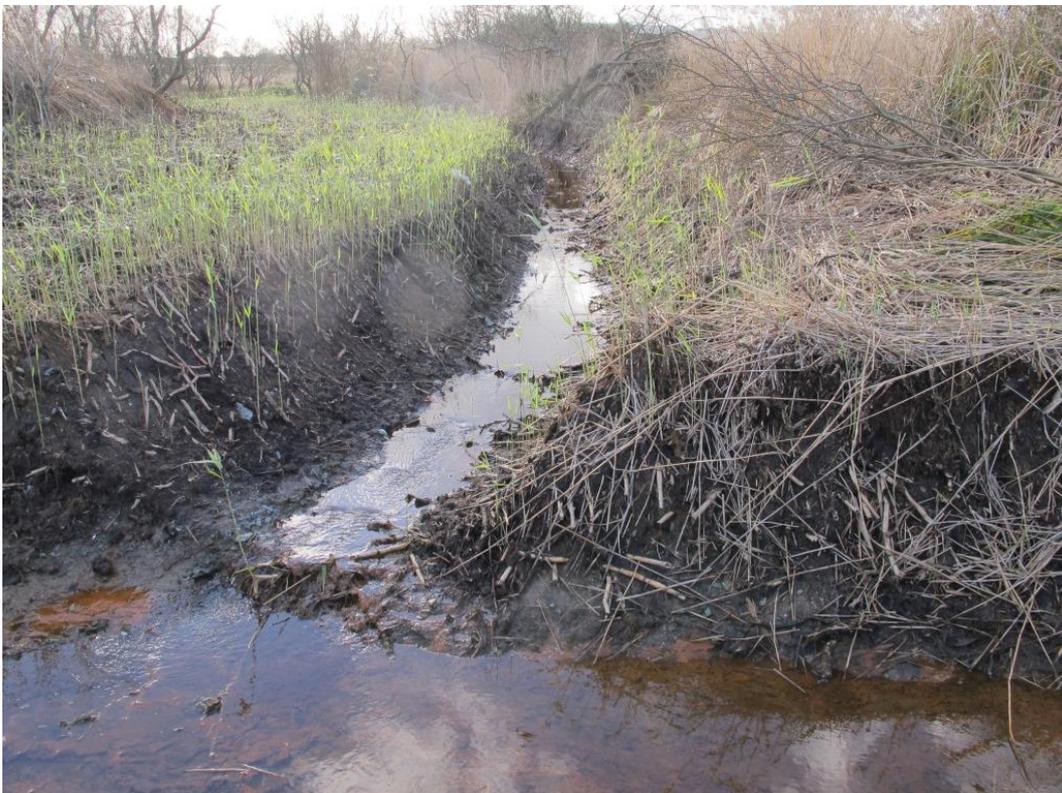
Figure A.3.8. Point at which ditch from Hirdre Uchaf joins the main axial drain at Cors Hirdre, December 2013. Looking N from N side of axial ditch. This ditch was completely occluded, with overbanking water prior to ditch reinstatement. The main area of alkaline fen vegetation occurs to the right of this image. This ditch yielded high concentration of nitrate in June 2010 (see main text).
