River Habitat Surveys (RHS) and Plant Community Surveys of the River Wye SAC (Wales) in 2024 and 2025

Report No: 967
Author name: Julie Bywater, Bywater Ecology
Author affiliation: Contractor

Report series: Evidence Report
Report number: 967
Publication date: May 2026
Contract number: RHS_Wye_2025
Contractor: Julie Bywater, Bywater Ecology
Contract manager: Francesca Sanchez, Natural Resources Wales
Title: River Habitat Surveys (RHS) and Plant Community Surveys of the River Wye SAC (Wales) in 2024 and 2025.
Author(s): J. A. BYWATER
Technical editor: F. Sanchez and S. Hearn
Quality assurance: Tier 3
Peer reviewer(s): Jennifer Owen, Melissa Lacan
Approved by: R. Thomas and R. Cardwell
Restrictions: None

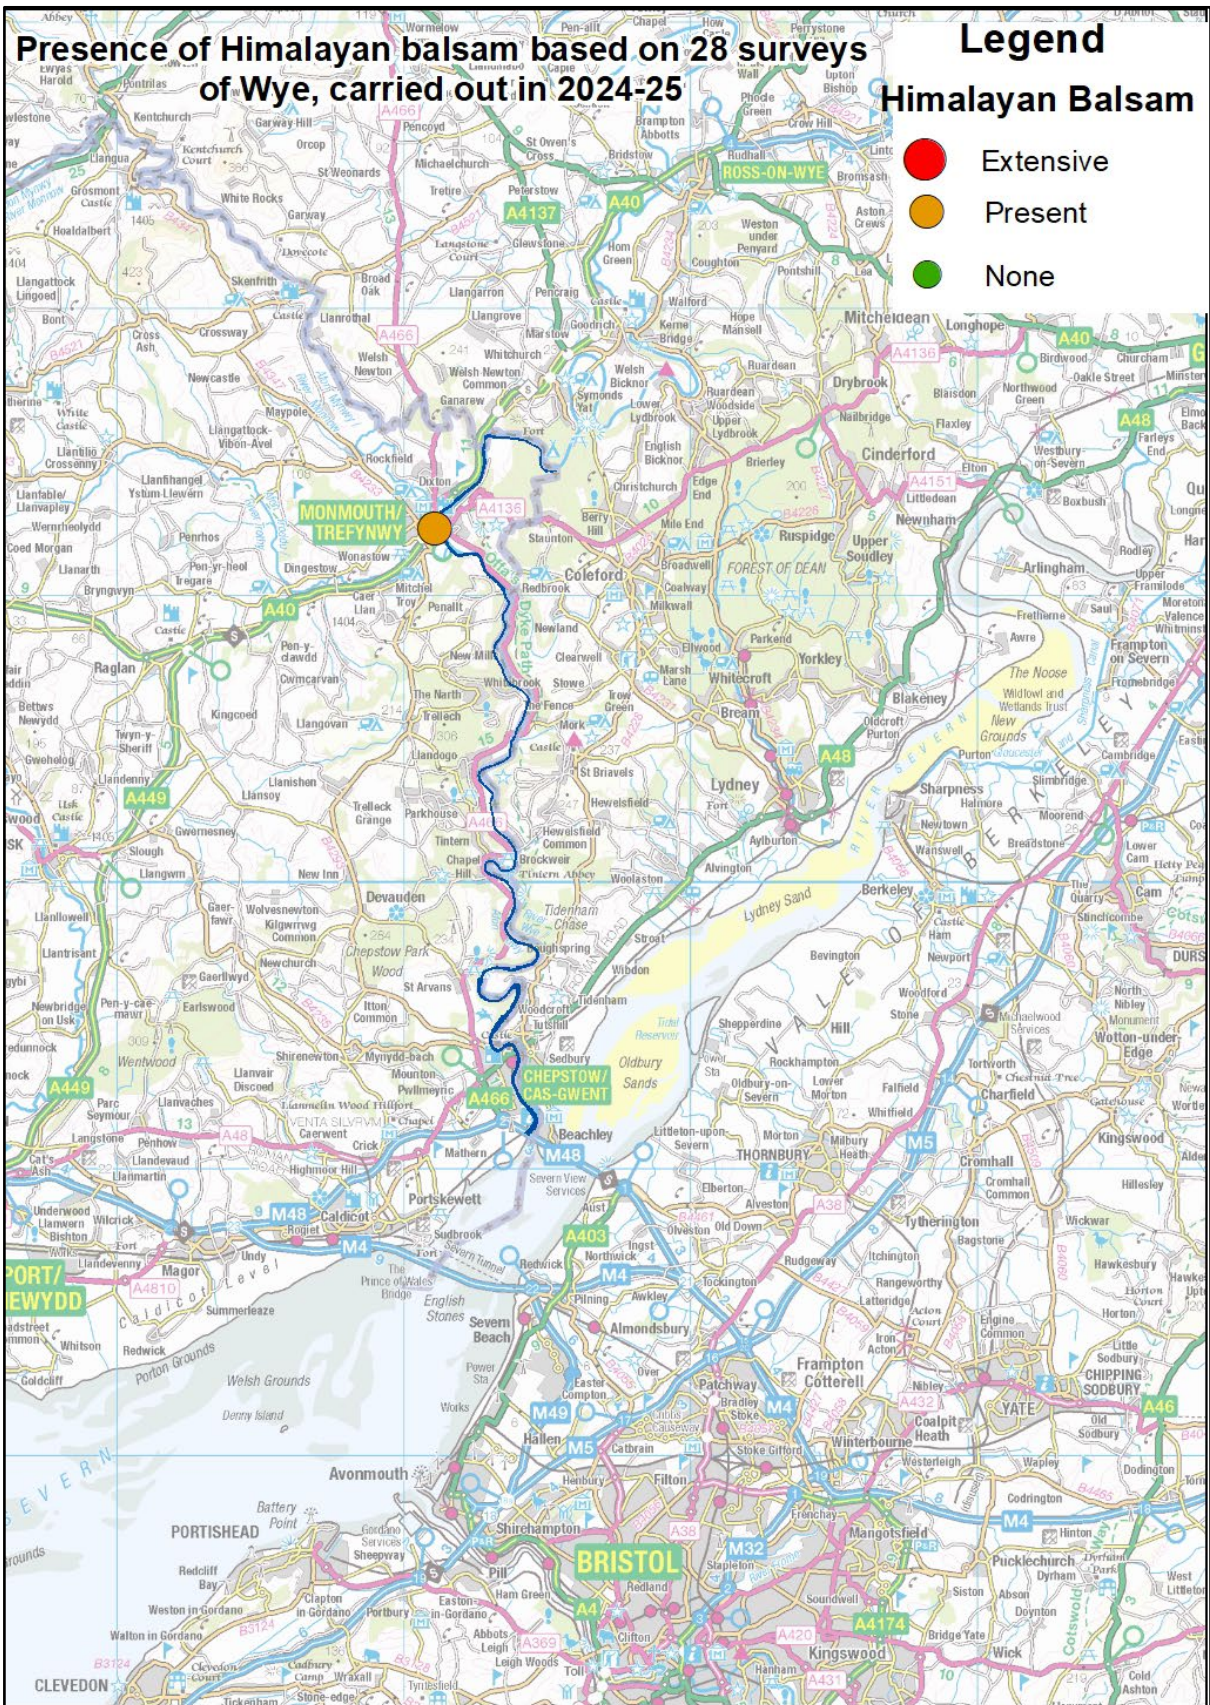
The presence of Invasive Non-Native Plants recorded in the RHS are summarized, in table 6 as none, present or extensive (i.e. occurring in more than a third of the bank) at each site. Invasives are distributed throughout the survey sites with Himalayan balsam present at 54 % of sites and extensive at 14 % of sites. Japanese knotweed was present at 21 % of sites, and no sites had Japanese knotweed occurring in more than a third of the bank (extensive). Both of these invasive plants were found in the main River Wye and the Irfon, and Himalayan balsam, but not Japanese knotweed, was recorded in the Ithon. Hogweed was not recorded at any of the sites.

Figure 6. Presence of Himalayan balsam in Lower Wye Survey Site

In addition, control of the invasive non-native species, Himalayan balsam and Japanese knotweed is recommended where they occur within the catchment.

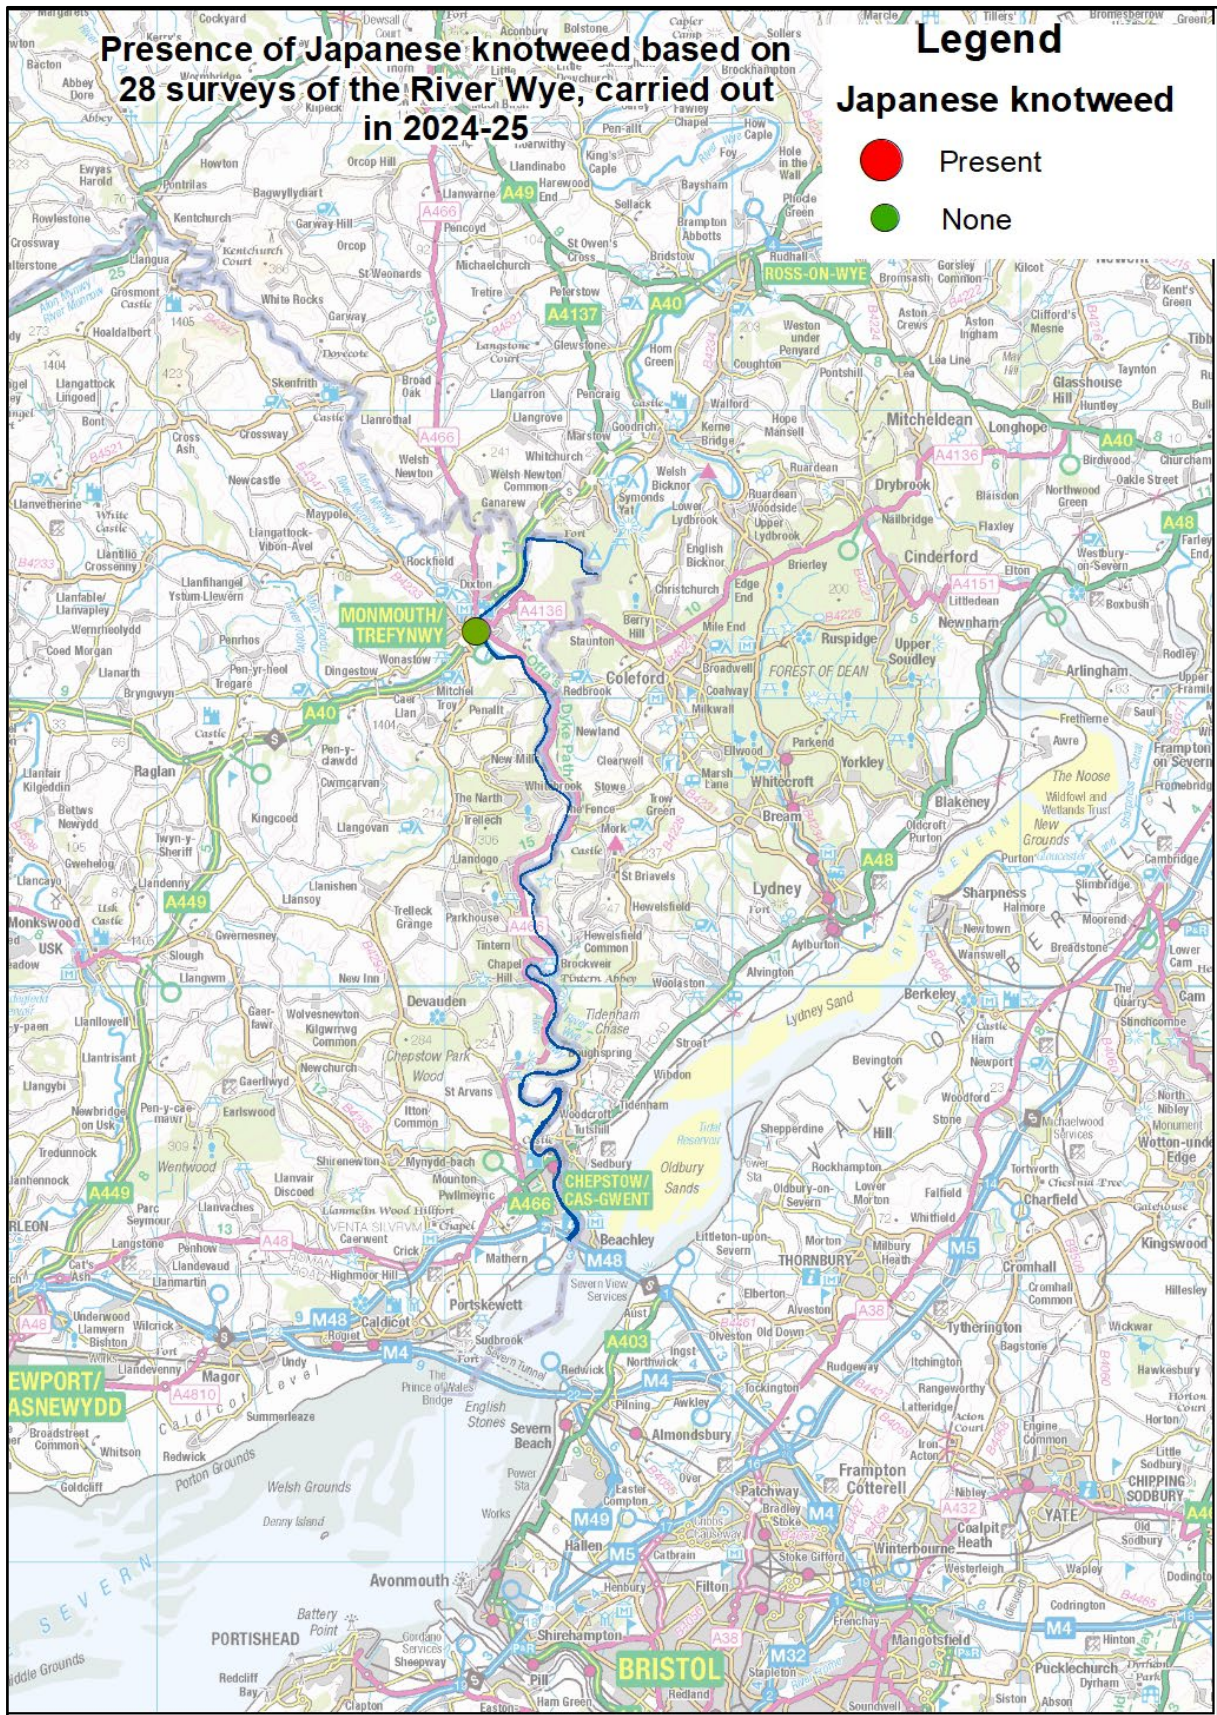
Figure 8. Presence of Japanese knotweed in Lower Wye Survey Site

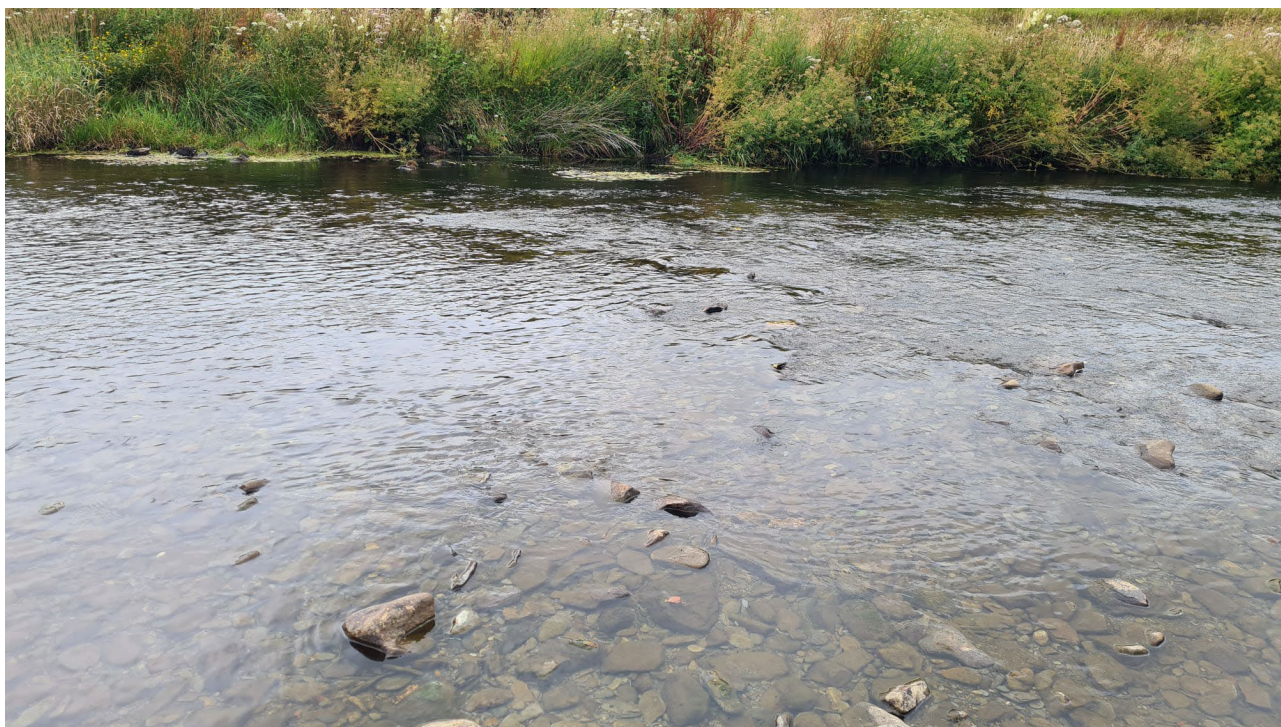
In the 100 m macrophyte survey length, the river channel was approximately 18 m wide at the midpoint with a predominantly cobble and gravel/pebble substrate. There was a large side bar along approximately half the right bank, extending halfway across the channel for most of the length, with the water only 4 m wide at the downstream end of the survey length. There was no obvious sediment on the riverbed and the water was clear. There was no shading of either bank. An embanked area noted in the 2012 macrophyte survey was no longer present due to erosion of the bank.

Figure 11. Photo of Wye at Llangurig at the midpoint across the channel

It is recommended that fencing on the left bank is moved back from the bank top to allow colonisation of the banks by native flora where there has been historic re-sectioning and the bank is eroding, to create a buffer to disturbance and diffuse pollution.

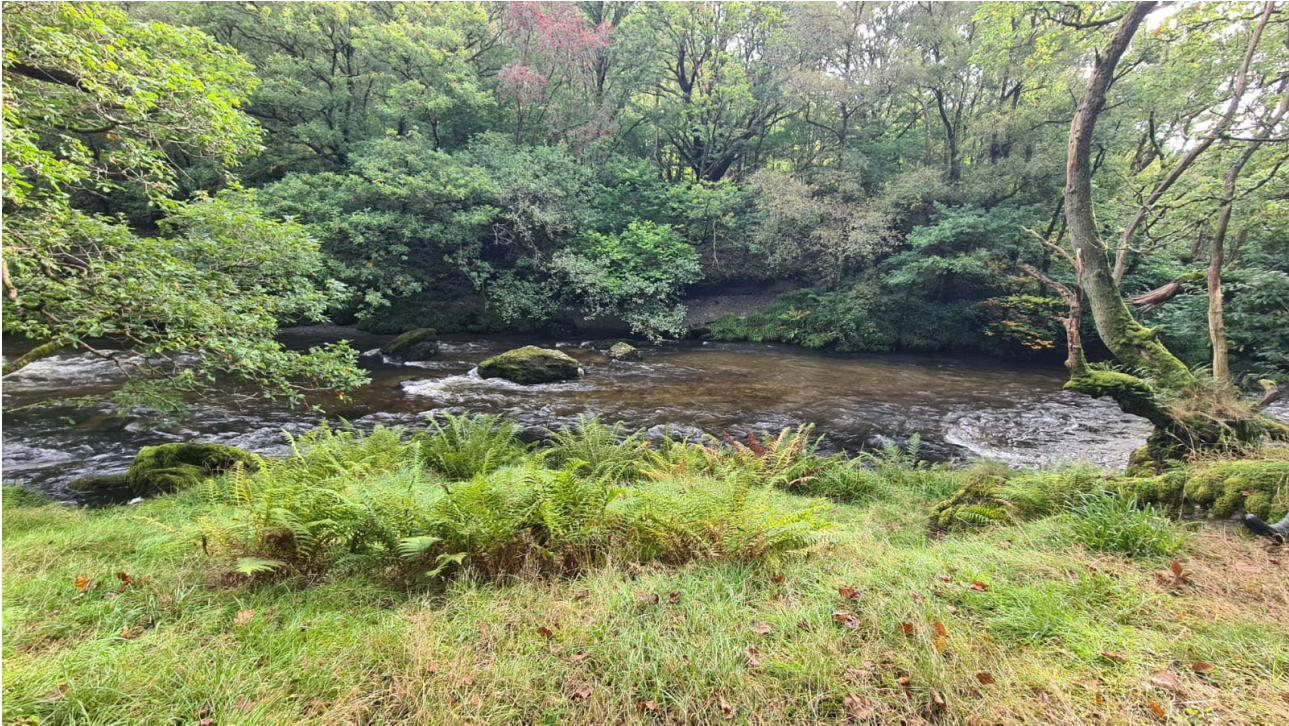
The macrophyte monitoring site was within a deep gorge cut into bedrock. It was not chosen originally as it was unlikely to support a representative Ranunculion assemblage but was surveyed as a reserve site utilized to replace the downstream sites that were too dangerous to sample due to high flows. The water width was approximately 12 m wide and 0.4 m deep with a predominantly cobble and gravel/pebble substrate. Whilst there was some riffle, the main flow type was 'run' and some small pools and slack areas. Flows were high, and fast making survey difficult, but the water was clear. There were numerous exposed boulders with varying degrees of moss cover. Both banks were shaded with more dense shade on the right bank.

The macrophyte community was dominated by bryophytes with eight moss species recorded including greater water-moss (*Fontinalis antipyretica*) and alpine water-moss (*F. squamosa*) which dominated the aquatic flora. There was only one species of higher plant, reed canary grass (*Phalaris arundinacea*) recorded with low cover value. No filamentous algae were observed despite searching, but not all of the site was accessible due to high flows. This site is naturally unsuitable for Ranunculion vegetation as it is in a gorge.

Figure 14. Photo of Wye, u/s of Marteg, at the midpoint across the channel

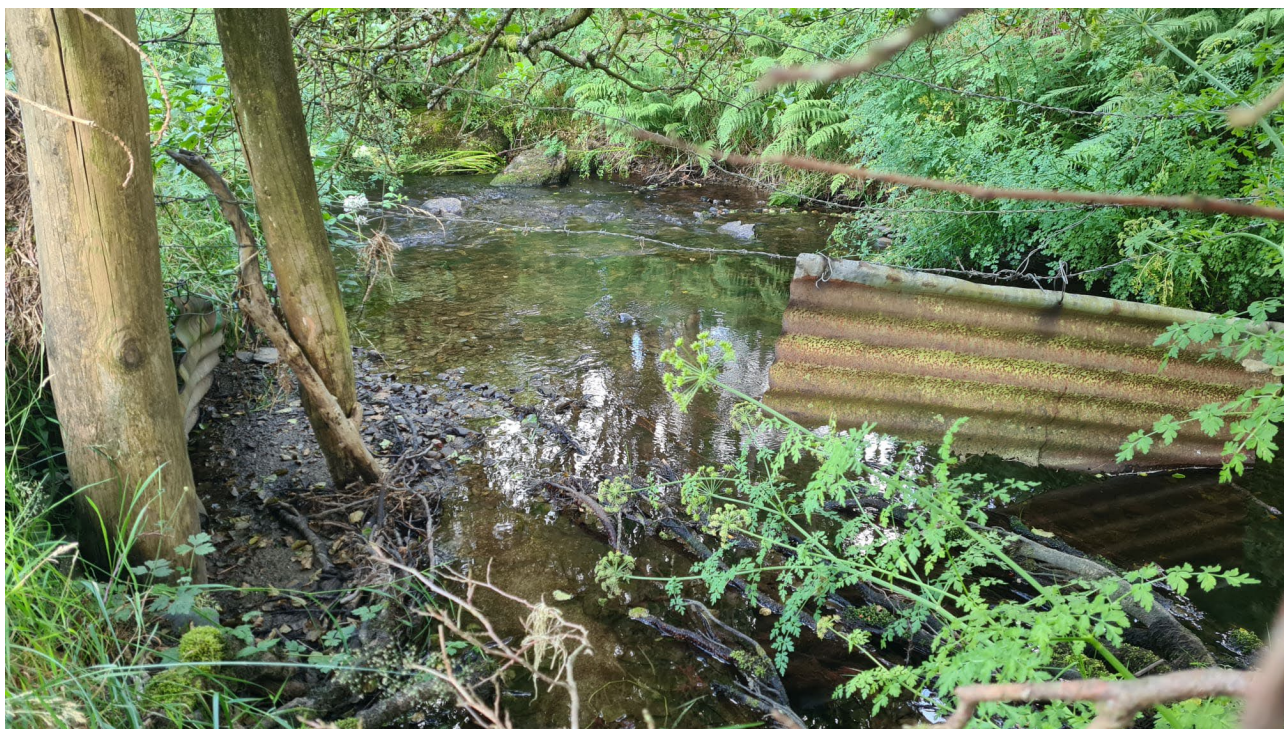
Negligible cover of filamentous algae was observed (<1 %) Some siltation was seen associated with the ford.

Figure 17. Photo of Nant y Dernol at the midpoint across the channel

Protection of the bank top vegetation is recommended where there is urban encroachment, with education of local residents to prevent unauthorised development and dumping of garden waste and enforcement where appropriate.

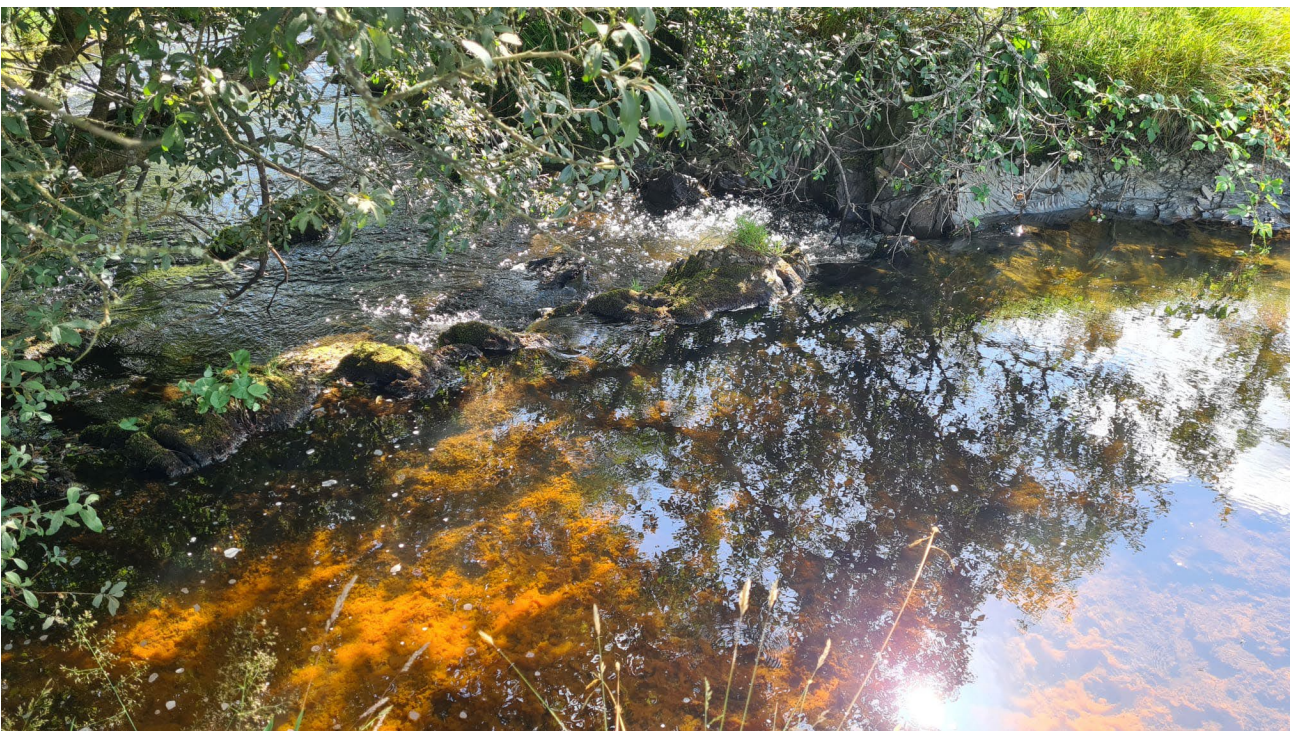
There was less than 0.1 % cover of filamentous algae, and iron bacteria were observed in the downstream section of the survey (figure 22).

Figure 22. Photo of Afon Bidno of iron bacteria observed downstream

Reprofiling of previously re-sectioned banks to a more natural profile or allowing them to degrade where it is safe to do so, is recommended.

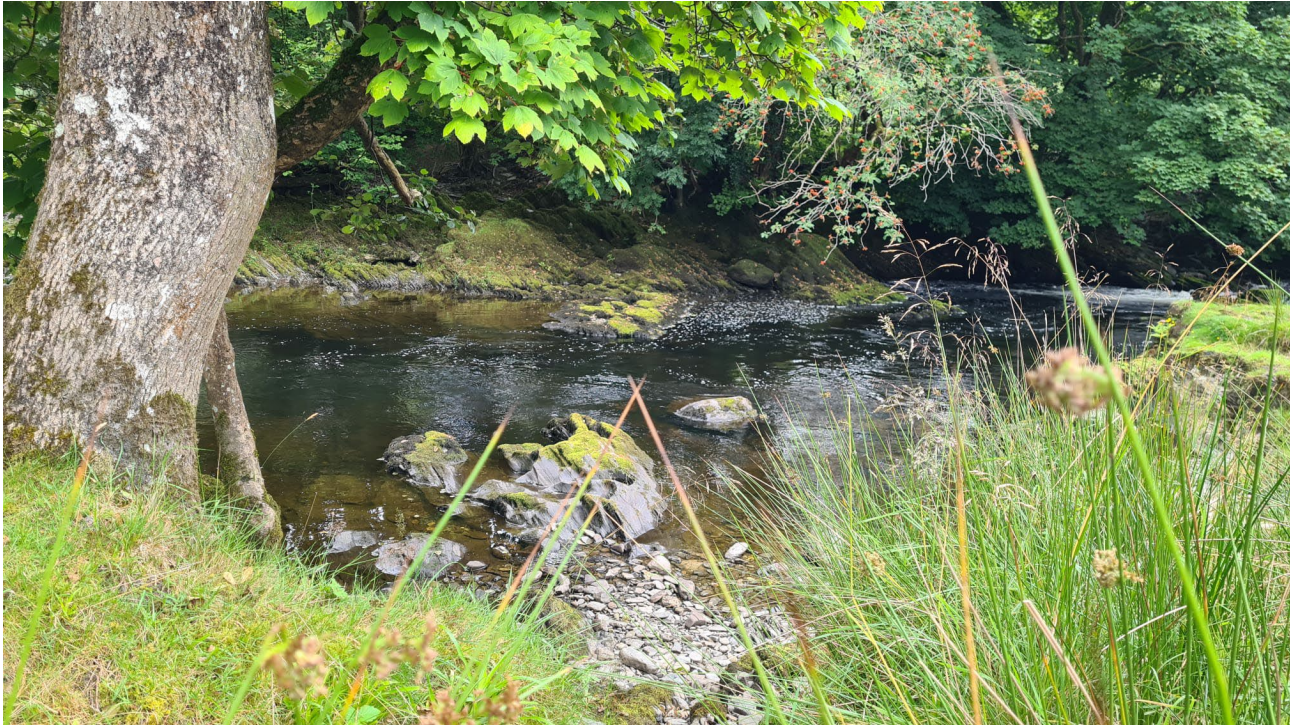
This site is therefore impacted by agricultural use, bank re-sectioning and reinforcement, possible sewage discharge resulting in epiphytic algae cover, and bank poaching. Reprofiling of previously re-sectioned banks to a more natural profile or allowing them to degrade where it is safe to do so, is recommended, along with fencing set back from the bank top to allow colonisation of the banks by native flora, creating a buffer to disturbance and diffuse pollution.

Figure 23. Photo of Wye, Rhayader, at the midpoint across the channel
