Restoring hydrological regimes for rich-fen habitats on the Anglesey & Llŷn Fens Special Areas of Conservation, North-west Wales.
(extract from Proceedings of Technical LIFE Project Workshop).

Peter S. Jones, Justin Hanson, Janine Guest & Rhoswen Leonard

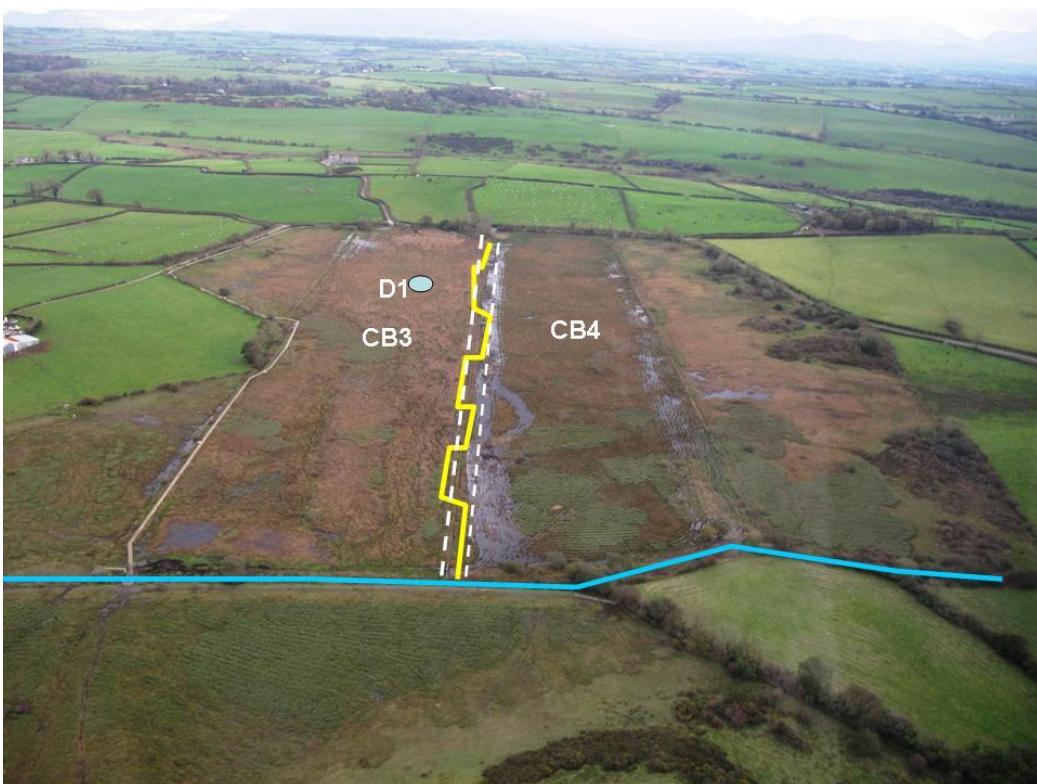
Figure 1. Oblique aerial photograph of Cors Bodeilio taken in October 2011 and looking SE down the long-axis of compartments 3 and 4. The newly opened ditch line (yellow line – diagrammatic only and not exact form) replaces two earlier largely infilled features (dashed white lines) and drains NW into the main axial ditch (blue line) which flows from R to L in this image. Hydrological and rainfall data for location D1 are presented in Figure 2 and Table 3.

The mire level falls by only c. 0.4 m along the 500 m long axis of compartment CB3. The pale line on the LH side of this image is the boardwalk.

An overview of Cors Bodeilio is provided in the relevant conference excursion account. Three extended rectangular and more or less flat compartments occupy much of the south-eastern part of the site, extending some 0.5 km from the SE edge of the site to the axial drain (Figure 1). All three compartments were once drained by

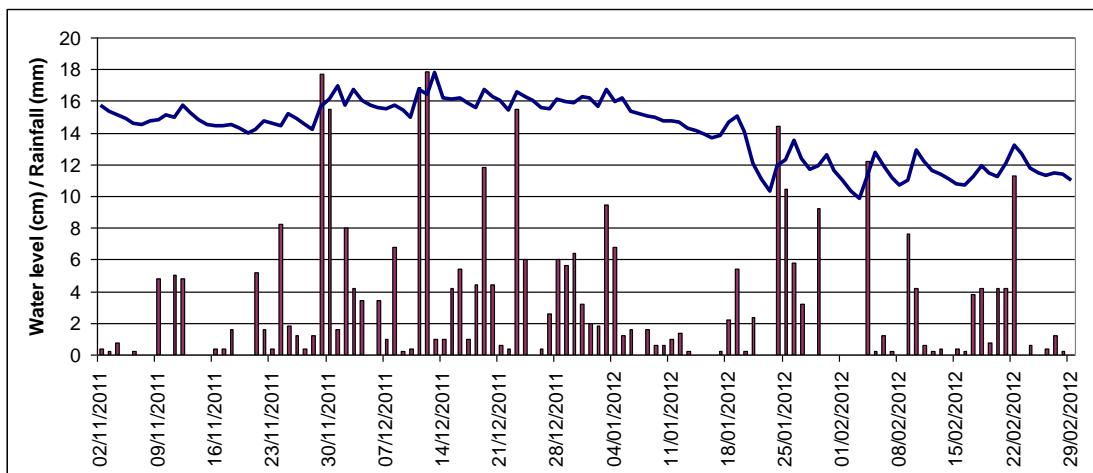
Figure 2. Average daily water levels (cm relative to peat surface, mean of 24 hourly measurements) and daily rainfall totals (mm) for station D1 at Cors Bodeilio between 2 November 2011 and 29 February 2012. Work to re-open the ditch between compartments CB 3 and 4 began on 18/1/12.

Re-excavation of the ditch resulted in a drop in water level at station D1 in the centre of the compartment (some 52 m away from the ditch line – see Figure 2) of 2 cm between 20 and 21/1/12 despite 2.4 mm of rainfall on the 21st, and thereafter water levels deeper than 14 cm do not occur again during the following month despite a series of significant rainfall events. Comparison of monthly mean water levels before and after the ditch was re-opened indicate it has achieved a mean drop of a few cm (Table 3) and there is evidence from hourly data-logger measurements of water level that water level spikes induced by rainfall are of shorter duration, though the overall duration of flooding has probably not been affected significantly (further statistical analyses of these data are underway).

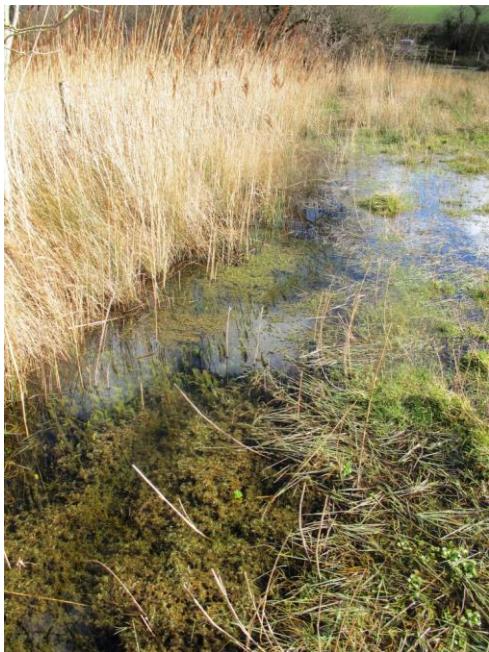
Figure 3. Drainage ditch between compartments CB3 and CB4 at Cors Bodeilio NNR. Photo taken in March 2014, two years after the ditch was re-opened. Note dense patches of *Chara* in the foreground and surrounding flooding.

The rather modest effect of drain re-opening probably reflects the shallowness of the ditch and the very gentle hydrological gradient of 0.08% along the long axis of the compartment and 0.01% across its width. In hindsight, sections of the ditch could have been excavated to a greater depth (though this would have created even more spoil, with attendant problems of disposal) to further reduce the depth and duration of flooding, with a system of simple sluices employed to avoid significant seasonal dewatering of adjacent peats. A significant associated benefit of this project has been the appearance of substantial new populations of *Potamogeton coloratus* and Charophytes in the ditch (Figure 3).

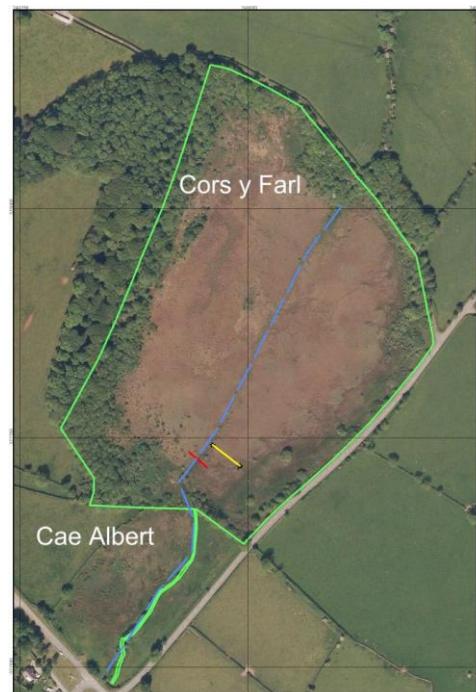
Figure 4. Aerial photograph of Cors y Farl (Anglesey) showing the SSSI boundary (green line), the axial ditch (blue dotted line), the levelled transect referred to in the text (yellow line) and the weir and stock-bridge (red line). Fine black lines are OS 250 m grid lines. An annex to the site (Cae Albert) was restored through scrub removal, mowing and grazing by LIFE project Konik ponies, which revealed important stands of alkaline fen.

Cors y Farl (SH 490778) occupies a shallow basin on Carboniferous Limestone and supports a large central stand of *Cladium* swamp and fen (Figure) with a narrow fringe of more open rich-fen including *Carex rostrata* – *Calliergon* spp. mire (M9), *Schoenus* dominated mire (M13) and a swampy form of *Juncus subnodulosus* fen meadow supporting a range of M9 species (Birch, 2008). The extent of wet *Cladium* swamp at Cors y Farl is unusual amongst the fens series (Figure 4).

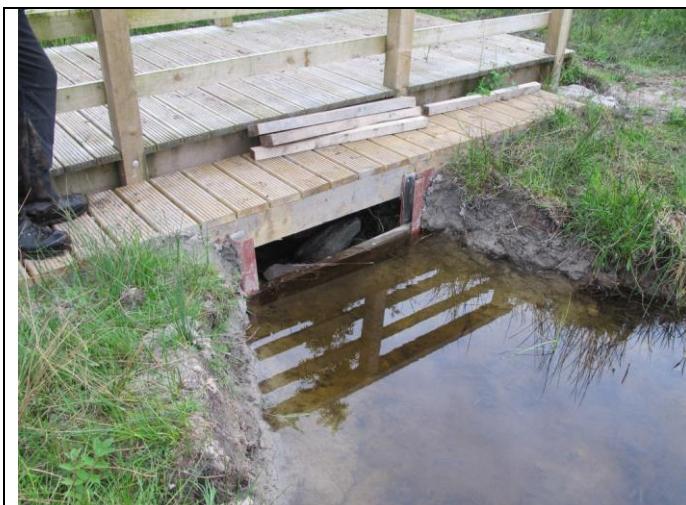
Figure 5. The main drain sluice at Cors y Farl installed by LIFE contractors A.J. Butler and Matt Sutton in spring 2013. Alder weir boards are visible stacked on the boardwalk ditch crossing beside the stock-bridge.

The LIFE project assessment for this site was that water levels in the main drain should be maintained at a high level to sustain wet *Cladium* swamp, but with a slight hydrological gradient down towards the drain from the site margins. Water quality data indicated there were no significant enrichment issues related to the drain water chemistry, thus ruling out the need to maintain an open drain to prevent overspill of potentially enriched water (see for comparison the case study for Cors Hirdre). The ability to adjust drain levels was considered important to enable access for mowing or grazing for at least the peripheral stands of *Cladium*, and also to encourage a more significant hydrological gradient from edge to axis (a levelling survey indicated a more or less flat water table profile over a 40 m transect out from the main drain). The option chosen for Cors y Farl was to replace an existing but leaking timber sluice with a cheap adjustable design installed in conjunction with a stock-bridge to encourage pony access to the western side of the fen (Figure 5). The 1.2 m wide sluice consists of two metal open-sided box sections into which 15 cm high hardwood (alder) planks can be dropped, thus allowing fairly sensitive manipulation of drain levels. Manipulation of drain levels can now be undertaken in association with water level monitoring across the fen to determine an optimum long-term level for the main drain.

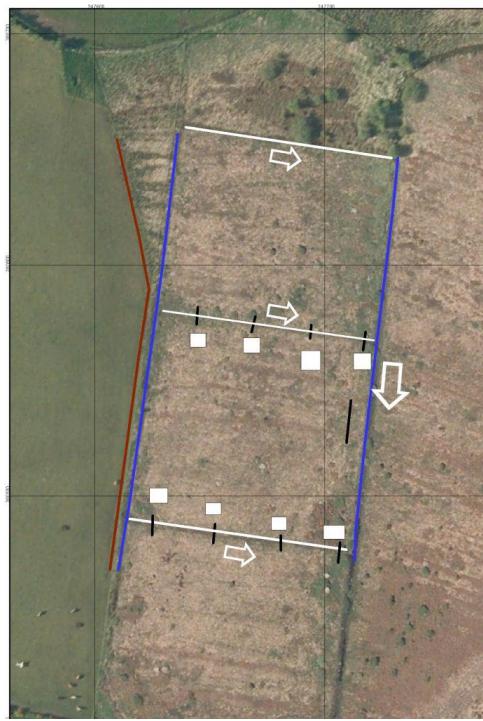
Figure 6. Part of the Cors Cefn Uwrch fen subject to installation of peat dams. White lines indicate lateral ditches feeding into the main axial drain (blue line) with peat dams shown in black and scrape areas as white circles. The fen-margin drain (also shown in blue) lies just inside the original fenceline (part of which is shown here in brown). Purchase of the western side of the fen included a substantial grassland buffer. Fine black lines are OS 250 m grid lines. Dams are only shown for two of the ditches for clarity – see also Figure 8.

Vegetation was removed from selected ditch sections between dams to create linear open water pools, but with sections of *Cladium* swamp within the ditch lines avoided (Figures 9 & 10). All operations required the use of a 360 degree tracked excavator – in this case a specialised 12 tonne machine fitted with 1.2 m wide tracks (Figure 11). Table 4 provides an analysis of the main advantages and disadvantages of the approaches employed, and Table 5 provides a comparison of water levels in blocked and unblocked ditches.

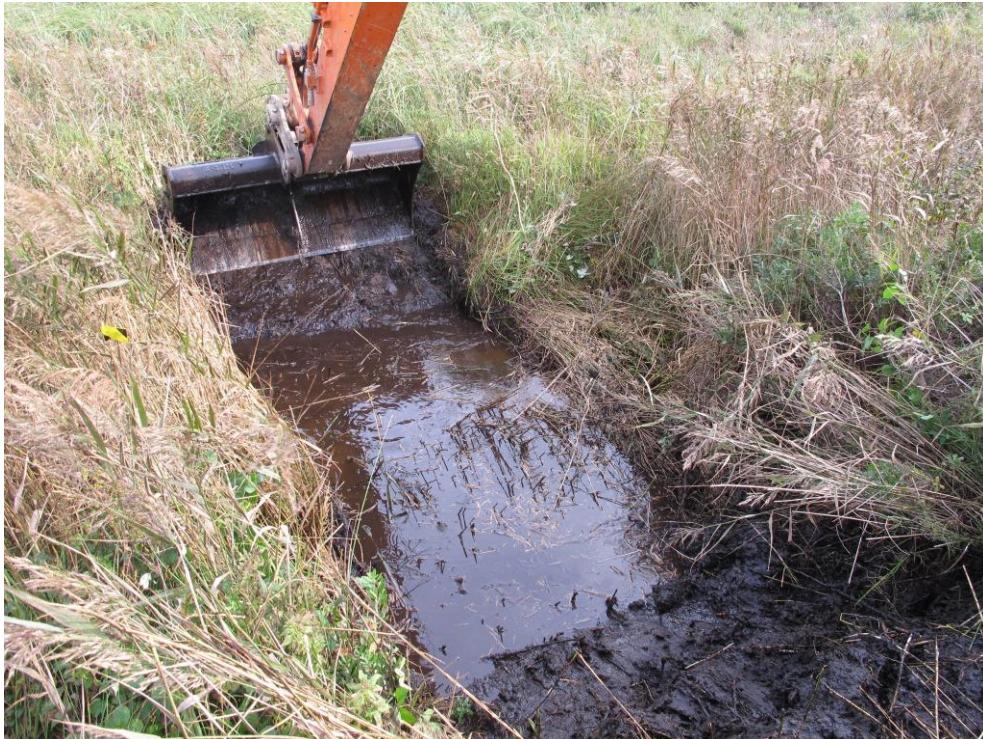
Figure 7. Excavation of a notch in a ditch line running left to right. The notch is recessed into solid peat either side of the drain to act as a 'key' for the peat dam.

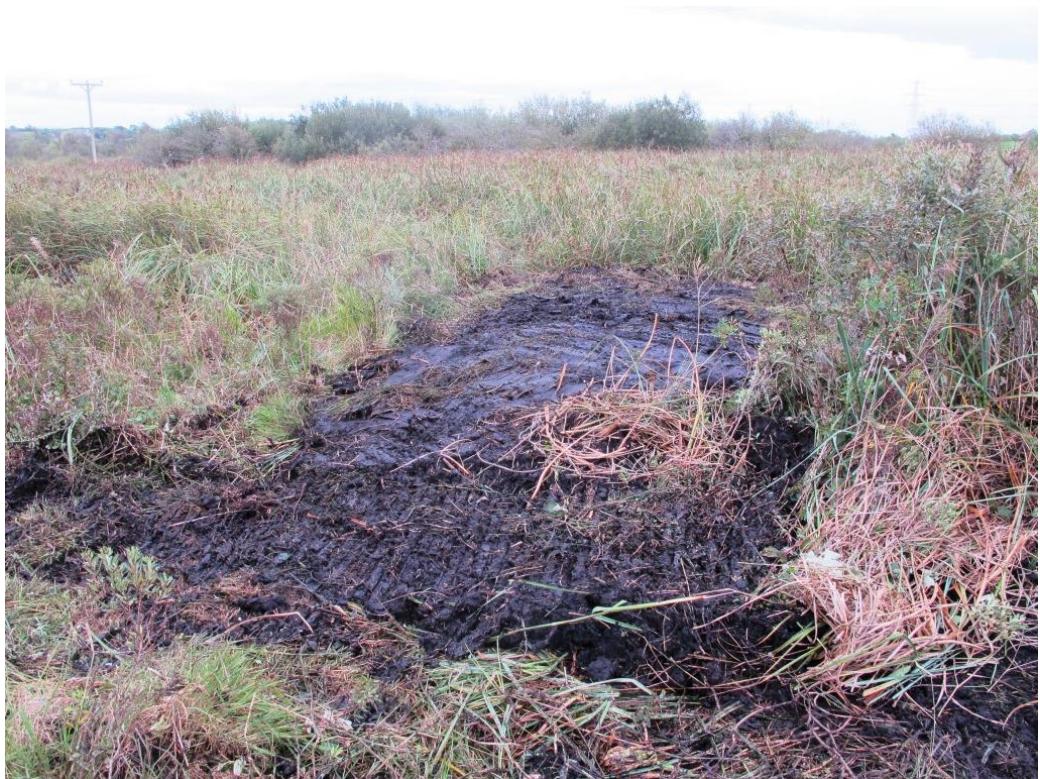
Figure 8. Completed peat dam perpendicular to the left to right axis of the drain. Note the thickness (left to right in this image) of the dam.

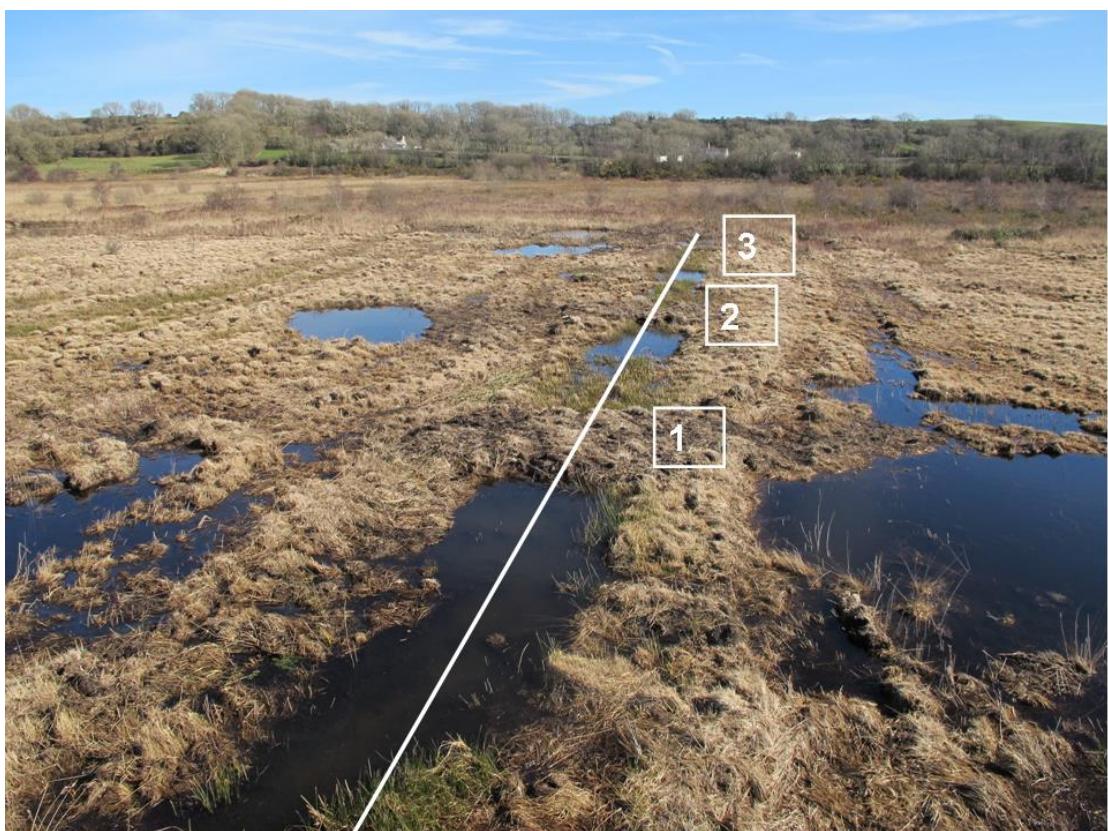
Figure 9. Mast photograph from an elevation of c. 5.5 m above ground level looking down one of the blocked ditch sections at Cors Cefn Uwrch. Three dams are visible, with the

original line of the ditch indicated with a white line and flooded peat pits either side. Image is looking ESE

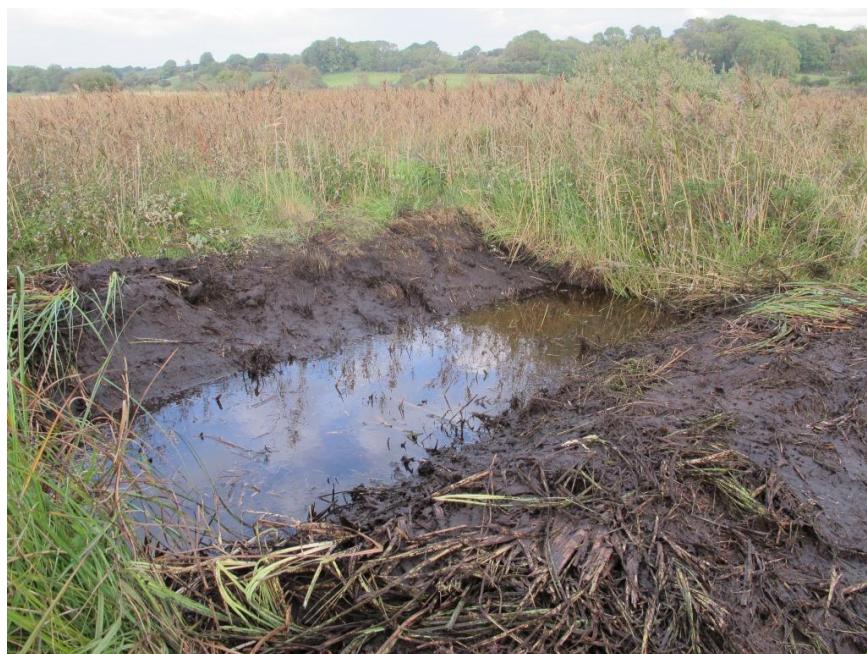
Figure 10. Section of ditch between dams subject to 'de-weeding' to create open water.

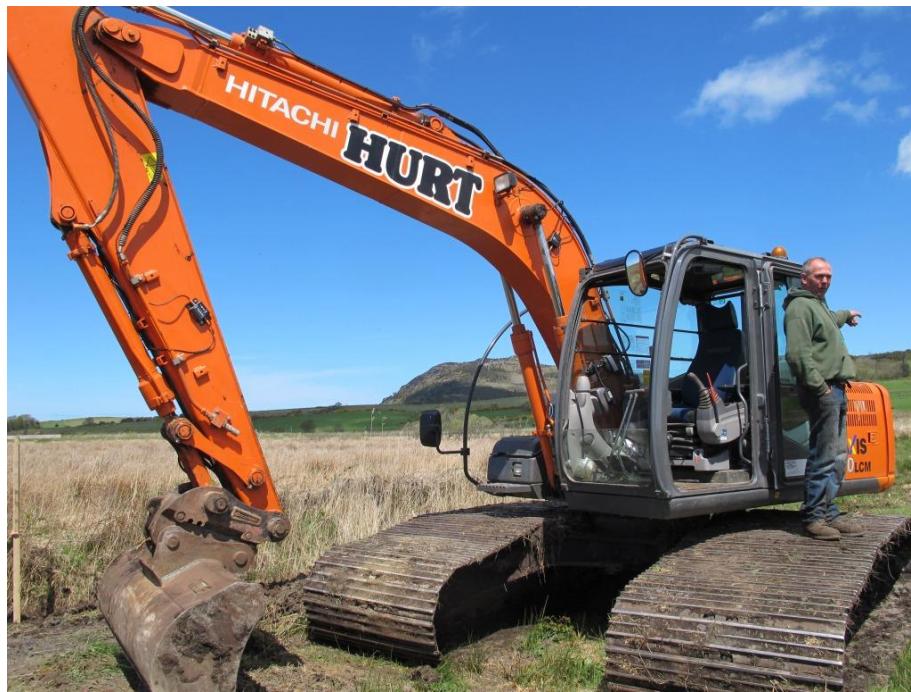
Figure 11. 360 degree Hitachi excavator fitted with 1.2 m wide tracks. This or similar machines were used at Cors Cefn Uwrch, Mathan Uchaf, Cors Bodeilio and Cae Gwyn for peat stripping and hydrological restoration projects.

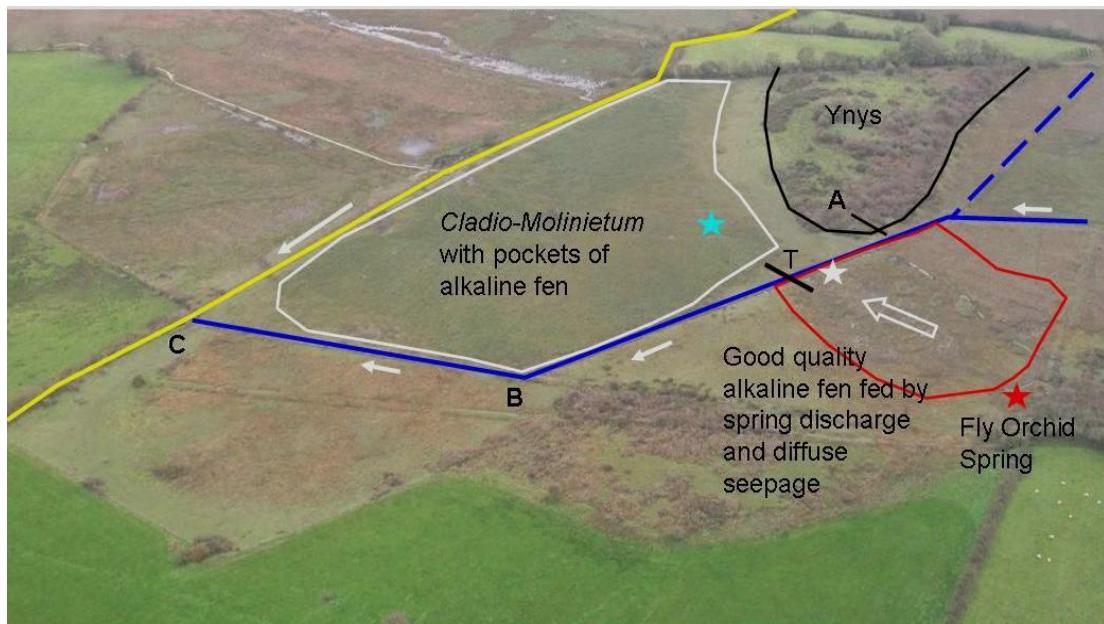
Figure 12. Oblique aerial photograph of fly orchid spring restoration area looking SE from approximate NGR SH 500778. The ditch described in this case study is shown as a solid blue line with flow direction indicated with white arrows. This ditch connects with the main axial drain (yellow) at point C. The bypass pipe installed during this project runs between points A and B. Fly orchid spring is marked with a red star and the former point of focussed discharge to the drain as a white star, with the open white arrow denoting one of the key flow routes. The blue star E of the Ynys marks a point where a groundwater upwelling was noted in the winter of 2012/13. The dashed blue line marks a minor non-flowing drain which separates an area of alkaline fen at the base of the Ynys (left) from calcareous fen to the right. The red boundary line denotes the main area of good quality alkaline fen (mainly M13) influenced by fly orchid spring.

Discharge from the spring irrigates one of the best areas of M13 alkaline fen in the fens series and up until the LIFE project was intercepted by a side ditch of the main axial drain downgradient of the M13 (Figure 12). The side ditch prevented groundwater discharge from fly orchid spring reaching an area of *Cladio-Molinietum* vegetation with areas of alkaline and calcareous fen. Restoring groundwater flow to this area was an obvious option, but complete infill of the ditch could not be undertaken because of the need to maintain free drainage for neighbouring farmland. For this reason the option chosen was to bury a 450 mm diameter bypass pipe along the 145 m length of ditch section A-B shown in Figure 12 and then carefully backfill the void to encourage diffuse groundwater flow across it.

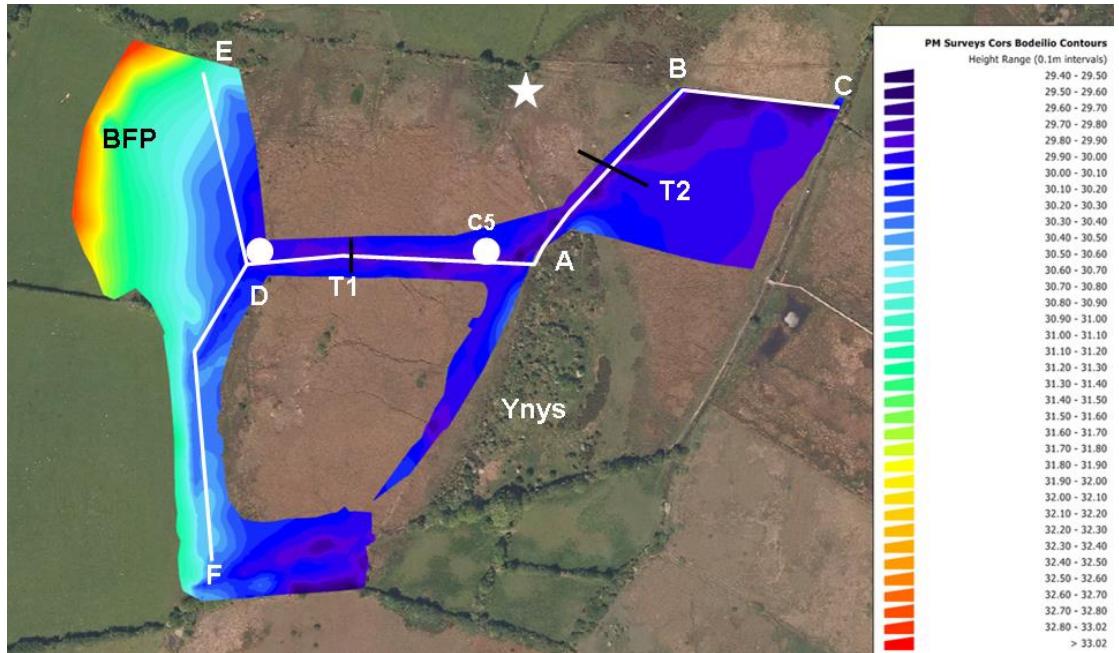
Figure 13. Topographic survey plot of part of Cors Bodeilio showing areas of land delimited by 0.1 m elevation aOD contours. The white star marks Fly Orchid Spring and the white line indicates part of the ditch network. Section A-B is the bypass pipe, with water levels from A-D raised according to the level of the bypass pipe U bend. T1 and T2 indicate dipwell transects across the ditches; white circles denote ditch stage measurement points. The plot indicates scope for over-banking of ditches within the fen sufficient to prevent any nuisance flooding of the higher agricultural land to the west. See also Figure 2.2.

A benefit of the bypass pipe option chosen here is that the inlet of the pipe could be fitted with an adjustable 90 degree bend to raise levels in the upstream ditch network, thus countering seasonal water table drawdown in the ditch and adjacent peats (see Table 7 and Technical Report 2) whilst also providing overspill into the pipe. Topographic survey confirmed that overbanking of the ditch system would serve to prevent any flooding of neighbouring agricultural land (Figure 13)

Table 7. Water level data for measurement point c5 in ditch section A-D at Cors Bodeilio – see Figure 13. for location. Water levels are in cm relative to the measurement datum at 29.701 maOD. The two water level measurements for January and June 2014 lie beyond the range recorded since 2007 for the respective half-year periods, indicating a significant rise in ditch levels post restoration (May 2013). The June 2014 measurement was after a dry period of xx days.

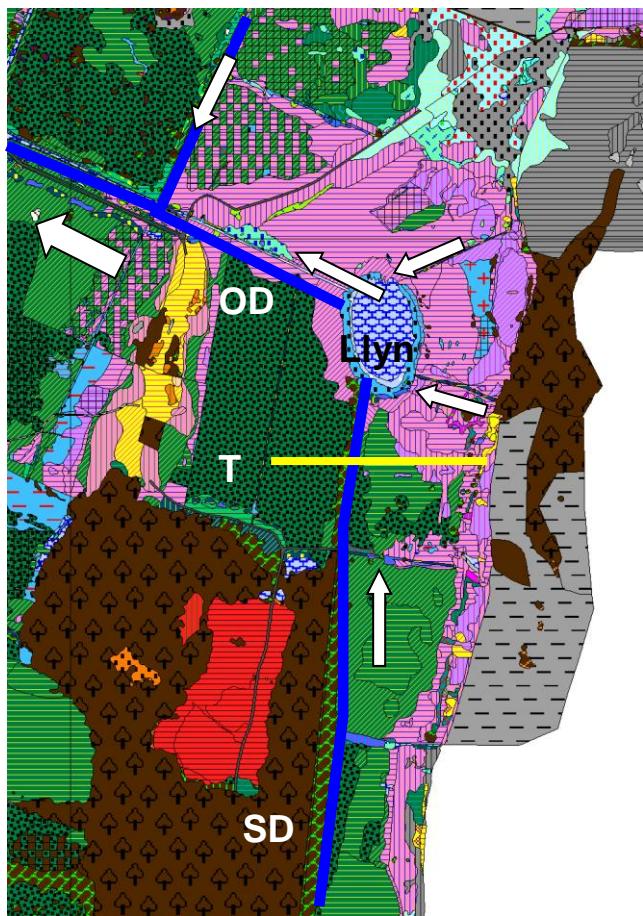
Figure 14. Plant community map of the central-eastern section of Cors Erddreiniog showing Llyn yr Wyth Eidion, the inflowing South Drain (SD), the SE-NW flowing outflow drain (OD), the two predominantly groundwater fed drains to the east of the lake and the topographic survey transect (T – yellow line). White block arrows denote directions of flow. This map is an extract of the full-site plant community map reproduced as Figure 2a in Birch *et al.*, this volume. The topography survey line (T) passes from west (left) to east (right) through a very species-poor form of M25 with *Phragmites* and *Myrica* west of the drain, a thin bank of M25 mire east of the drain, M13 *Schoenus* mire and then *Juncus subnodulosus* fen ,meadow (M22). Dipwell 3 of the Institute of Hydrology study (Gilman & Newson, 1982) was located just S of the OD lettering in the area of degraded *Molinia* dominated fen and showed a significant response to hydrological restoration in the 1980s..

Diverting the South Drain and then infilling its channel would deliver two major benefits. Firstly it would restore groundwater supply as the dominant terrestrial hydrological input to the lake, thus reducing the overall flux of water through the lake and also the suspended sediment and nutrient load. Secondly, it would restore a degree of groundwater influence west of the current ditch line. The first stage in assessing the feasibility of such a scheme was to establish a topographic transect line across the South Drain (shown in Figure 14).

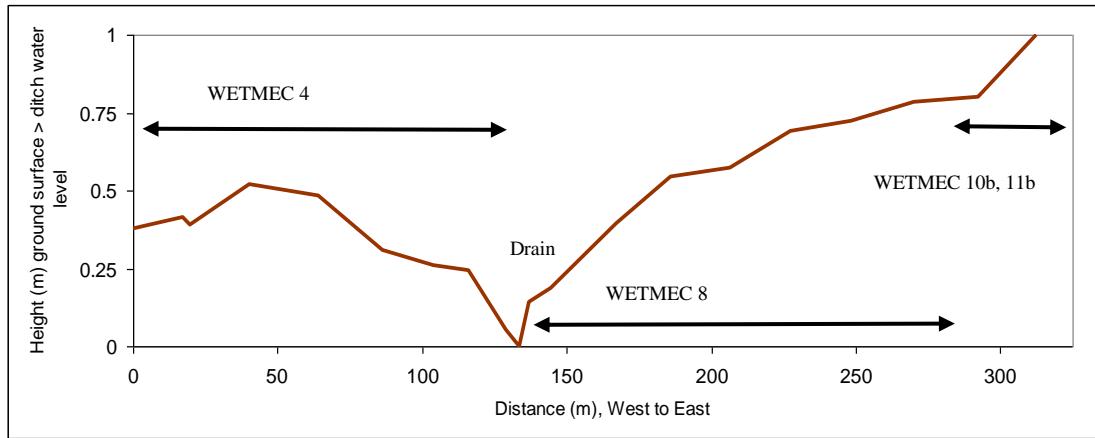
Figure 15. Plot of ground level relative to water level in the South Drain at 138 m on the west to east transect line indicated in yellow on Figure 14. Water levels closely follow ground level.

The plot (Figure 15) shows significant wastage of peat either side of the South Drain and wastage associated with a minor drain which runs parallel to the South Drain in the middle of the peat body at 0 m (this had already been blocked some years ago). This has left the peat body to the west of the South Drain with a markedly domed profile (as observed originally by Meade & Blackstock, 1988), indicating much of it is probably now referable to WetMech 4. The slope east of the drain receives groundwater seepage from the eastern limestone slope and there is some groundwater upwelling in the centre of this peat block. These results indicate that ditch infilling would not achieve any significant additional influence for groundwater unless a substantial volume of peat was placed in the valley of the ditch line, though infilling the ditch would at least limit ongoing wastage of adjacent peat. One possible source for peat infill could come from re-profiling the crown of the peat dome to the west of the drain. Another major factor determining the feasibility of this project is the availability of an alternative route for the South Drain. The drain would originally have flowed south to join the axial drain of Cors Cefn Uwrch and this remains the best option and is currently being reviewed through the Mawndir Mon project (see Cowley, this volume) as part of the after-LIFE programme.

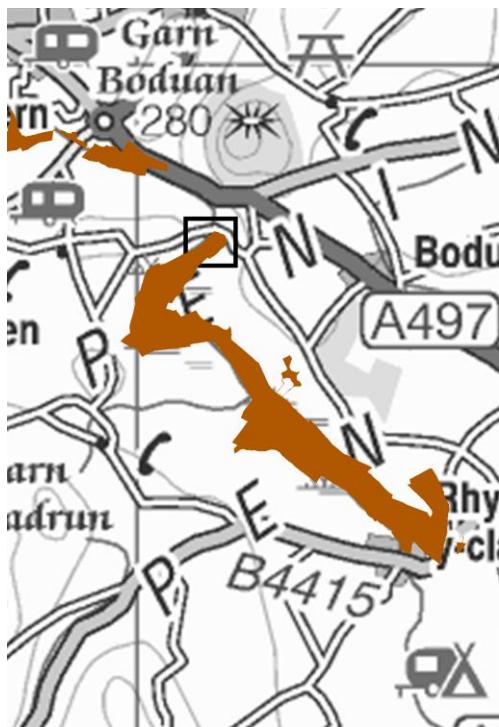
Figure 16. Location of Cors Ceidio (bordered in black) in relation to the rest of Cors Geirch (brown shading).

Cors Ceidio is a narrow strip of fen at the northern tip of Cors Geirch (Llyn Fens SAC; Figure 16). The site supports some of the deepest peat deposits within the SAC (up to 230 cm were recorded by Shaw & Wheeler, 1991) but it has been heavily modified as a result of several factors, including deepening and straightening of the Afon Geirch, drainage at the margin of the peat body, and a fire c. 25 years ago which resulted in combustion/modification of some areas of peat and subsequent peat enrichment. These impacts are reflected in significant humification of the peat (Figure 17), marked changes in surface profile adjacent to the river (Figure 18) and significant modification of the vegetation, with *Holco-Juncetum* mesotrophic grassland (MG10c), *Typha latifolia* swamp (S12), *Rubus fruticosus* underscrub (W24) and patches of *Chamerion angustifolium* (OV27) present in place of more typical topogenous fen (Figure 19).

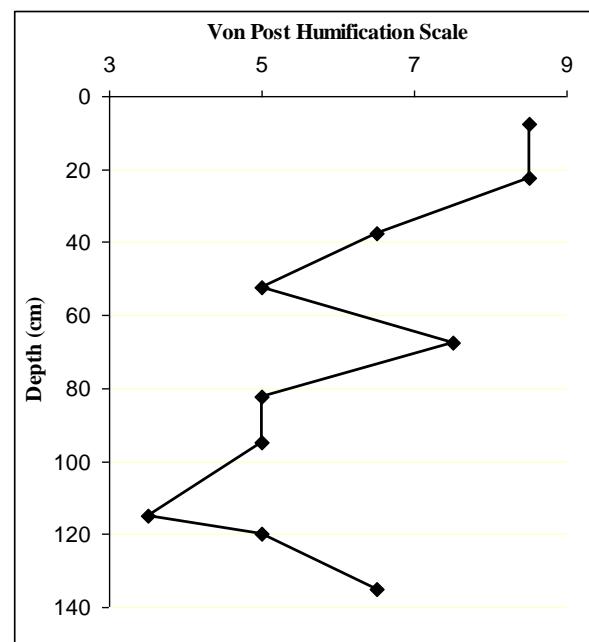
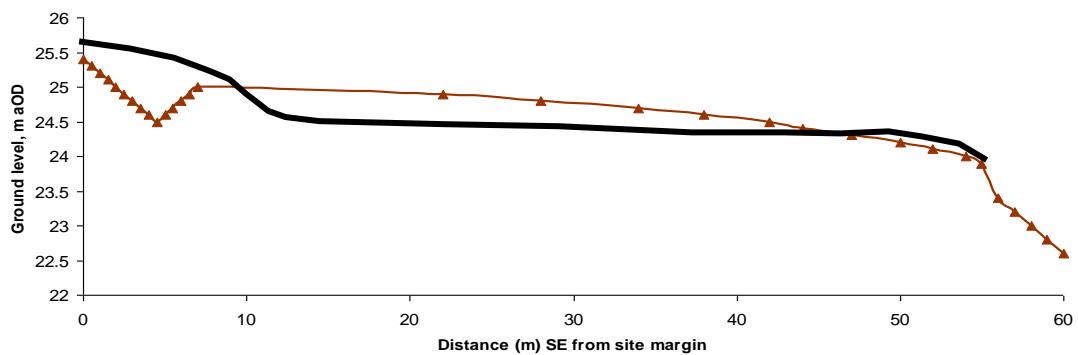
Figure 17. Changes in humification with depth recorded at Cors Ceidio dipwell DW3 (SH30650.38080). Humification is assessed qualitatively using the Von Post scale (see Rydin & Jeglum, 2006), with the degree of decomposition increasing up the scale. Scores between integers represent the mid-point of ranges of humification recorded during field examination of samples from particular depth bands. Von Post scores of 8-9 (recorded here in the uppermost 30 cm of the peat profile) represent very strongly or almost completely decomposed peat; this is likely to reflect the drainage history of the site.

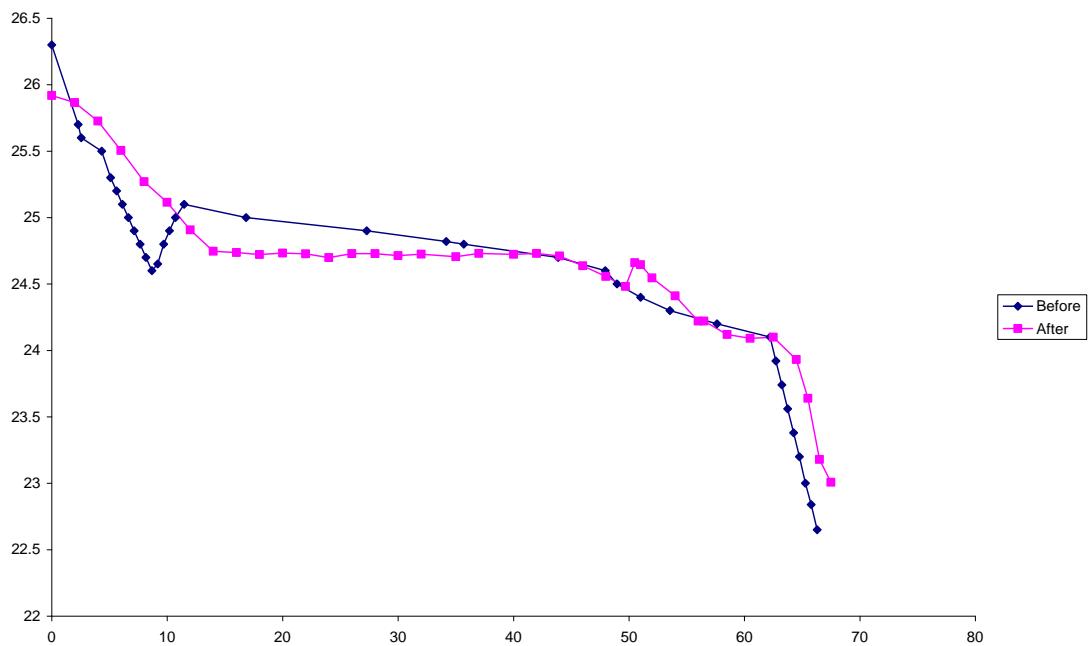
Figure 18. Upper: Ground level profile (m above OD) along section T0 (NW) to T1 (SE) of Figure B. The brown line and points are extracted from a topographic survey of the site undertaken by Digital Mapping Surveys under contract to the *LIFE* project. Dipwell DW3 shown in Figure C is at c. 30 m on this plot. The black line shows the approximate form of the peat re-profilling, with peat removal from the RH area and infill of the site margin ditch on the left and more limited deposition over part of the wastage slope adjacent to the river at 60 m. Note the sharp drop in surface profile down to the bed of the Afon Geirch from 55 – 60 m, with a less marked break of slope visible at c. 43 m. The lower plot shows the post restoration profile based on field measurements.

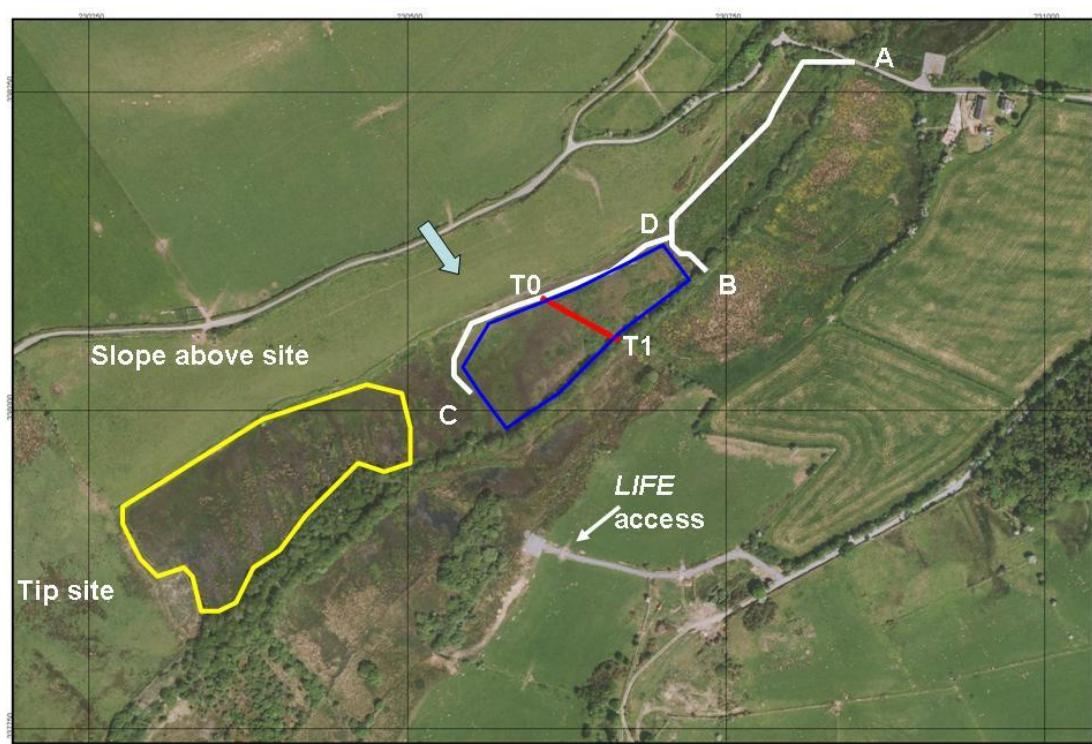
Figure 20. 2013 aerial image of part of Cors Ceidio (Cors Geirch) showing ditch sections A-B and C-D in white, the dipwell and topographic survey transect of Fig. C in red (from T0 to T1) and the outline of the peat scrape area in blue. The Afon Geirch is visible as a line of willow and alder trees running as a curving line from NE to SW. The area outlined in yellow denotes the area of peat cuttings which support rich-fen vegetation, including alkaline fen. The blue block area shows the location of Figure G. This figure shows the new *LIFE* track created to allow access to the E margin of the fen and land acquired through the *LIFE* project at Allt Goch. Fine black lines denote 250 m grid lines of the British National Grid. Centre of image is at c. SH3065.3810.

The primary restoration element concerned the removal of a tapering wedge of peat from the area marked in blue on Figure 20, with the depth of cut decreasing from the upslope margin of the site towards the river. This profile was guided by a detailed topographic survey of the site (Digital Mapping Services, 2013) which yielded height contours at 0.1 m height intervals and was designed to reduce the slope of the restored peat surface towards the river.

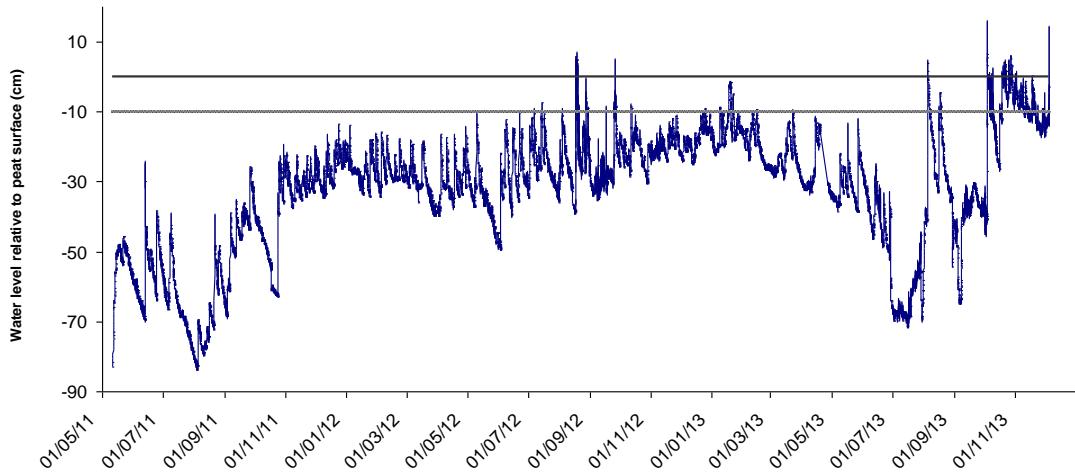
Figure 21. Hourly records of water table level at dipwell DW3, Cors Ceidio, prior to restoration measures in January–February 2014. Ground level is shown at 0 cm as a solid line. The post-restoration surface which is 10 cm lower than the original ground surface at this location is shown as a dotted line. Well DW3 is located mid-way along transect To-T1 of Figure E.

Cors Ceidio is flanked to the NW by a slope which forms part of the series of fluvioglacial terraces bordering the site. This landform forms part of a large kame-moraine complex, with fine sand the dominant component (National Assembly for Wales, 2003). A stratigraphic sequence revealed in a now infilled nearby quarry cutting into this landform at SH 302379 revealed >15 m thickness of coarse gravels, sands and diamicts (Edge, 1990) and several seepage zones are visible at the base of the slope at the margin of the fen, particularly above former ditch alignment D-C and continuing to the WSW (Figure 20). This seepage was formerly intercepted by ditches cut along parts of the 'upslope' fen margin – particularly section D-C. Ditch section A-B was dug in the early 1990s in an attempt to irrigate the upslope (NW) margin of the fen peat body through diversion of the Afon Geirch, but this had the inevitable but unwanted effect of intercepting seepage entering the fen from the drift slope to the west. Weirs were previously installed along both ditch sections C-D and A-B to try and limit seasonal drawdown of water levels, but interception of seepage would still have occurred and automated hourly monitoring of water levels down-gradient of section C-D shows water levels significantly below ground surface for much of the year and thus outside the range normally associated with either target Annex I habitat (Figure 21).

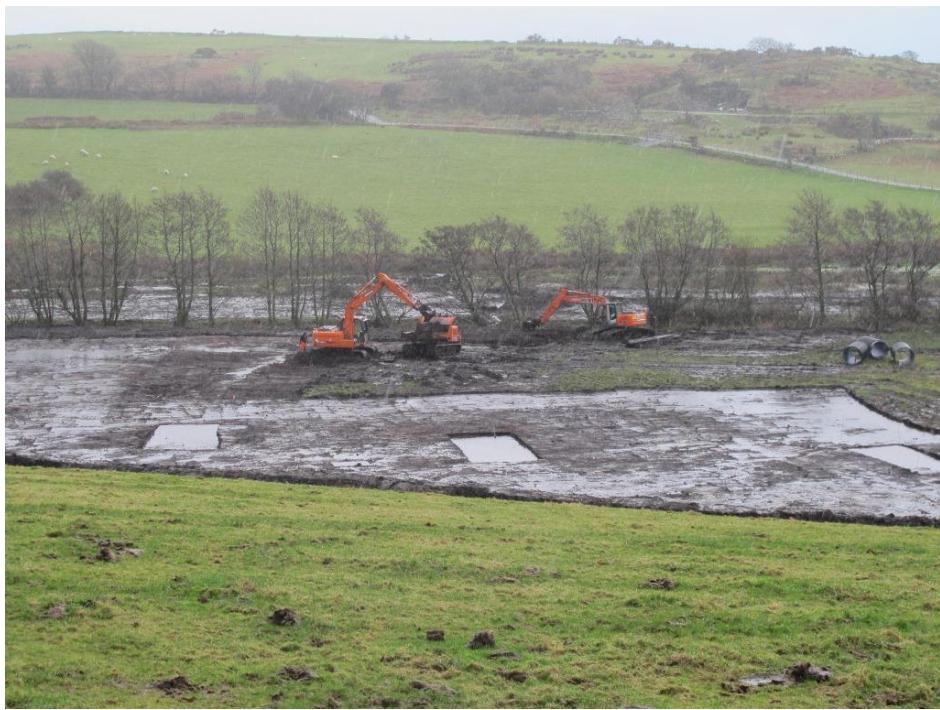
Figure 22. Peat stripping work in progress at Cors Ceidio in February 2014 as seen from the lane at the top of the slope to the NW of the site (see Fig. E for location). The three flooded oblong areas are deeper excavations designed to mimic historic peat cuttings which remain a short distance to the right (SW) of this image. The new access track to the opposite (E) side of the fen is seen to the right in the distance.

The same specialist low ground pressure excavator employed at Mathan Uchaf (see D.V. Jones *et al*, this volume) was used for this project, together with relatively light-weight tracked dumpers to move peat (Figure 22). Excavated peat was deposited in

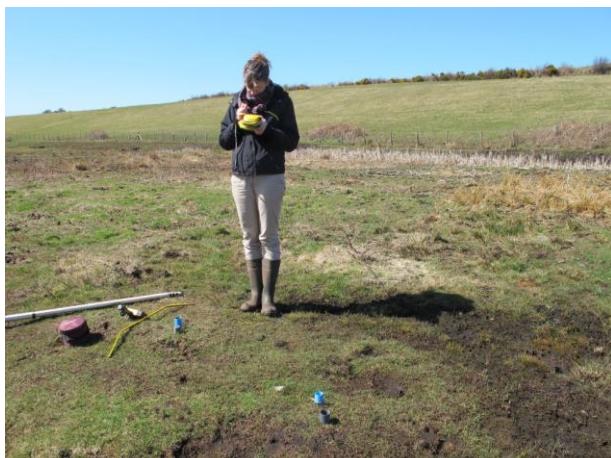
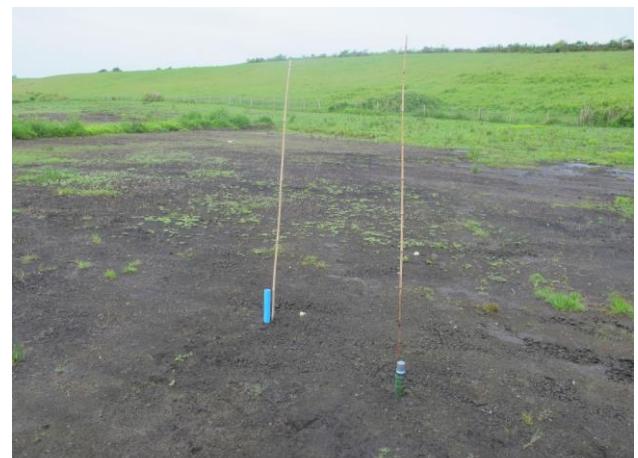
Figure 23 a & b. Photographic comparison of part of Cors Ceidio looking WNW from the dipwell transect marked as line T0 to T1 on Figure E. Figure left (19 April 2013) shows the situation pre-restoration with the rising drift slope in the distance, ditch-line C-D filled with dead *Typha* stems and wells DWP3 and DW3 to the left and right respectively of LIFE Project Officer Rhoswen Leonard. Figure right (28 May 2014) shows the same scene post peat stripping. Note the increased height of exposed well liner resulting from removal of c. 10 cm of peat at this location, and the infilled ditch at the edge of the peat body, with excavated peat piled as a sloping surface up to the fenceline.

three main areas, (i) as infill for the ditch at the upslope edge of the fen beneath the kame-moraine slope (Figures 23 and 24), (ii) to replace peat lost to oxidative wastage on both sides of the deepened and canalised river, and (iii) to create a floating road across a highly modified part of the peat body on the E side of the Afon Geirch, thereby enabling access to the restored site from a track installed leading down to the eastern margin of the fen.

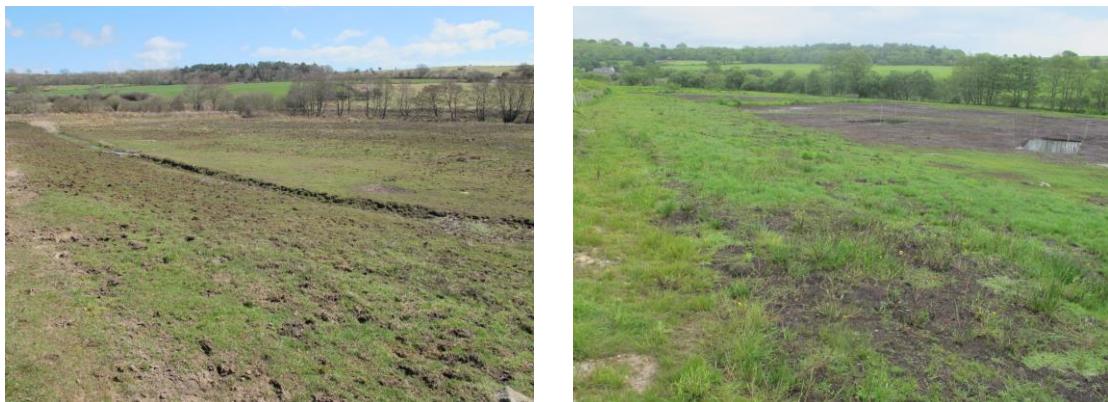
Figure 24. Before (L, April 2013) and after (R, May 2014) views of part of the restoration area at Cors Ceidio showing the upslope ditch prior to restoration and the restored profile with peat infill of the ditch.

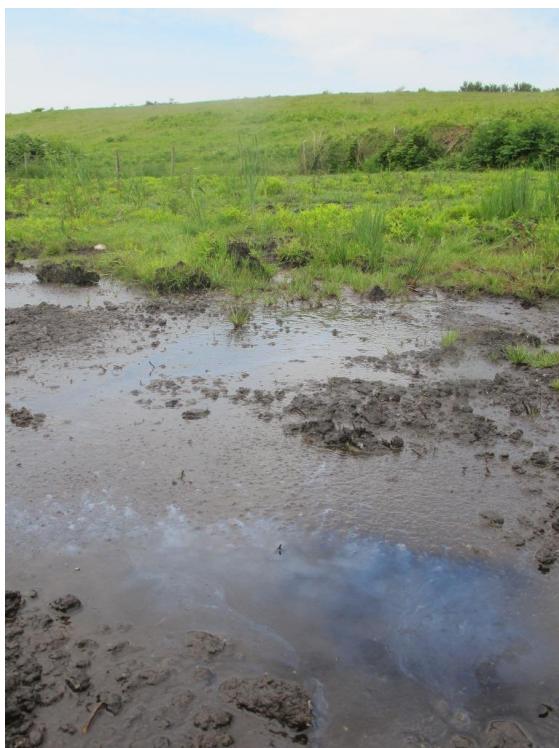
Figure 25. View looking upslope from the edge of Cors Ceidio showing peat exposed by peat stripping, a band of seepage with a natural iron film, and the wedge of now revegetated deposited peat used to infill the drain.

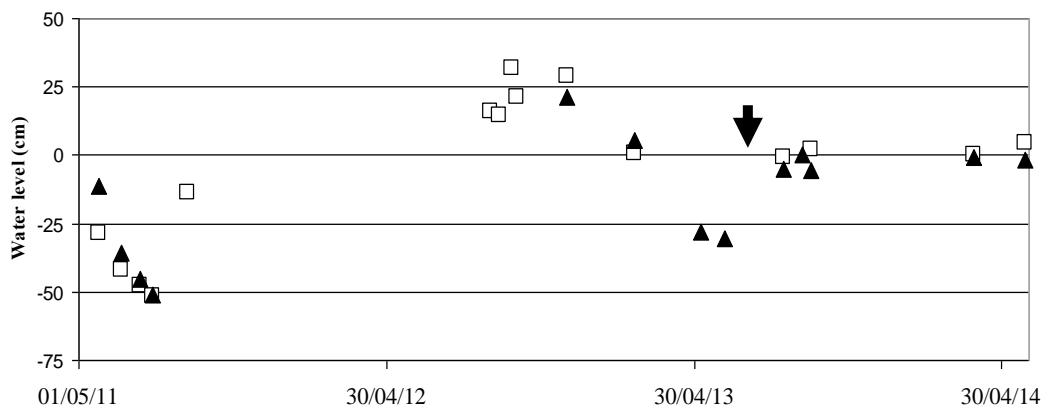
Figure 26. Plot of water levels relative to peat surface recorded before and after restoration of spring inflows at Mathan Uchaf (Cors Geirch, Llyn Fens SAC) on 17 July 2013 (see arrow mark). Data are shown for dipwells 2 (triangles) and 3 (open squares) – see Figure M3 for locations.

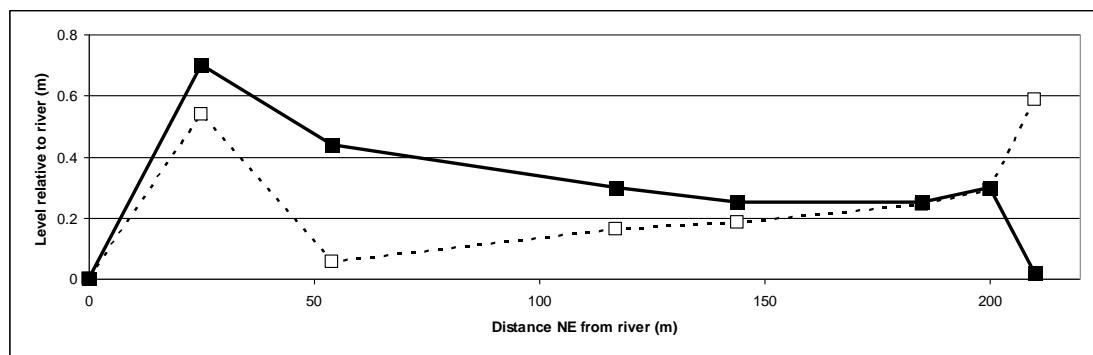
Figure 27. Topographic profiles along the NE to SW alignment shown in Figure M3 at Mathan Uchaf (Cors Geirch) before (solid line and squares) and after (dotted line and open squares) restoration. Levels are shown relative to river level (0 m) with the levels at 210 m representing the original footslope drain water level and the subsequent water level within the constructed wetland. Pre-restoration elevation data are derived from DMS (2013) – post restoration levels were obtained through a laser level survey in March 2014.

Peat stripping was designed to create a profile which greatly expands the influence of seepage water entering the site from the outflow of the constructed wetland installed over the top of the infilled footslope drain (see D.V. Jones *et al.*, this volume). The continuation at a right angle of the peat stripped area as a profiled cutting running from NW to SE (Figure 28) prevents deep flooding where the cutting abuts the river bank and, in effect, increases the overall length of the artificial seepage feature. An

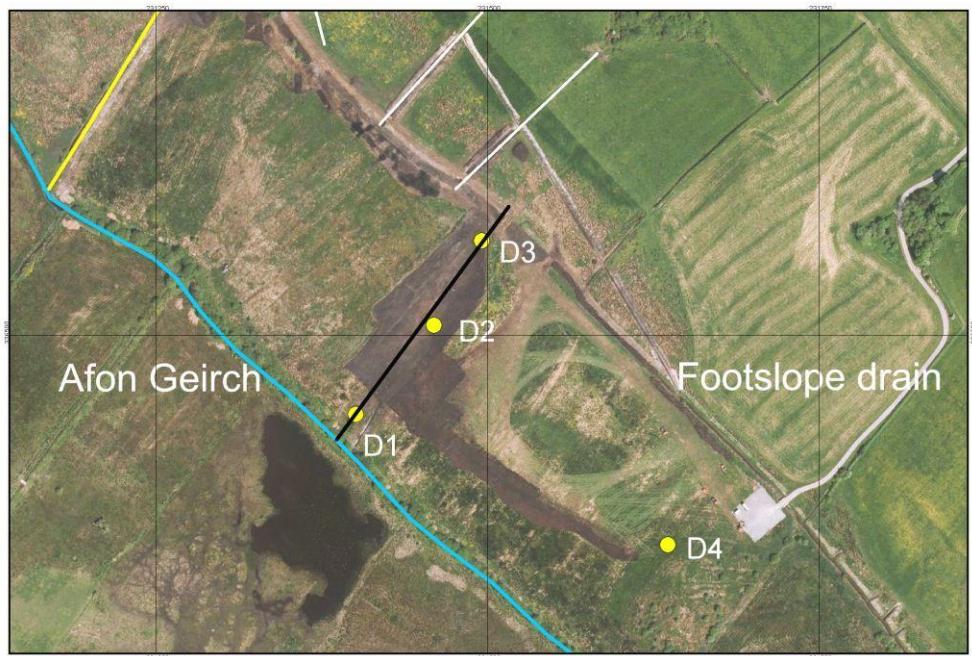
Figure 28. 2013 aerial view of Mathan Uchaf (Cors Geirch) showing the peat re-profiling and spring water diversion work in progress. Exposed peat is clearly visible, though the full extent of this is not yet apparent in this image, nor the constructed wetlands which will overlap the former footslope ditch. The dipwell transect D3 to D1 and the Afon Geirch is shown – see Figure M2. The NE tip of the transect is coincident with the constructed wetland system installed shortly after this photograph was taken. Grid lines are at 250 m intervals. The square hard-standing and access track built with LIFE funding are shown to the right of the image. Centre of image is at SH 314364.

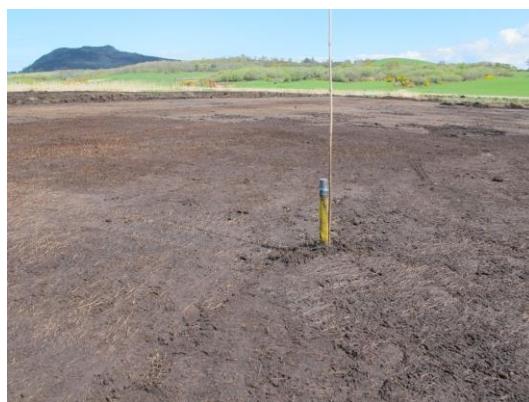
Figure 29a. Dipwell D2 and the peat stripped area at Mathan Uchaf shortly after its completion in June 2013 but before irrigation of the surface with outflow from the constructed wetlands.
