Restoring hydrological regimes for rich-fen habitats on the Anglesey & Llŷn Fens Special Areas of Conservation, North-west Wales.
(extract from Proceedings of Technical LIFE Project Workshop).

Peter S. Jones, Justin Hanson, Janine Guest & Rhoswen Leonard

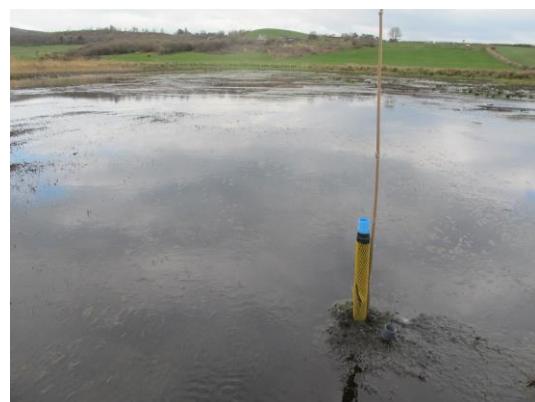
Figure 29b. The same scene as Figure M4a in March 2014 with outflow from the constructed wetland in the distance flowing towards the observer as a shallow sheet of water.
