Dune Rejuvenation Trials Overview Report

Ken Pye and Simon Blott

Kenneth Pye Associates Ltd

Report No 296

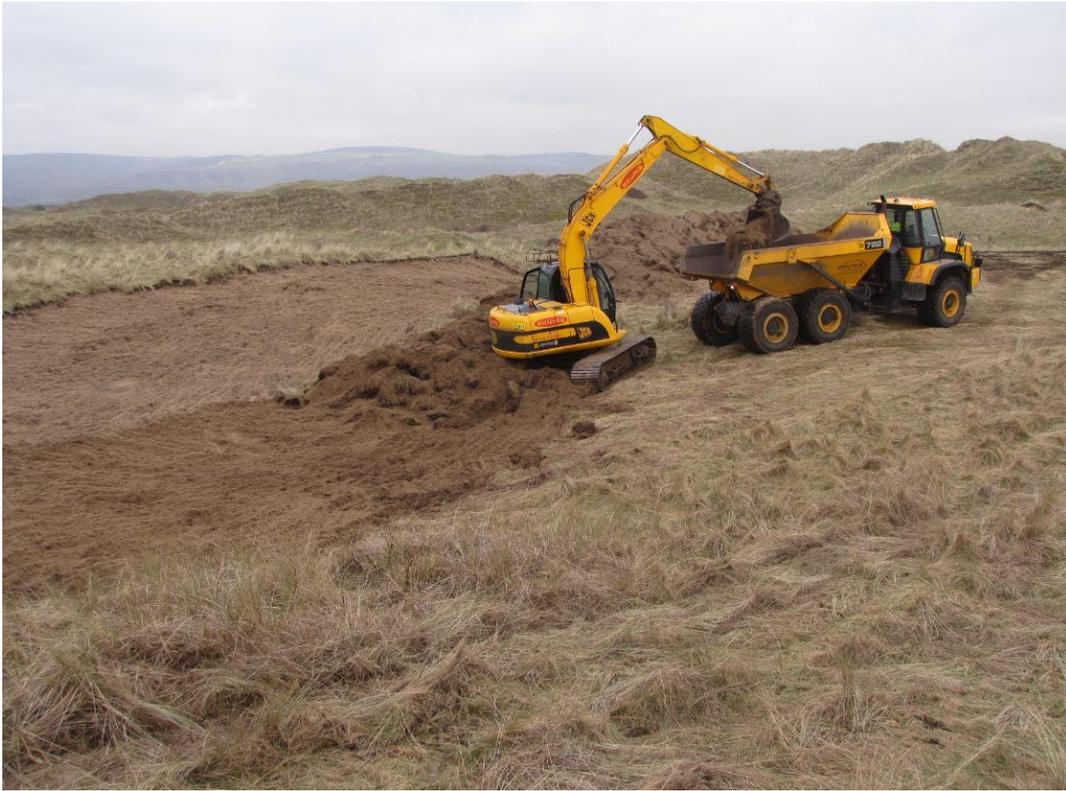
Figure 5. Turf stripping, Kenfig Phase 1, February 2012 (photograph by David Carrington, Reserve Warden, Bridgend Borough Council)

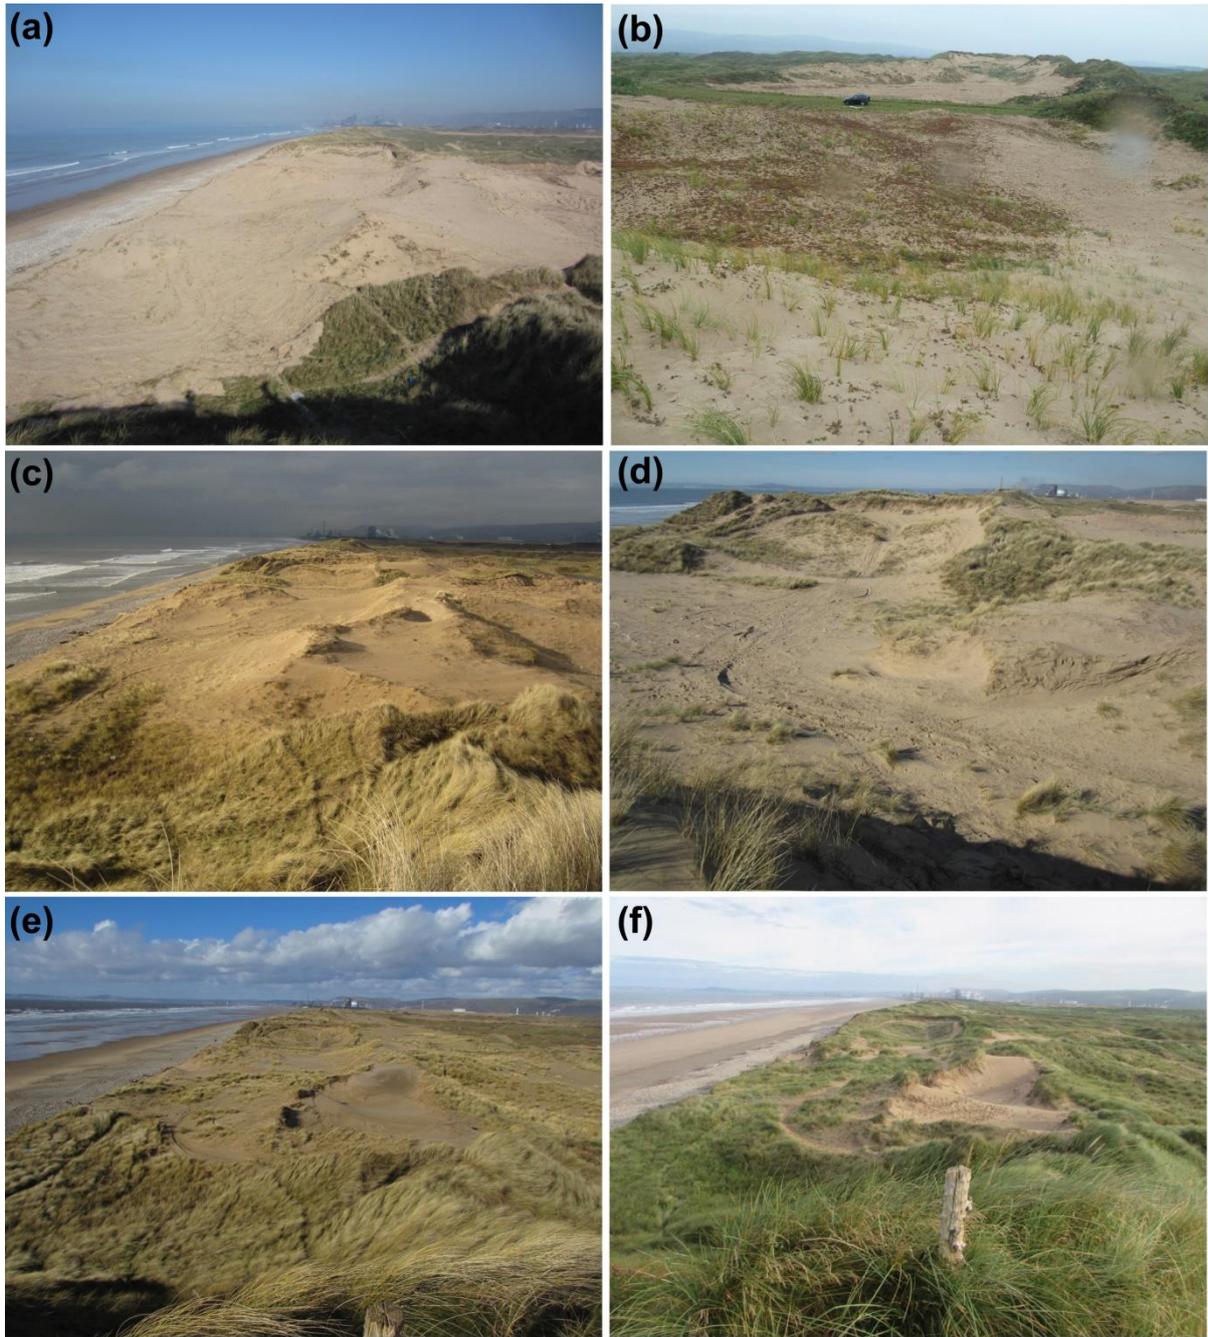
Figure 7. Photographs of the seaward end of the Phase I area where turf stripping and dune lowering was undertaken: (a) March 2012 (photograph by Mike Howe, NRW); (b) October 2012, showing regrowth of *Rubus* and marram; (c) March 2013, after spraying; (d) January 2014; (e) March 2015; (f) 26 July 2016

and *Ammophila arenaria* (Marram) (Figure 7b). Regrowth was facilitated by a failure of the turf stripping operation to completely remove or kill the plant roots, by a cool, wet spring and summer of 2012 which favoured plant recovery, and by a very small sand supply of fresh sand blown from the beach which on this part of the Kenfig shore is relatively low and often wet.

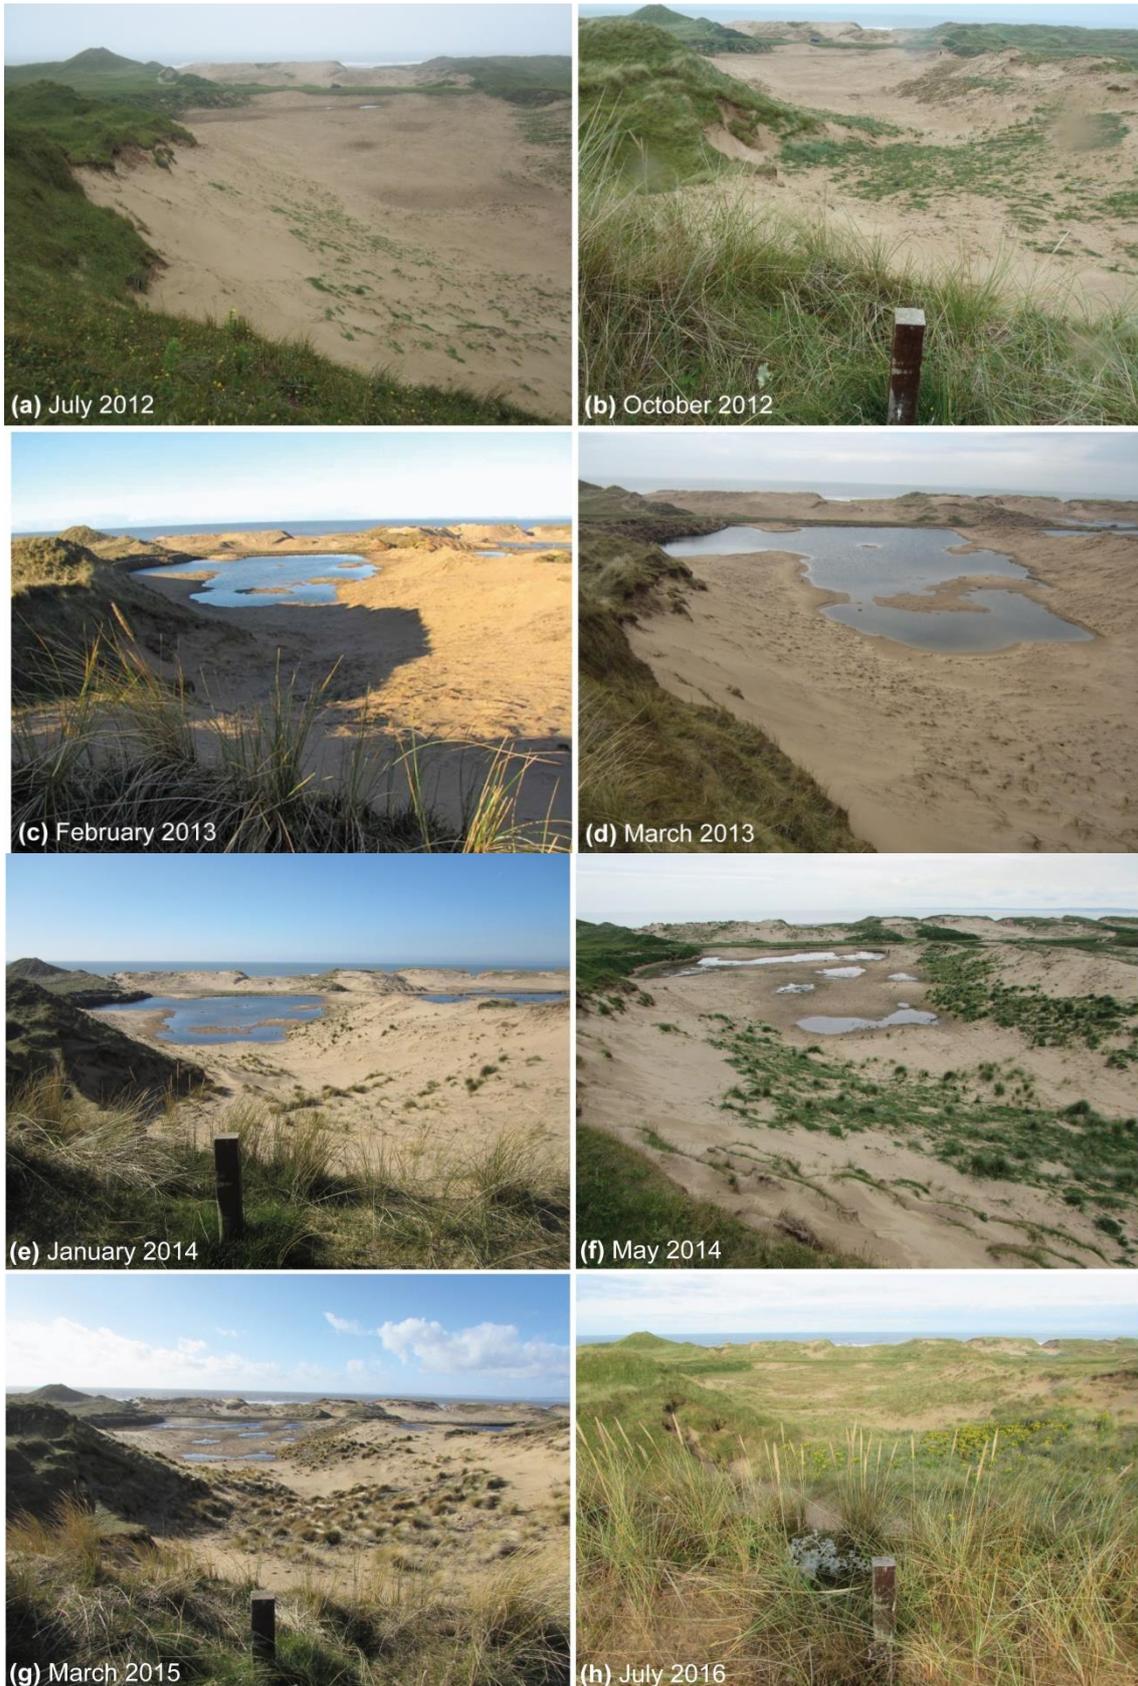
Figure 8. Photographs of the deflation corridor of the Phase 1 parabolic dune, view seaward from the dune crest. Note significant vegetation regrowth in 2012, followed by a decrease in 2013 partly due to spraying and partly to burial by blown sand, and further increase in vegetation cover since January 2014

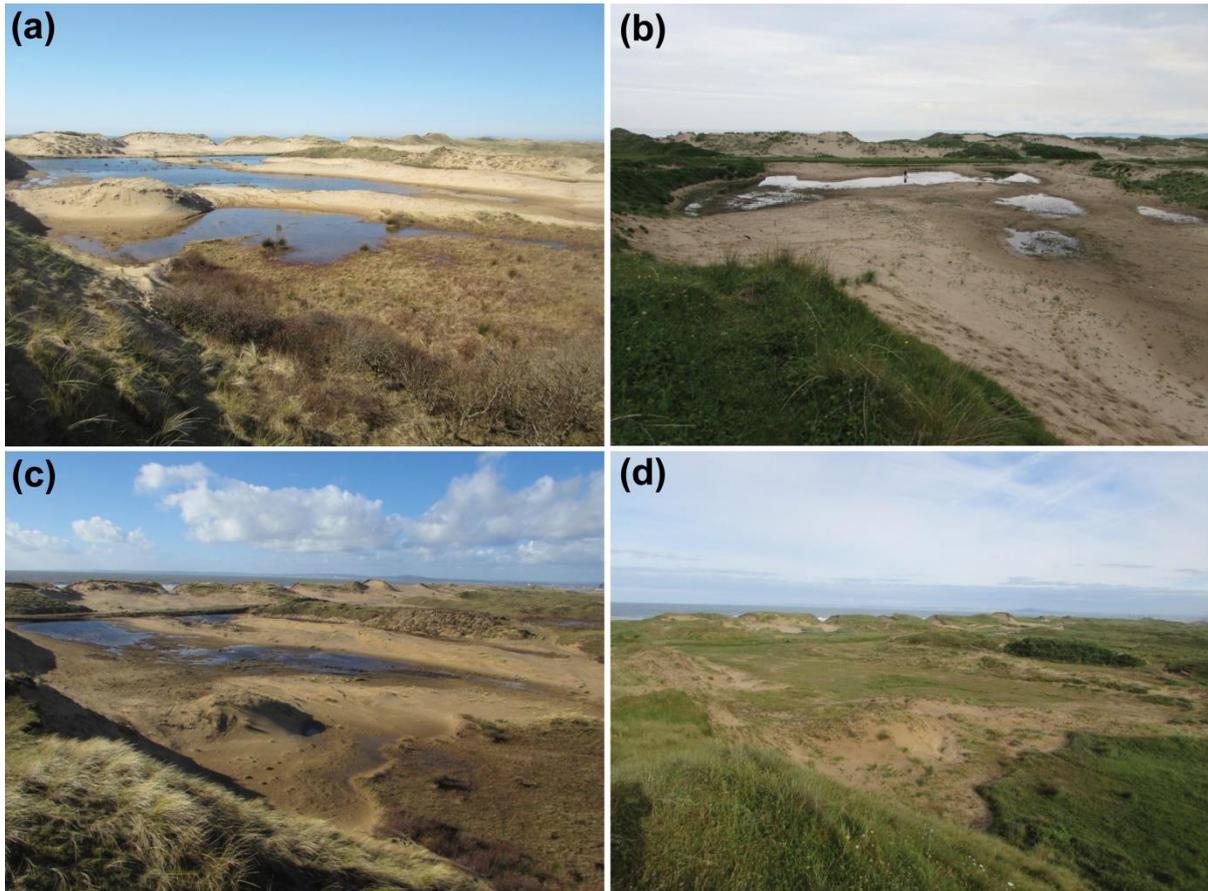
Figure 9. Photographs of the Phase 2 area, taken from the crest of the Phase 1 parabolic dune looking towards the sea: (a) March 2014; (b) May 2014; (c) March 2015; (d) July 2016

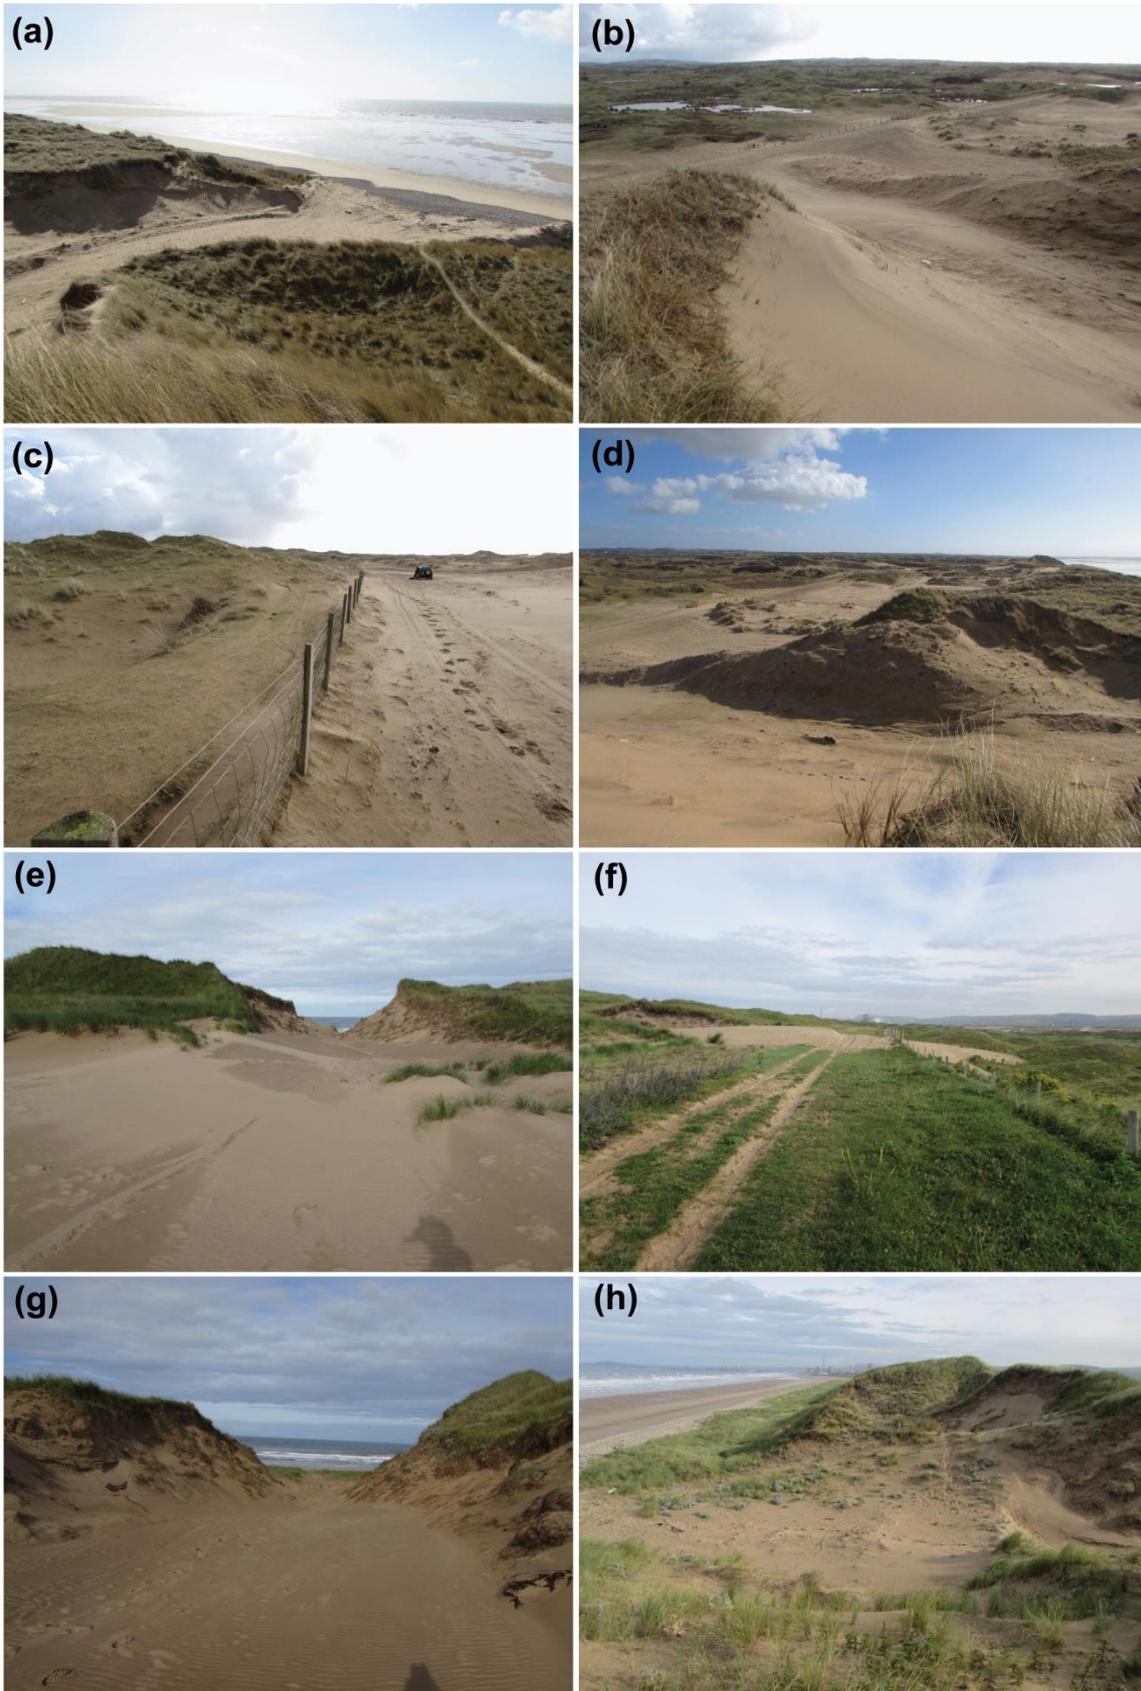
Figure 11. Photographs of the Phase 3 area: (a) March 2014; (b) March 2014; (c) March 2015 landward side of haul road behind notches; (d) July 2016; (e) July 2016; (f) July 2016; (g) July 2016; (h) July 20

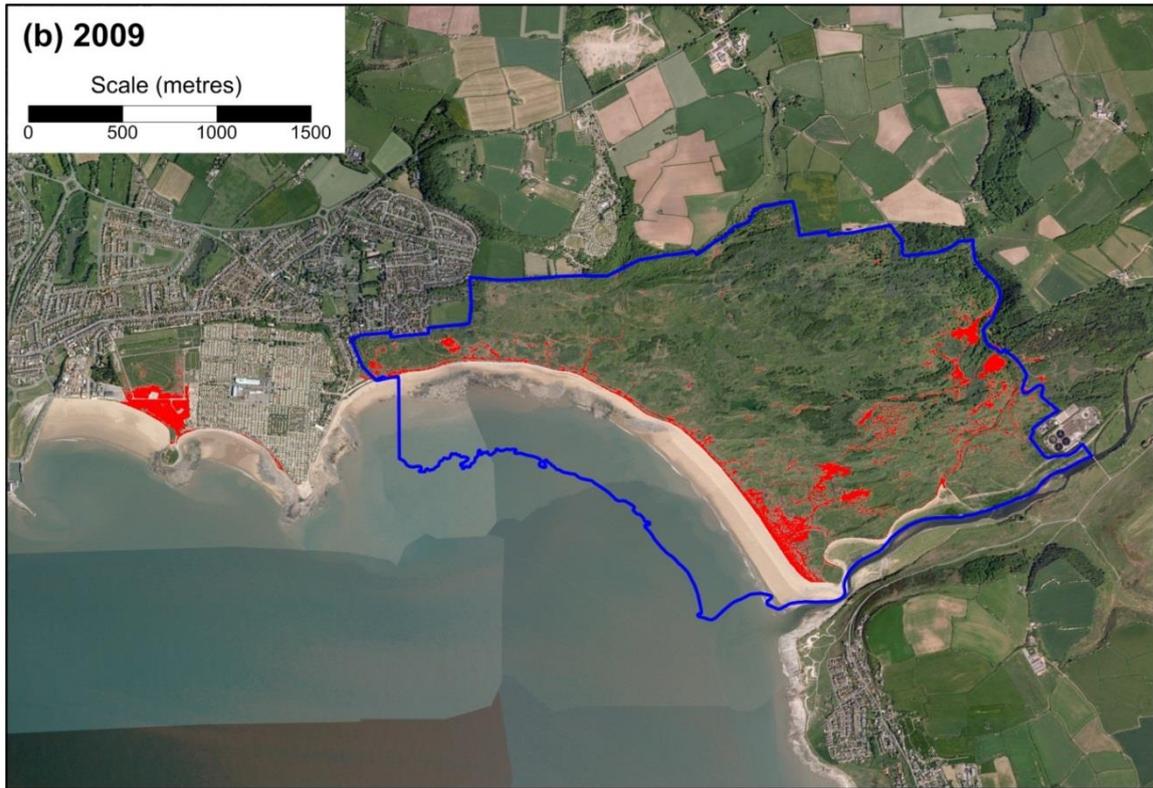
Figure 26. The extent of bare sand (red) at Merthyr-Mawr Warren in (a) 1947, and (b) 2009. The blue line indicates the SAC boundary

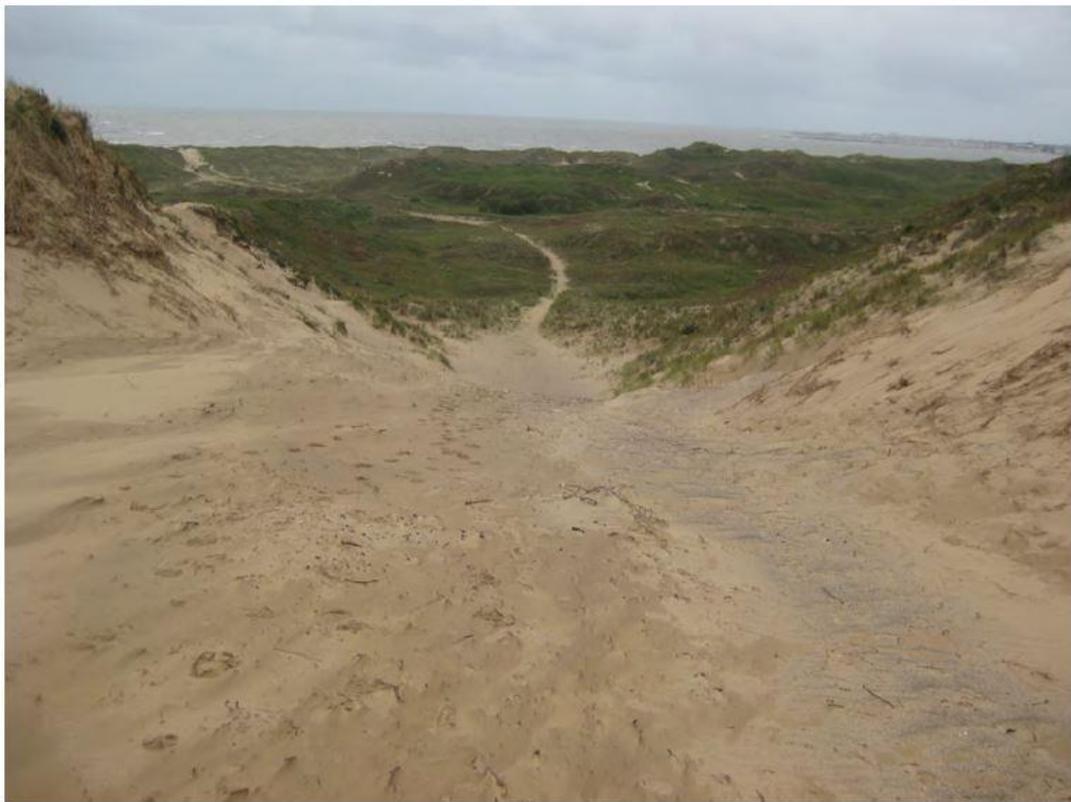
Figure 27. View from the crest of the large active parabolic dune (Dune 'A') at Merthyr Mawr looking seawards in September 2011

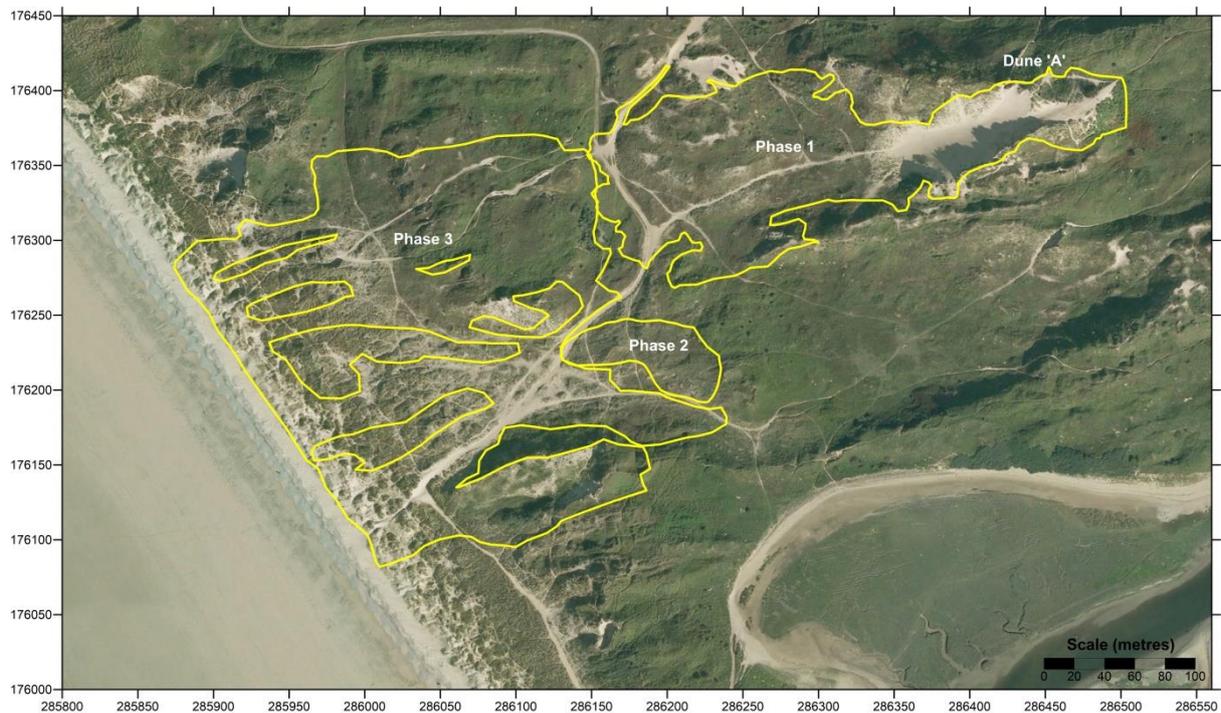
Figure 28. Pre-works aerial photograph of the southeastern part of Merthyr Mawr Warren flown 12 October 2009, showing extent of the Phase 1-3 rejuvenation works undertaken between November 2012 and November

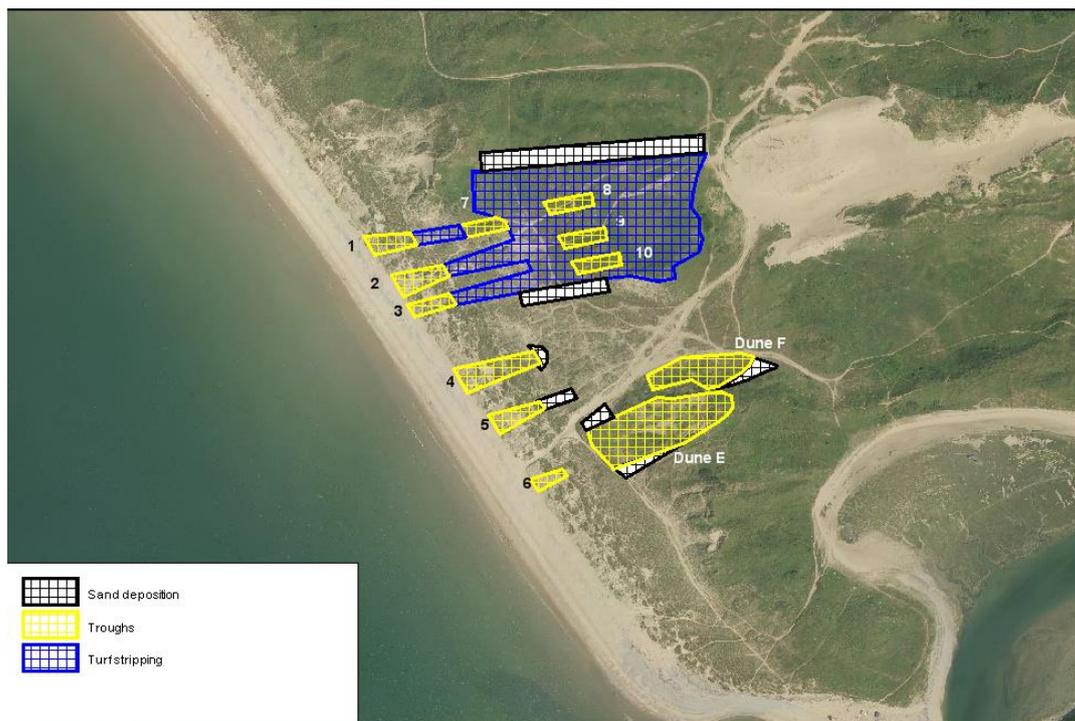
Figure 29. Aerial photograph showing the Merthyr Mawr Phase 3 work completed winter 2014-15 (source: Ludlow, 2014)

A large-scale programme of Phase 3 works was undertaken in November 2014 and consisted of the following elements (Ludlow, 2014; Figure 29):

- 6 notches cut in the frontal dunes (1 to 6 in Figure 29, re-numbered A to F for topographic monitoring purposes)
- 4 troughs excavated to remove dune ridge obstacles and link frontal dune notches with inland areas (7 to 10 in Figure 29)
- Turf stripping upwind to expose more bare sand of the Phase 1 area
- Excavation and re-profiling of one large parabolic dune (Dune E)
- Extension to the artificial dune (Dune F) created in Phase 2

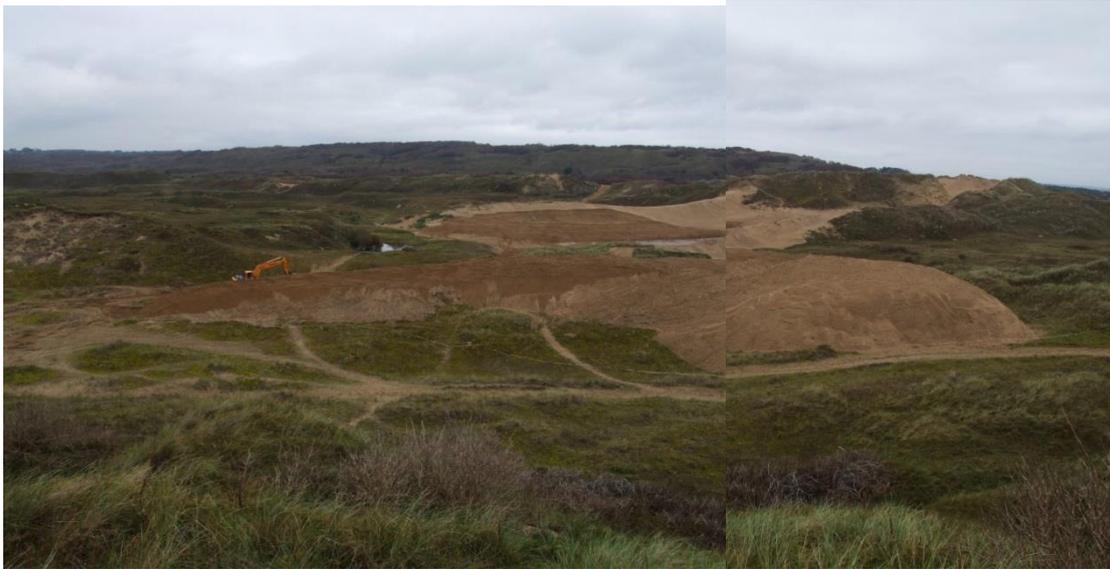
Figure 32. Merthyr Mawr Phase 2 area. View of work area looking north towards the end of the contract, with artificial dune in the foreground and sand excavation area in the distance (photograph by D Ludlow, NRW)

In winter 2013-14 a small area of Phase 2 works was undertaken, consisting of further sand excavation from the western side of the artificial slack created in Phase 1 and deposition of the excavated sand to create an artificial dune adjacent to the south-eastern corner of the Phase 1 works where an existing dune had been removed / destroyed during gravel extraction works in the early 1970s (Ludlow, 2013; Figure 28). The work was undertaken using one 20 tonne excavator, one 8 tonne excavator and three dump trucks. In the time available it was not possible to excavate all of the sand which was planned, and the sand placement site had to be relocated to avoid placing overburden above a sewage pipeline route. It was therefore not possible to make the eastern arm of the large parabolic dune 'A' as long and continuous as had originally been planned.

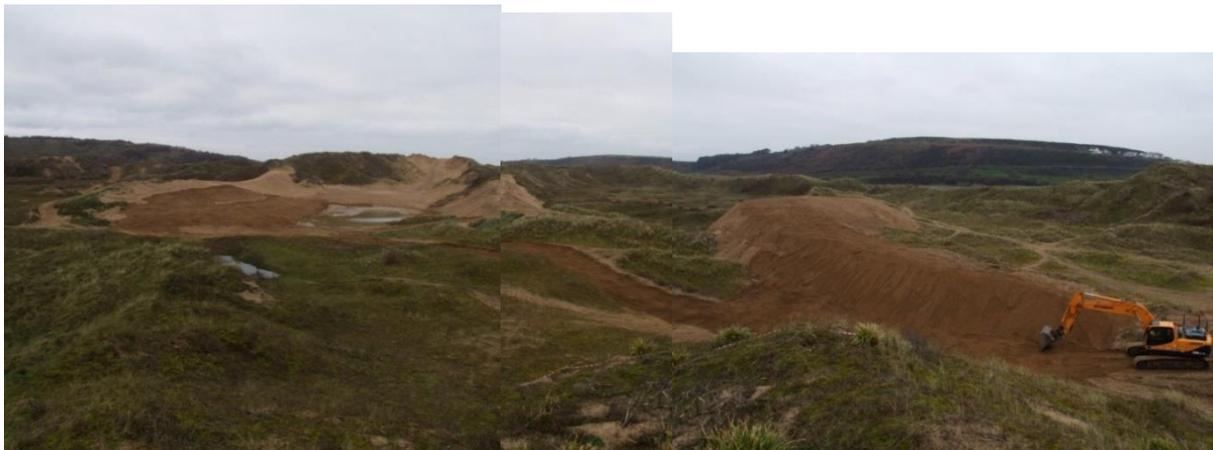
Figure 33. Merthyr Mawr Phase 2 area. View of work area looking east at end of contract, with area of sand excavation on the left and artificially constructed dune on the right (photograph by D. Ludlow, NRW)

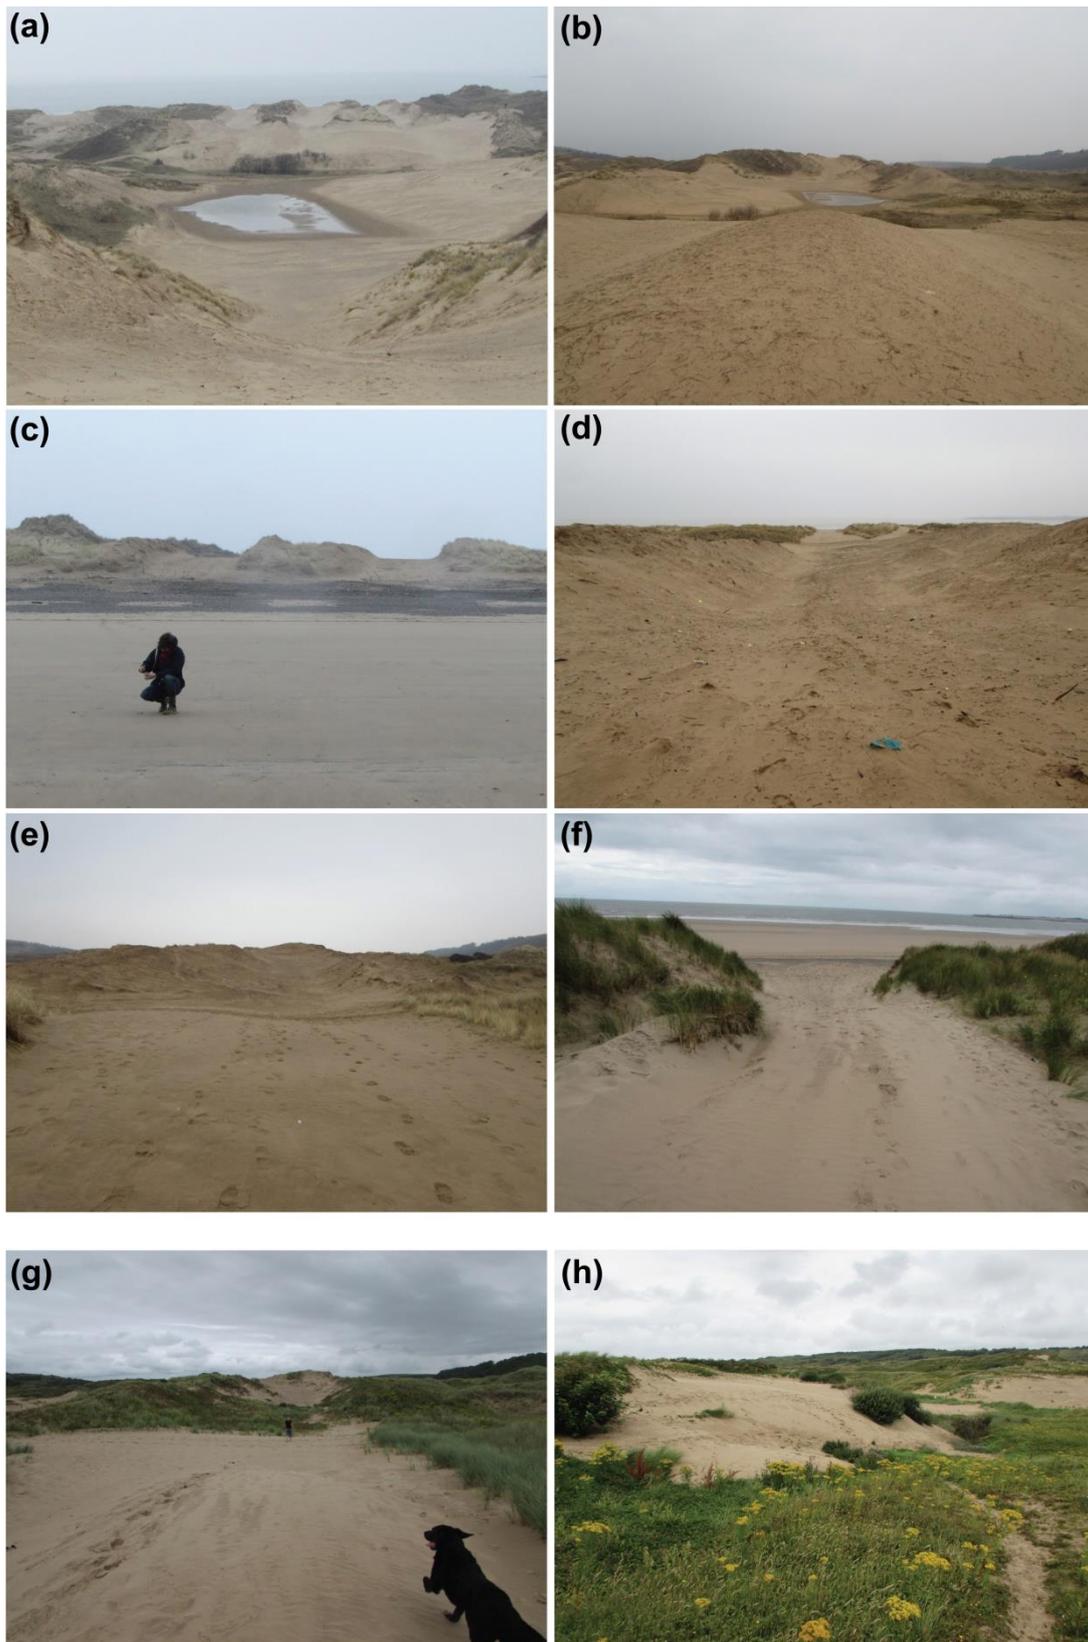
Figure 35. Photographs of the Merthyr Mawr Phase 3 area; (a) stripped deflation corridors in March 2015; (b) view landward March 2015; (c) notches March 2015; (d) Long 'trough' leading to stripped dune; (e) stripped dune at landward end of long trough in March 2015; (f) trough leading to long corridor, July 2016; (g) long corridor leading to stripped dune July 2016; (h) sand lobe transgressing into former shallow pool

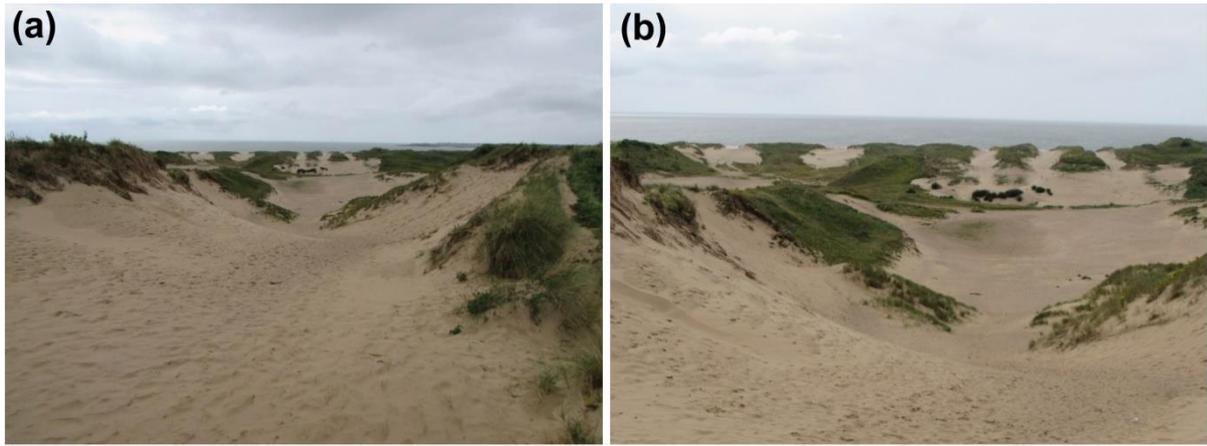
Figure 36. (a) Photograph taken from the crest of ‘Dune A’ looking seawards in July 2016; (b) closer view of the notches and corridors created in Phase 3

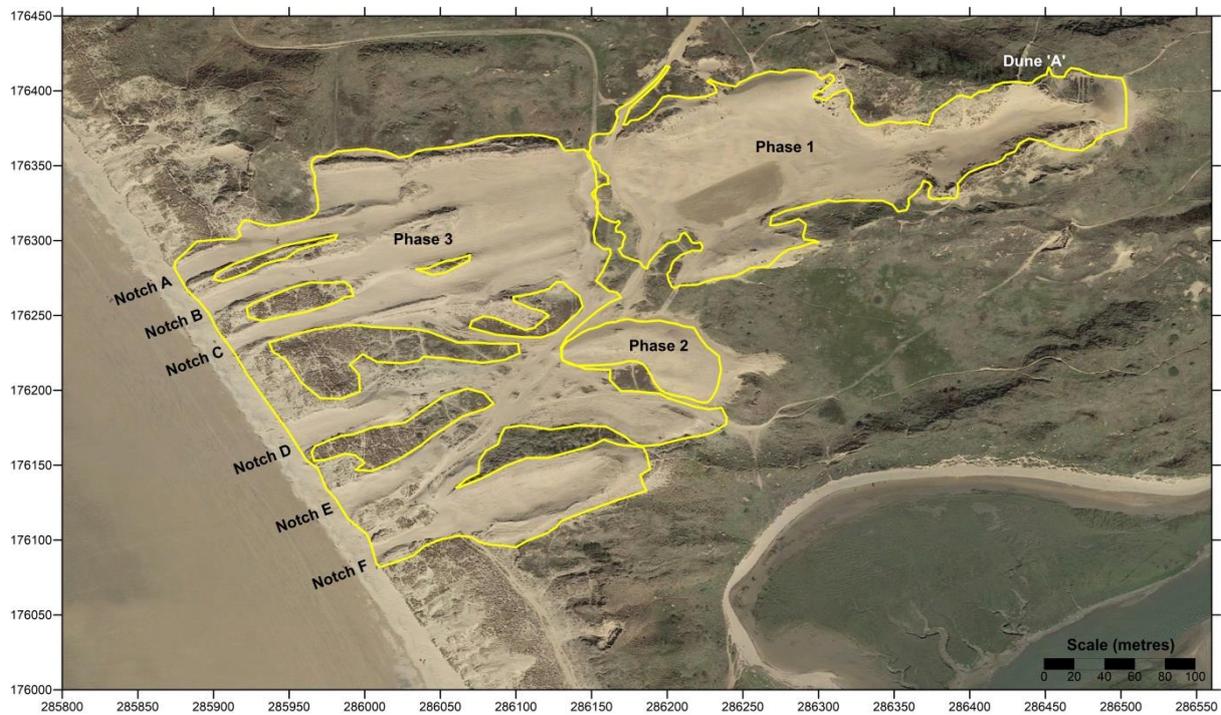
Figure 37. Aerial photograph taken 18 April 2015 showing the three phases of dune rejuvenation works at Merthyr Mawr (source: Google Earth)

Ground photographs illustrating various phases of the works and the ground conditions during selected post-works surveys are presented in Figures 30-36. An aerial photograph taken on 18th April 2015 (Figure 37) shows the total bare sand area created during the three phases.

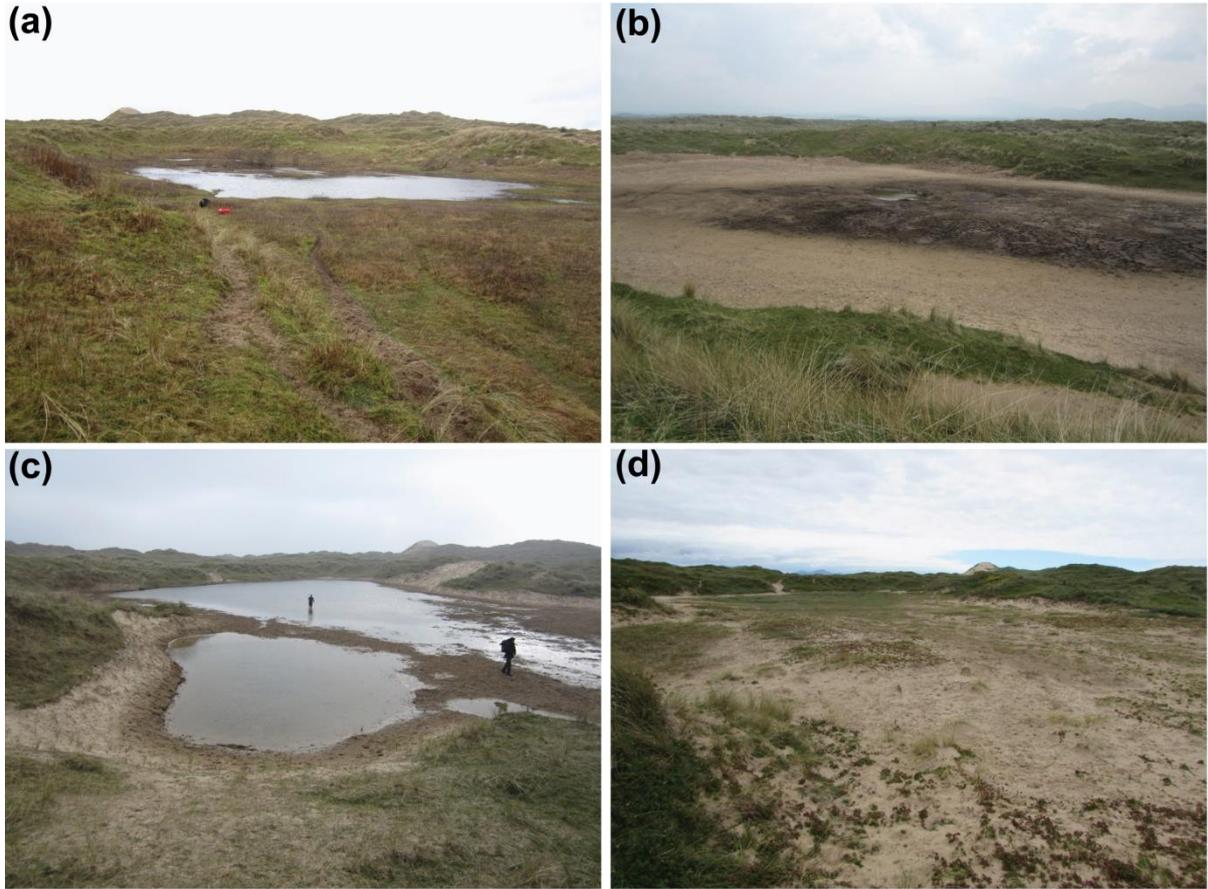
Figure 60. Ground photographs of Phase 1 Area 4: (a) Pre-works on 17 January 2013; (b) May 2013; (c) March 2014; (d) August 2016

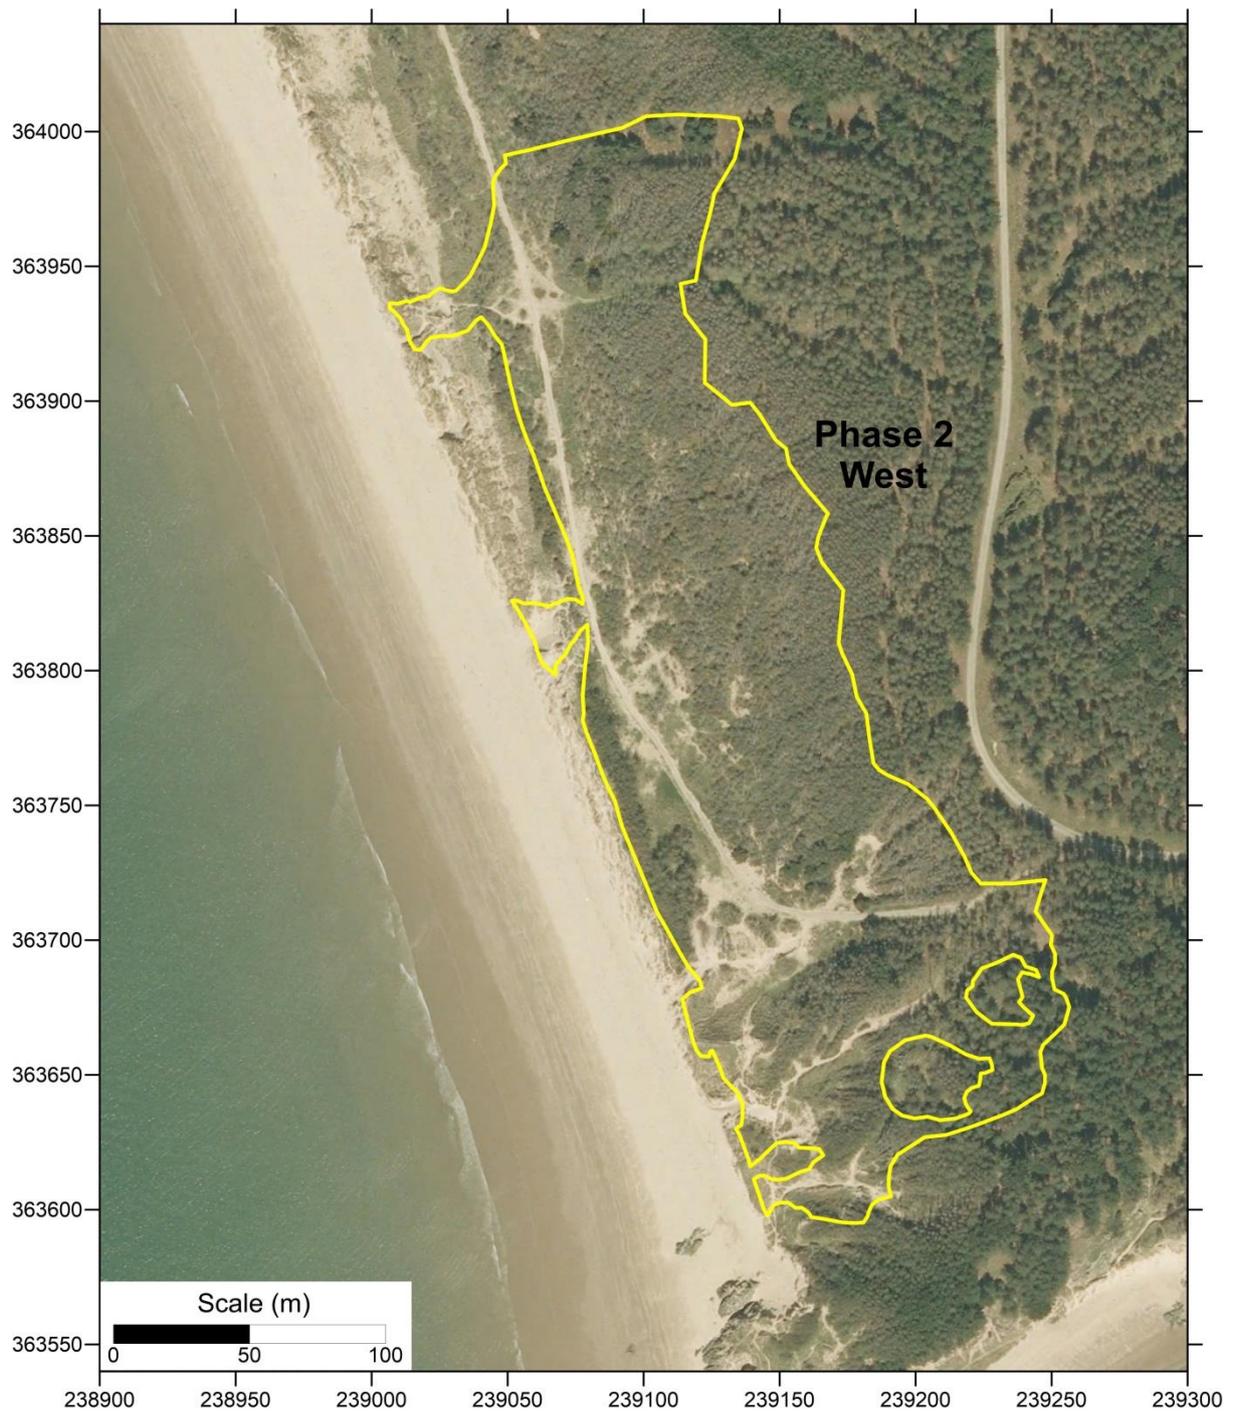
Figure 61. Pre-works aerial photograph flown 11 May 2009 of the Phase 2 West rejuvination trial area (at Traeth Penrhos). The yellow lines indicate the bare sand (vegetation stripping and sand heaps) created in December 2014 to March 2015, as surveyed on 25-27 March 2015 by ground RTK-GPS survey

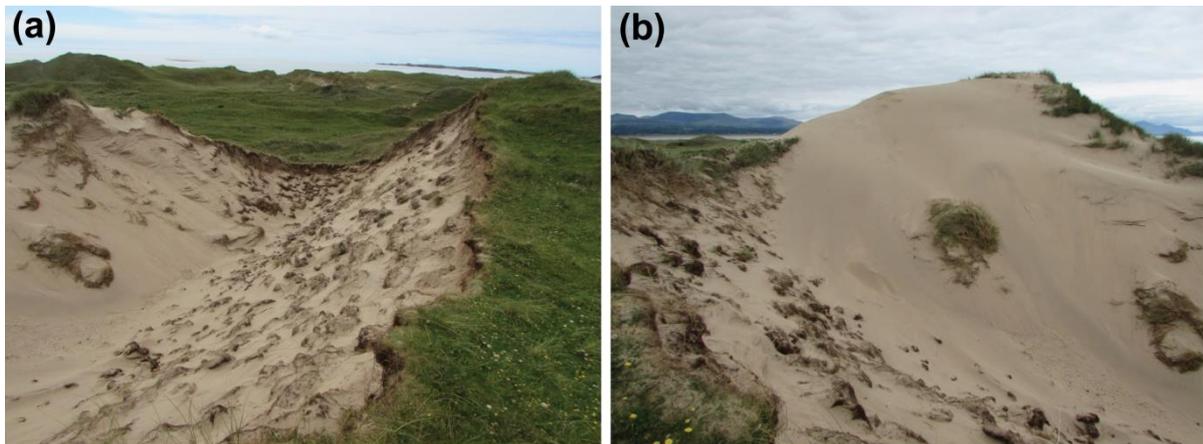
Figure 89. Ground photographs of Dune H, located in the southeast part of Newborough Warren, taken early August 2016; (a) deflation area, looking towards Llanddwyn island, (b) depositional area, view towards Morfa Dinlle

- Figure 89.** Ground photographs of Dune H, southeast Newborough Warren, early August 2016

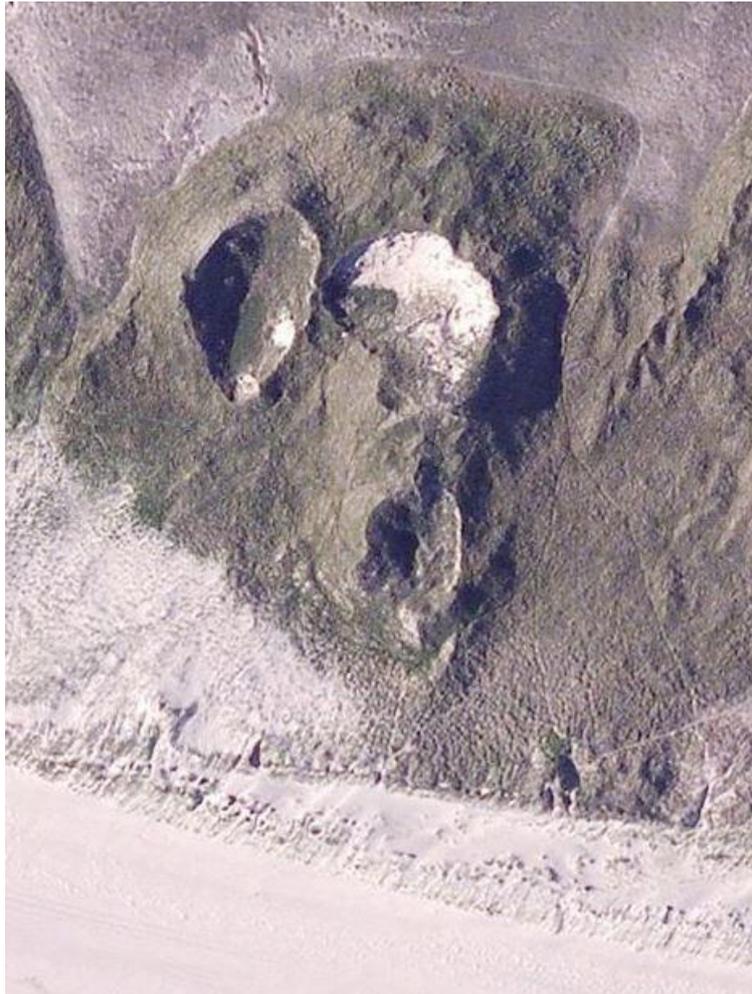
Figure 90. Aerial photograph of partially vegetated saucer blowout dunes NW Abermenai, taken 2011 (source: Bing Maps). Note also the extensive bare sand within and adjacent to the zone of recent frontal dune progradation
