Ecological Surveys of Welsh Lakes 2018

Goldsmith B, Stewart NF & Hatton-Ellis TW.

NRW Evidence Report No. 343

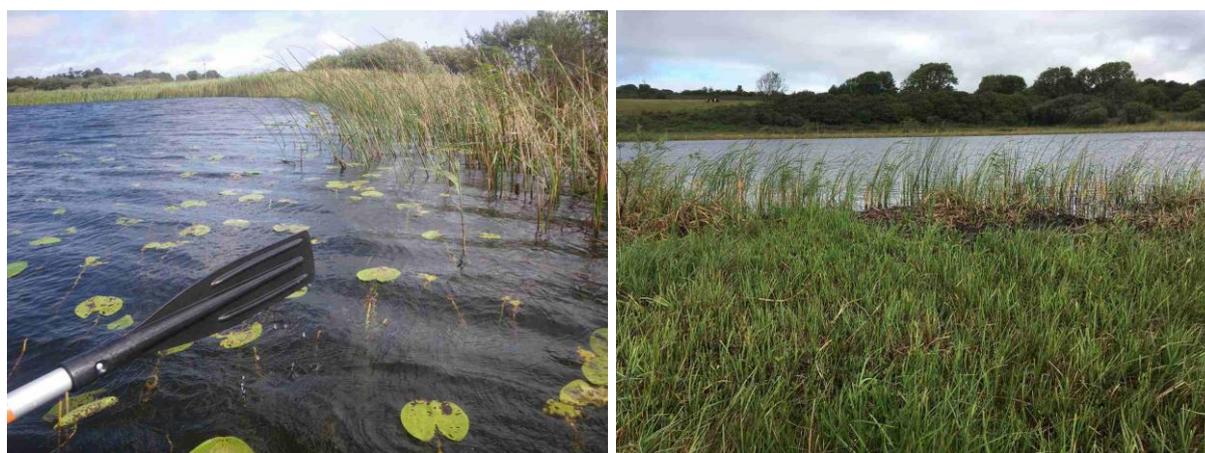
The site has been subject to cattle grazing in 2018, resulting in quite extensive loss of marginal reeds around the south and western shore of the lake (Figure 4a). The resulting reduction in shading may help to facilitate the growth of submerged plants in the littoral zone, including charophytes.

a.) Sparse band of *Nuphar lutea* and b.) area of heavily grazed reed at Llyn Cadarn

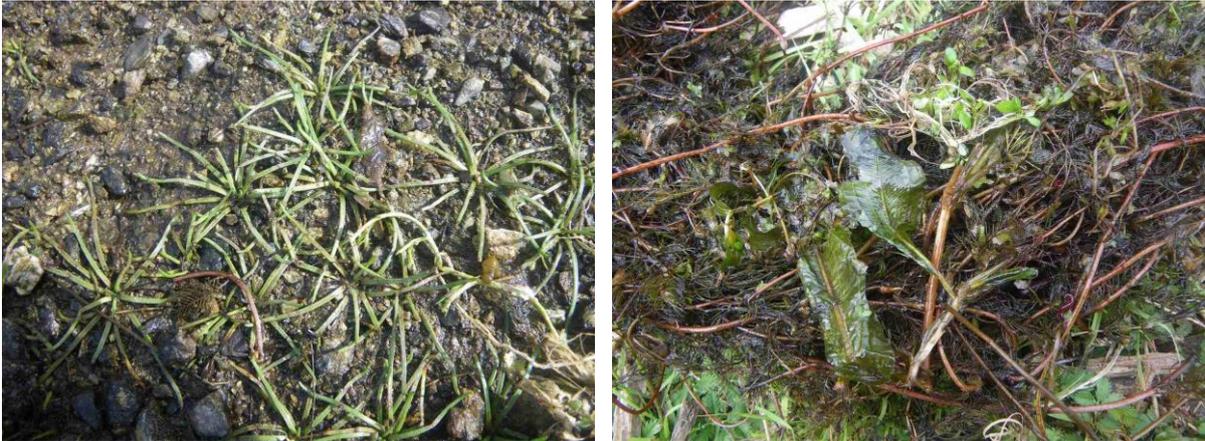
b) *Littorella uniflora* (S3 at lake edge and b) strandline material from S3, including *Potamogeton lucens*.

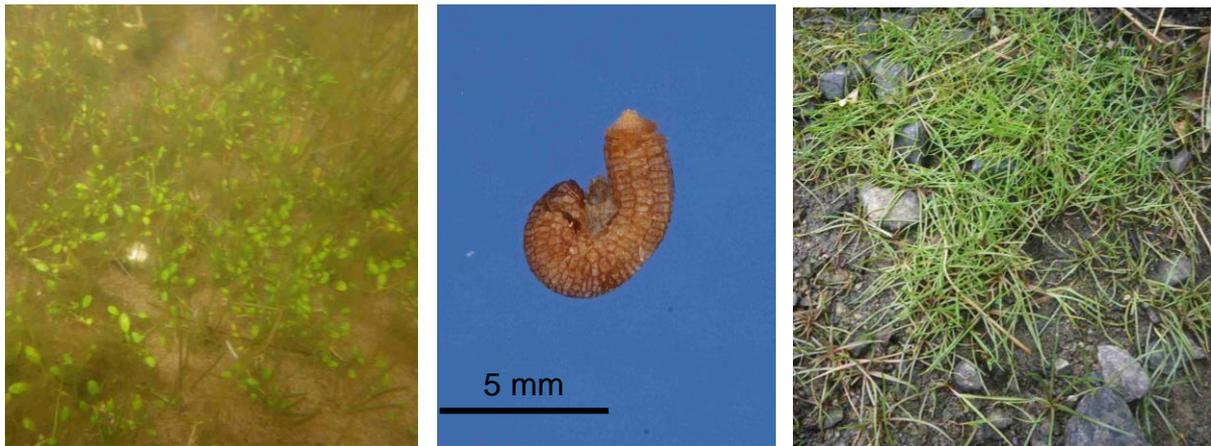
a). *Elatine hydropiper* growing with *Eleocharis acicularis* at S2; b) *E. hydropiper* seed; c) *Littorella uniflora* growing just above the waterline at S3.

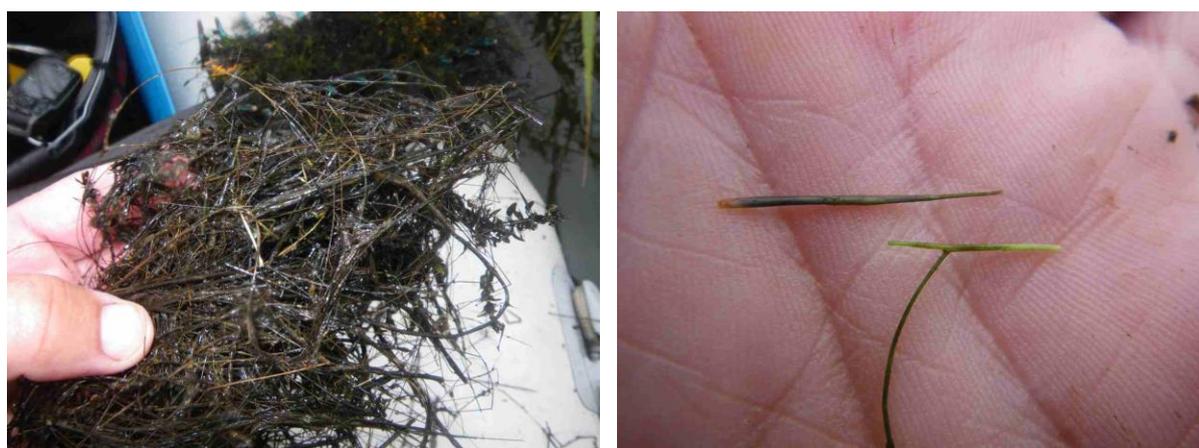
identification of *P. pusillus* and *P. pectinatus* being made from turions (b). Within the open water, the majority of degraded fine-leaf *Potamogeton* was accompanied by *P. pectinatus* turions and thus ascribed as such in the LEAFPACS tool and database. *Potamogeton pusillus* turions were less common. *Potamogeton perfoliatus* was still readily identifiable and the *Chara globularis*, where present, intact. *Elodea canadensis* and *P. pectinatus* were dominant, *Callitriche hermaphroditica* was present mainly in the strandline, and *Potamogeton crispus* recorded only as turions. *Eleocharis acicularis* and *Elatine hexandra* were recorded as rare in 2017, but not seen in 2018. The water was extremely turbid in the margins due to wave action, hampering efforts for visual surveys, which may account for these small species being overlooked.

Figure 25. a) senescing fine-leaf *Potamogeton* spp. sampled from open water in S4 and b) turions from *P. pusillus* (top) and *P. pectinatus* (below).

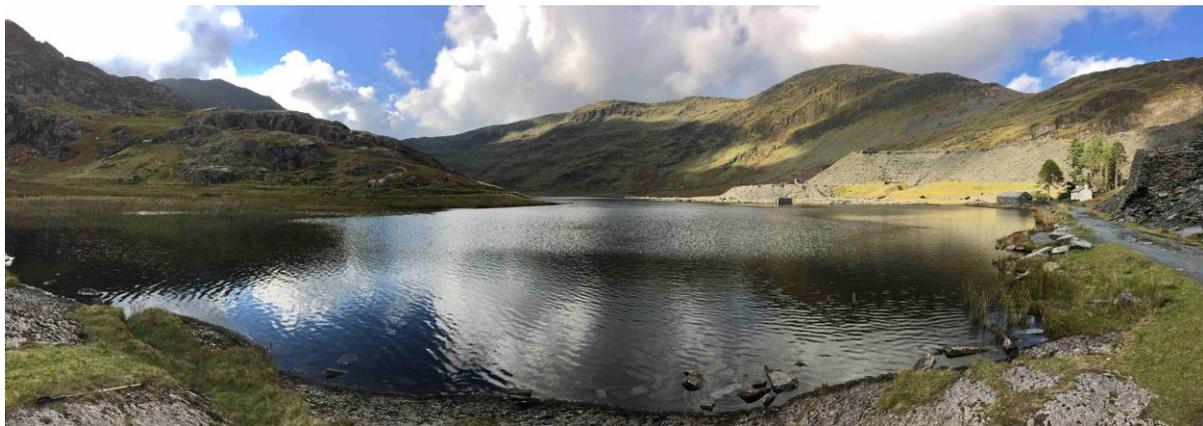
Figure 45. Llyn Cwmorthin site photo; from the south-east shore looking north-west.

Llyn Cwmorthin is a small (5.6 ha), shallow (max. 8.9 m) lake lying at 325 m AOD, and 2 km to the west of Blaenau Ffestiniog. The lake lies on the western edge of the vast slate quarries to which it owes its origins, having been dammed in the 19th century to provide a head of water for the slate dressing mills.

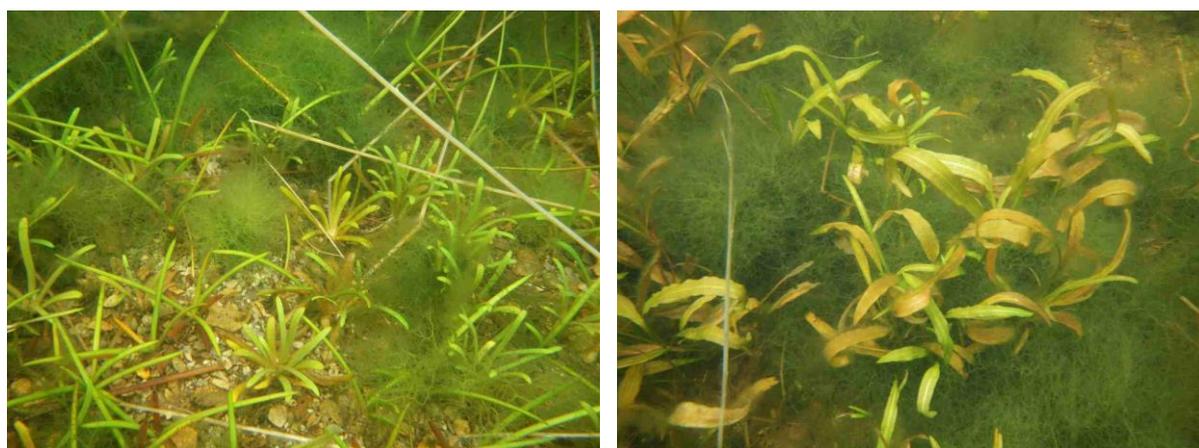
a) *Littorella uniflora* and *Lobelia dortmanna* growing within tufts of the red algae *Batrachospermum* sp. at S2 and b) strappy underwater leaves of *Potamogeton polygonifolius* in S2 at 0.9 m.

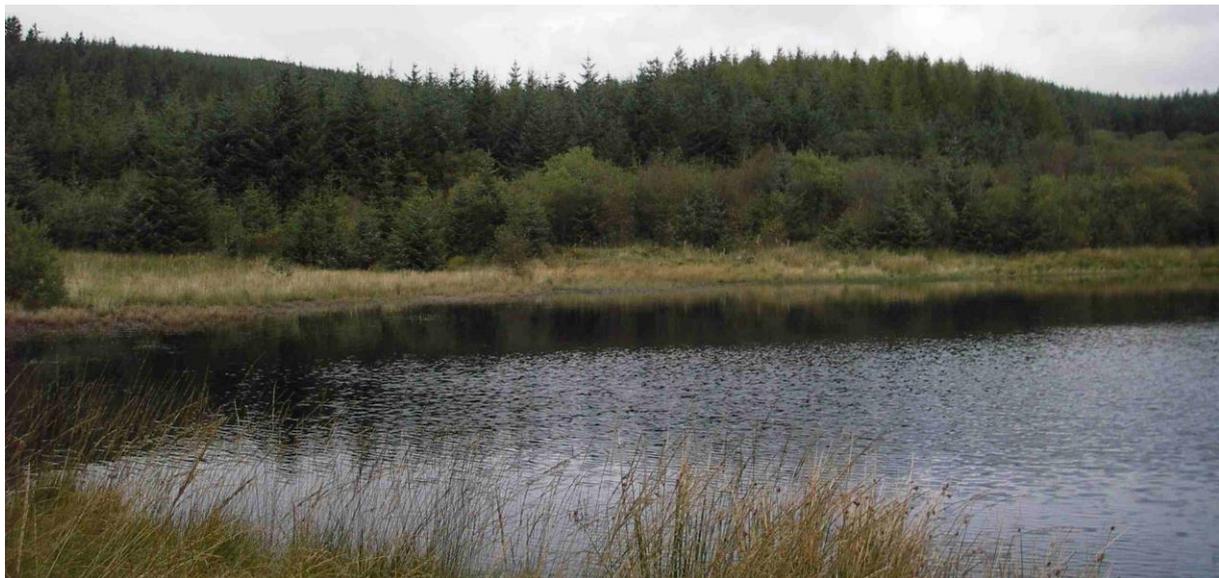
Figure 81. Llyn Blaenmelindwr site photo; from the south looking north-west.

Llyn Blaenmelindwr is an artificial water body retained by a stone and earth dam to the south-eastern end, over which the road now passes. Much of the immediate catchment to the north, east and west is planted with conifers, including both young

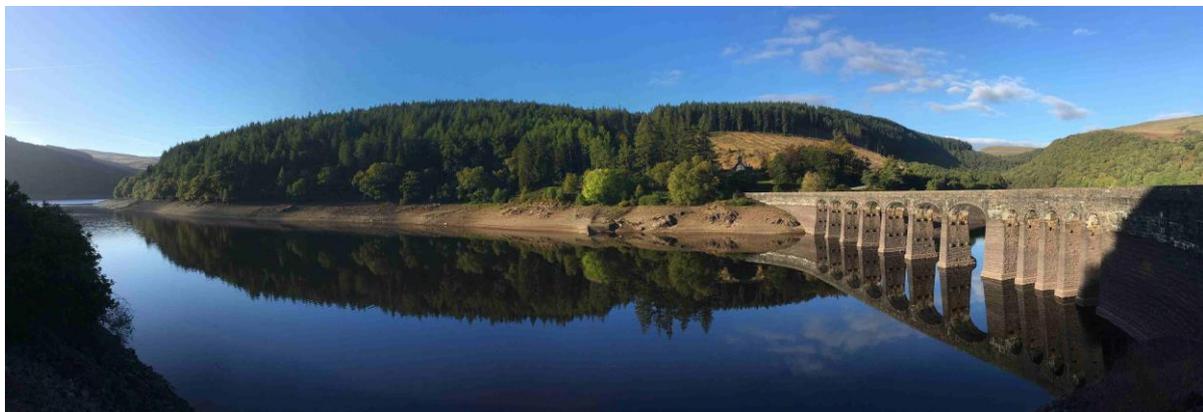
Figure 88 Caban Coch Reservoir site photo; from the north-west shore at Garreg Ddu dam, looking south-east.

Caban Coch Reservoir is the lowest of the four large Elan Valley reservoirs in Powys. The 37 m high dam at the north-west end, retains an area of just over 200 ha of open water with a top water level at 250.5 m AMSL. The Elan Valley reservoirs were constructed in the late 19th century to provide water to Birmingham.

Due to extensive drawdown (approximately 12 m below TWL), it was considered unsafe to launch and use a boat on the reservoir and therefore all survey work was conducted on foot. No dissolved oxygen / temperature profile was taken. A surface reading was taken close to the dam; DO = 9.58 mgl⁻¹ and water temperature = 13.3 °C.

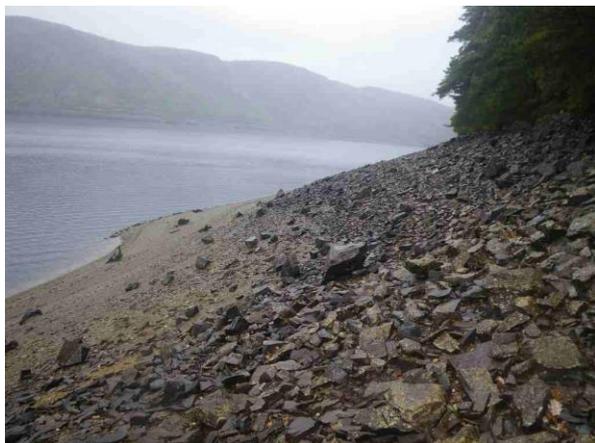
There was no evidence of any aquatic plants growing within the reservoir and none were found on the strandline. Much of the draw-down zone was steeply sloping and consisted of loose rocky material (e.g. Figure 89a S1 on the east shore). Where fine sediments have accumulated, the sustained period of exposure had allowed seedlings to establish, including *Juncus* spp. (mainly *J. articulatus* & *J. effusus*), *Lythrum portula* and *Carex ovalis* (Figure 89b).

Figure 89. a) East shore of Caban Coch Reservoir showing the draw-down zone b) *Lythrum portula* and *Juncus* spp. seedlings at S3.

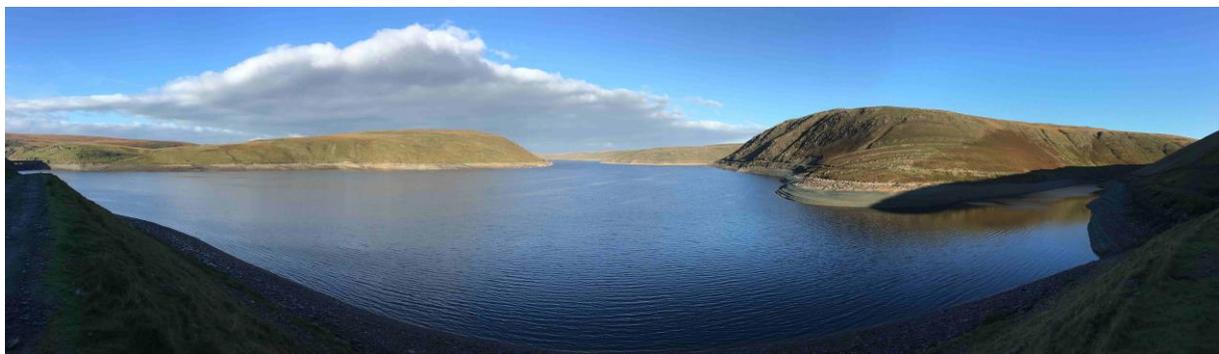
Figure 91. Claerwen Reservoir site photo; from the east shore looking west.

Claerwen Reservoir is the highest in the chain of the four large Elan Valley reservoirs in Powys, and is situated within an extensive upland catchment of acid grassland. The 56 m high dam at the south-east end, retains an area of 263 ha of open water with a top water level at 268.8 m AMSL. The reservoirs were constructed in the late 19th century to provide water to Birmingham, Claerwen releasing water to the Afon Claerwen, which flows into Caban-Coch.

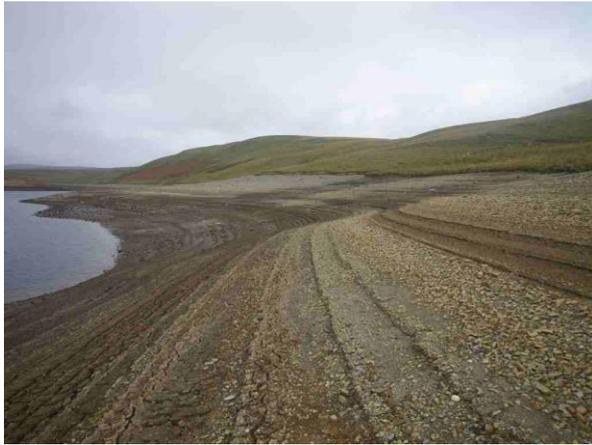
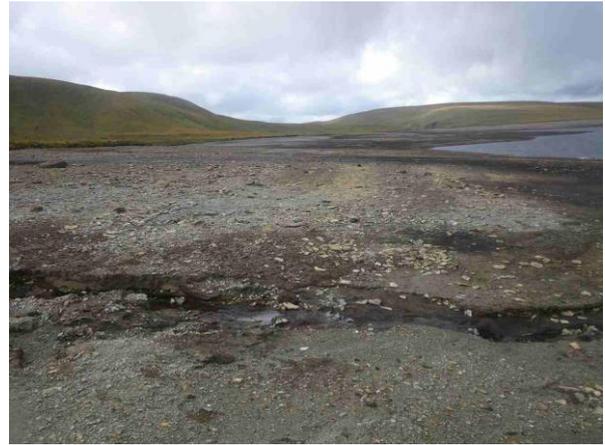
There was no evidence of any aquatic plants growing within the reservoir and none were found on the strandline. Much of the draw-down zone along the north shore was steeply sloping and consisted of coarse rocky boulders towards the top and finer material towards the water's edge. The north shore was largely unvegetated. The western end and southern shore was more gently sloping with finer sediments and eroded peat (e.g. Figure 92b), on which plants had established.

Figure 92. a) North shore of Claerwen Reservoir showing the draw-down zone b) Gently sloping Southwest shore at S1.

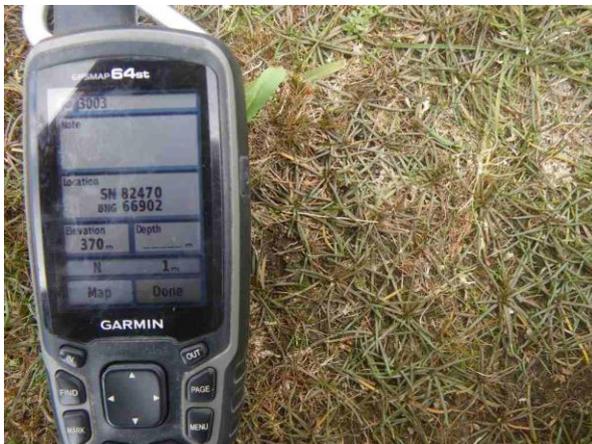
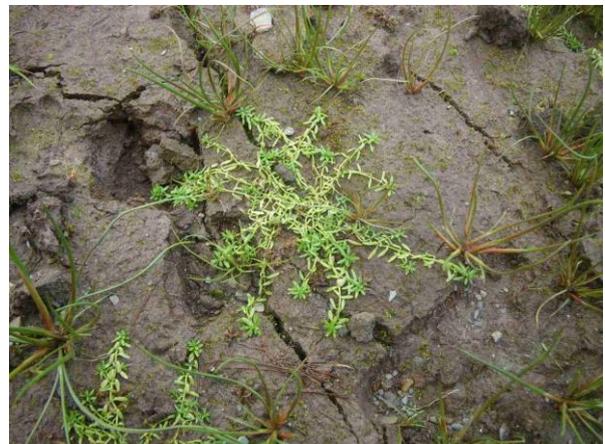
While much of the vegetation recorded within the draw-down zone was *Juncus* spp. seedlings and terrestrial bryophytes (mainly *Polytrichum commune*), in places towards the top water level zone, *Littorella uniflora* was present, and where the sediment remained moist, *Callitriche brutia* var. *hamulata* was found (Figure 93a). The inflow stream at the far western end, below Claerwen Farm, had *Myriophyllum alterniflorum* and *Callitriche brutia* var. *hamulata* present (Figure 93b). The paucity of plants and extensive draw-down means no reliable classification can be made using the aquatic macrophytes.

Figure 93. a) *Littorella uniflora* and b) *Callitriche brutia* var. *hamulata* growing near the top of the draw-down zone at the west end of Claerwen Reservoir.

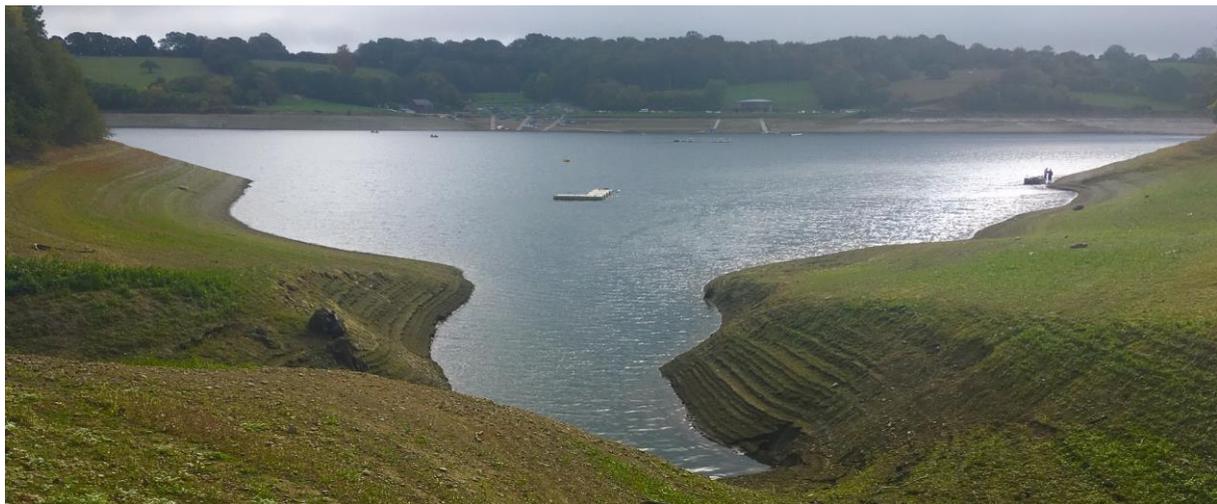
Figure 95. Llandegfedd Reservoir site photo; from the south-west shore, looking east.

The reservoir was drawn down to approximately 10 m below top water level and still falling at time of survey, with large areas of foreshore exposed. No aquatic plants were recorded growing in the water and only a few aquatic plants recorded growing on the exposed shore (Table 19). With the reservoir having been low for much of the summer, a number of generalist species were present, the most abundant being the fast growing annual *Chenopodium album*, often with *Potentilla anserina* towards the top water level. A small area of *Littorella uniflora* (Figure 96a) was recorded close to the line of top water level in section 5 where *Lythrum portula* (Figure 96b) and *Callitriche* sp. were also found.

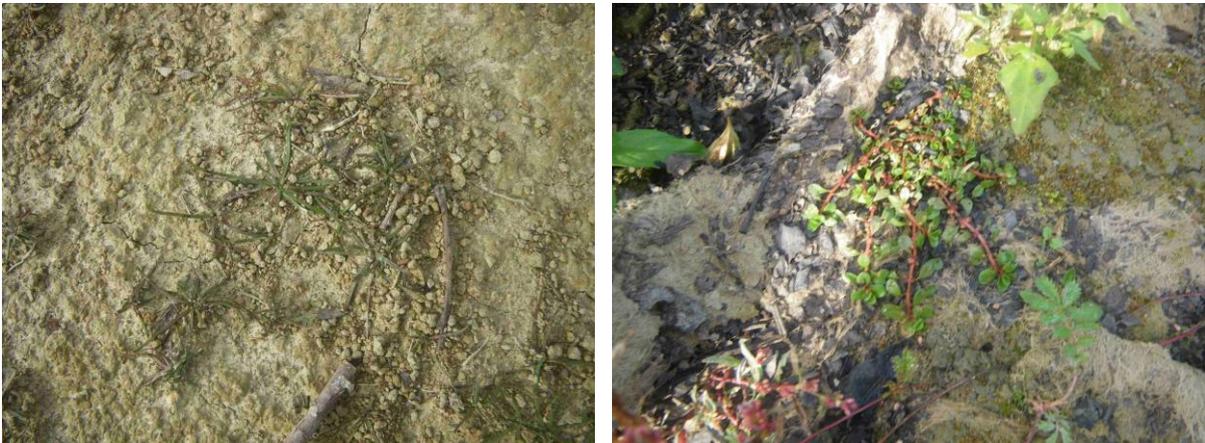
a) *Littorella uniflora* and b) *Lythrum portula* growing on exposed sediments in section 5.

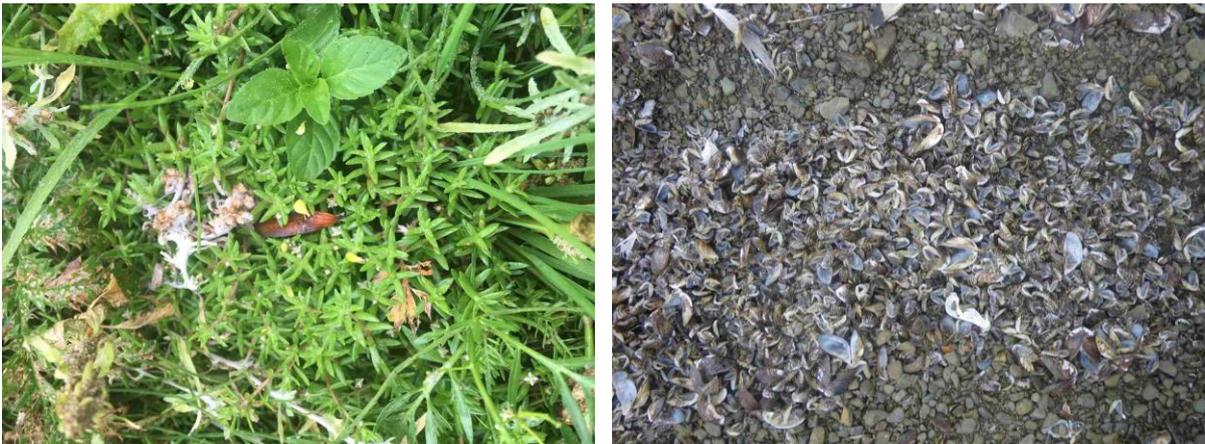
a) *Crassula helmsii* growing near the TWL at S2 and b) desiccated Zebra mussel shells at S1.

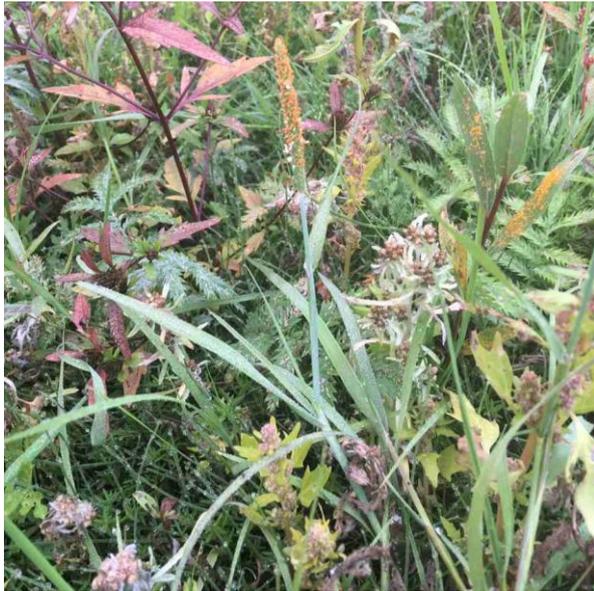
Section 2 spans an inflow stream resulting in the silts staying wet in the gully area. Here *Crassula* was abundant, but this area also supported a stand of the grass

Orange foxtail (*Alopecurus aequalis*), a species that is rare in Wales and has declined nationally.
