# Southern Damselfly habitat restoration works at Preseli and Gweunydd Blaencleddau SACs in March 2020

Jon Hudson Ecological Consultancy

NRW Evidence Report No. 451

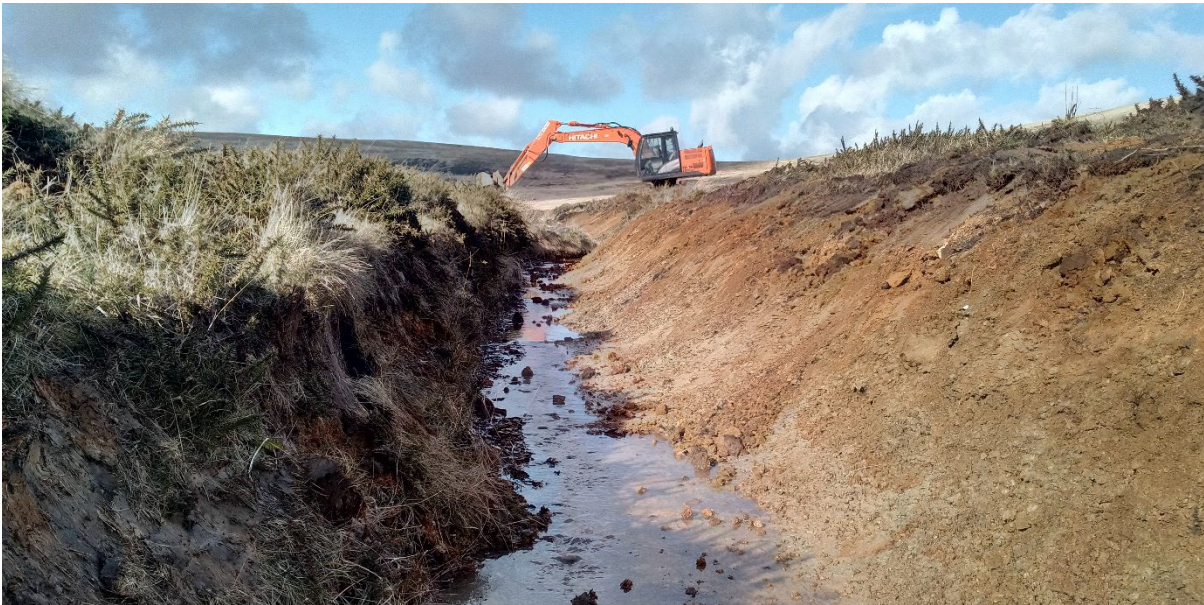
Figure 1. Pantithel Leat. The leat being cleared from upslope side.

Pantithel Leat is on the south side of Preseli common land, above Pantithel Farm. Work was undertaken along c.732m of stream and involved creating a more shallow, wider profile to the leat and the creation of new pools along its length. Several “cuts” were made into the downslope bank in order to allow flood waters to escape the channel both to avoid road flooding issues and stop a farm track from being eroded. Towards the western end of the leat, the channel was left intact and instead a series of larger pools were created as it was felt that the channel was not suitable due to its stony bottom and faster flow. It is hoped that the pools will collect sediment and slow flow rates, thus allowing suitable habitat patches to develop.

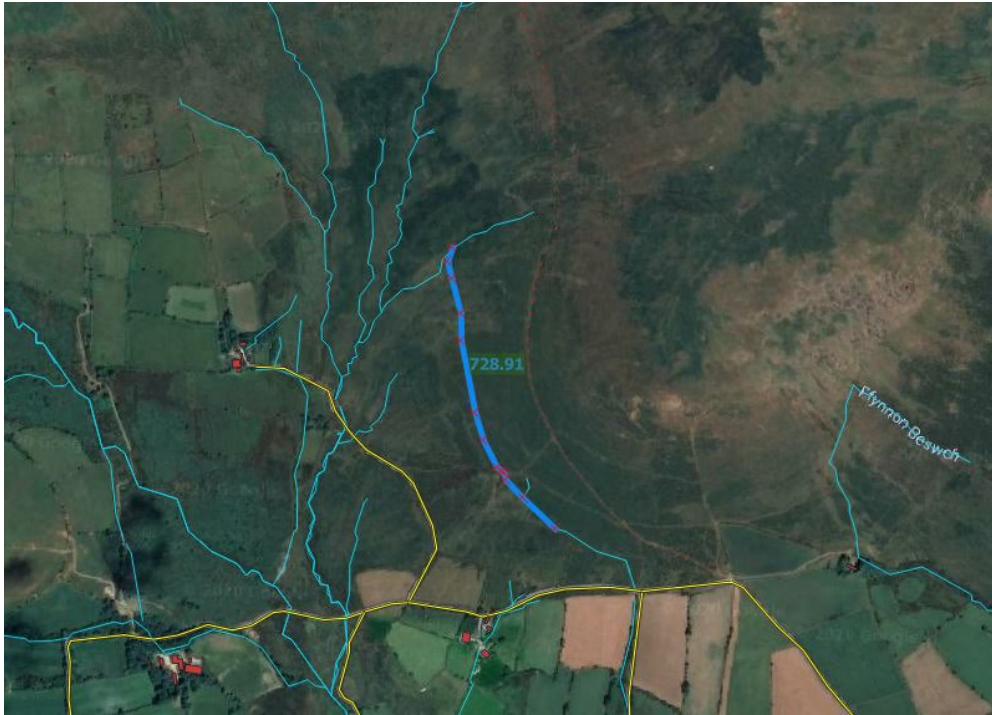
Figure 2. An aerial view showing Pantithel Leat

**Brief description of works and sketch map:** Pantithel Leat (on south side of Preseli common land, above Pantithel Farm). Work was undertaken along c.728 of stream. This involved creating a more shallow, wider profile to the leat and the creation of new pools along its length. Several “cuts” were made into the downslope bank in order to allow flood waters to escape the channel to avoid road flooding issues. Along the western half of the leat, the channel was left intact and instead a series of larger pools were created as it was felt that the channel was not suitable due to its stony bottom and faster flow.

**Length of restored habitat:** 728 m

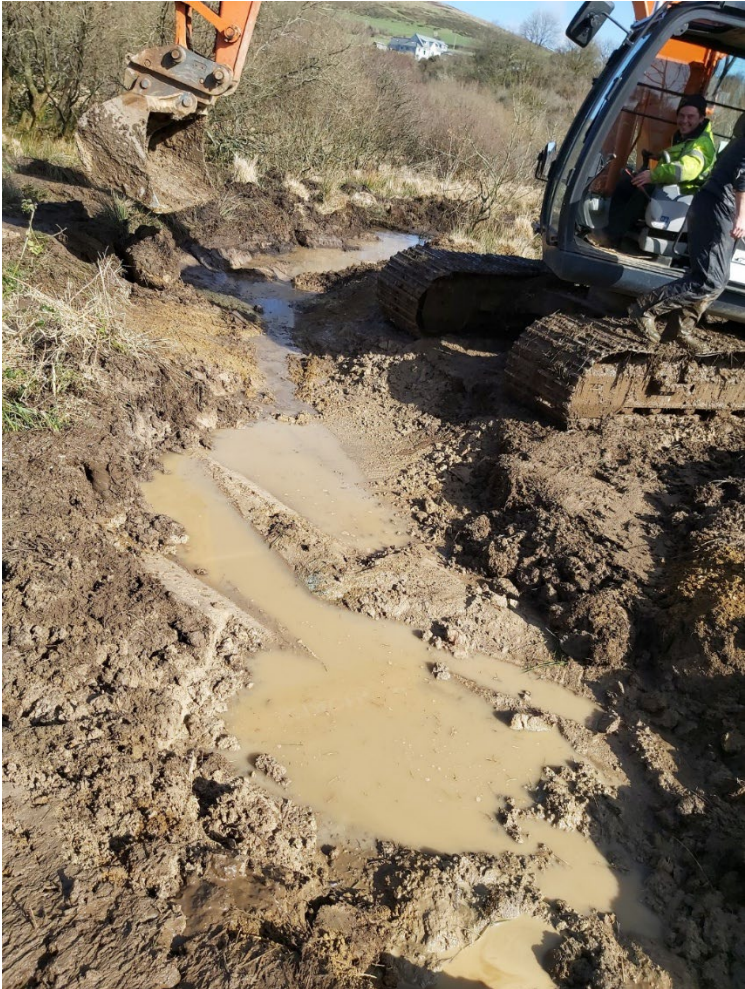
Figure 3. Waun Isaf. Working on the area where the footpath crosses the stream to create habitat and improve access.

This site was identified with PCNPA staff to show how access opportunities could be built into habitat creation schemes on project sites. The PCNPA Public Rights of Way officer had identified access issues caused by waterlogging of the footpath at the southern end of the common. Works to attempt to remedy this were undertaken and adapted to create potential new areas of suitable Southern Damselfly habitat. A new

crossing point was created for the path and water was directed into a newly-created stream (c.50m long). A ditch (c.65m long) was also dug alongside the footpath and two short (4m long) channels were created to carry water from the path into this ditch. It is anticipated that all newly- created channels will be able to support suitable habitat in time.

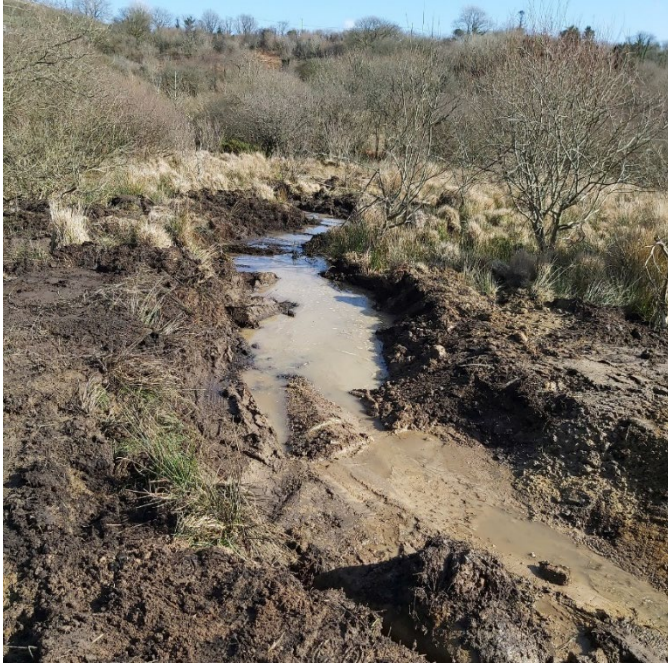
Figure 4. Waun Isaf. A newly-created stream channel carrying water away from the footpath.

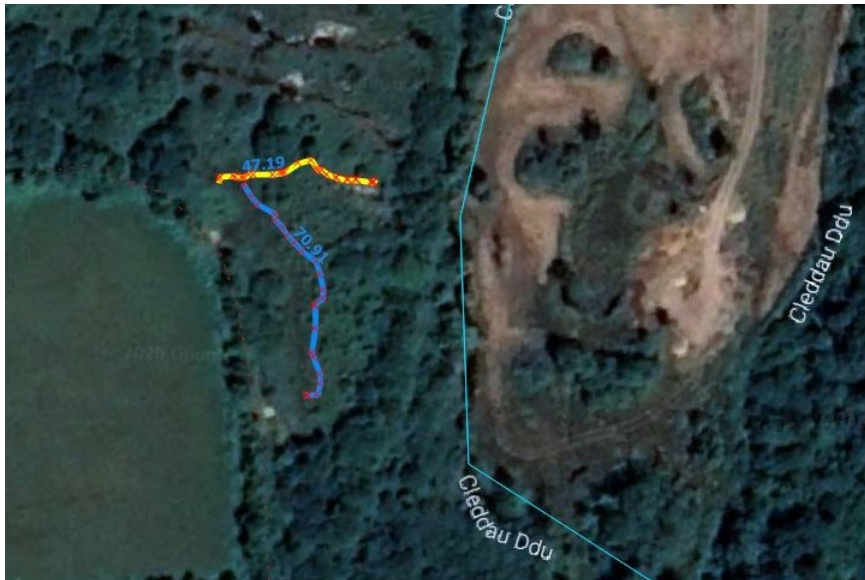
Figure 5. An aerial view showing new stream and ditch lines at Waun Isaf.

**Brief description of works and sketch map:** Works to improve drainage along a footpath and create Southern Damselfly habitat by creating a new stream and ditch.

**Length of restored habitat:** 177 m

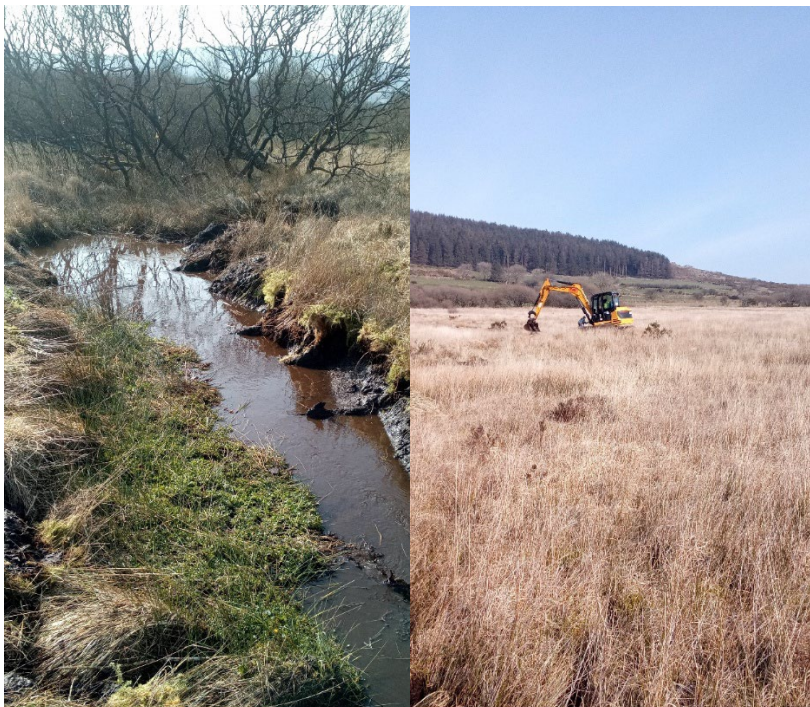
Figures 6 and 7. Blaencleddau. A silt trap pool at the lowest end of a restored stream and view of the machine on site (the stream is entirely lost in dense vegetation and has become piped).

This site was selected as all streams on the site were very overgrown and "piped" apart from in a few short sections. Restoration included opening up of 126m of piped stream, 58m of shallow ditch and 55m of a stream that had reasonable amounts of suitable habitat present in patches. The surviving patches of suitable habitat were **NOT** excavated. Areas where suitable habitat was present were expanded (made wider) and areas of unsuitable habitat between these patches was excavated.

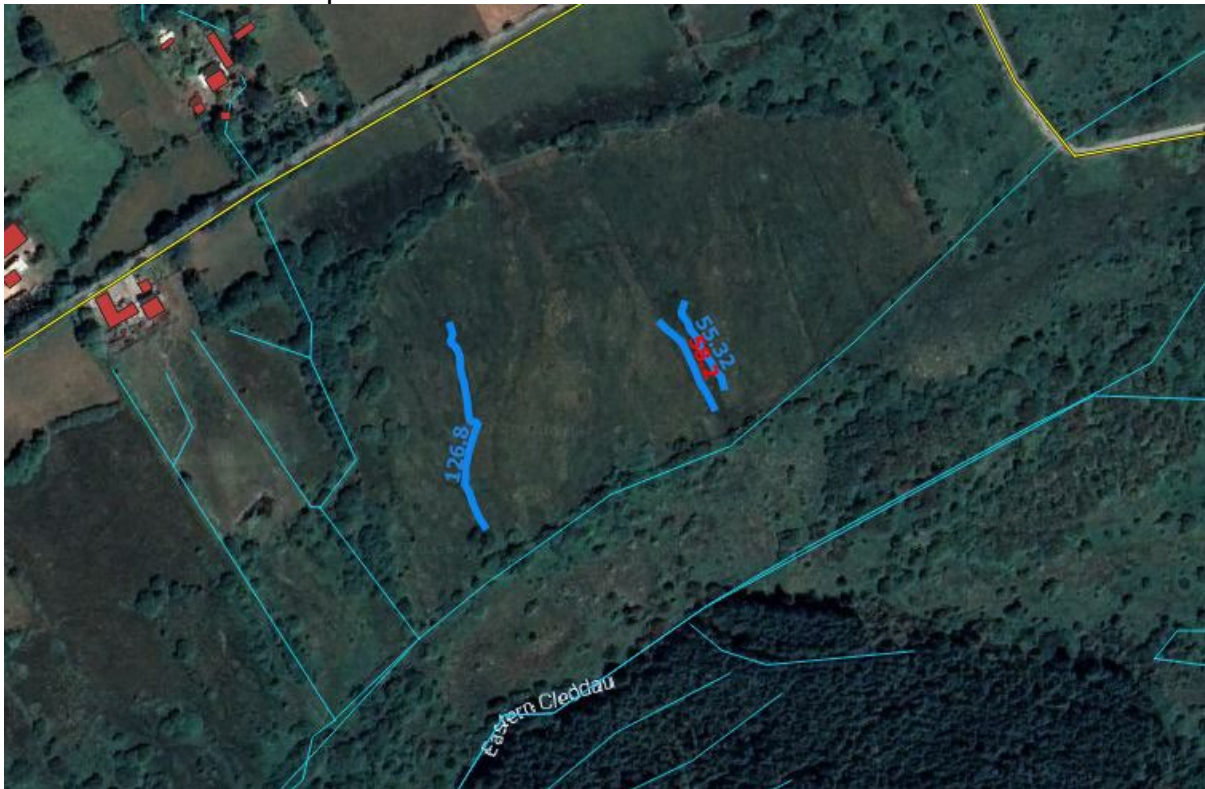
Figure 8. An aerial view showing stream and ditch lines at Blaencleddau.

**Brief description of works and sketch map:** Restoration of 126m of piped stream, 58m of shallow ditch and 55m of a stream that had reasonable amounts of suitable habitat present in patches. The suitable habitat was NOT excavated. Areas where suitable habitat was present were expanded (made wider) and areas on unsuitable habitat between these patches was excavated.

**Length of restored habitat:** 239 m

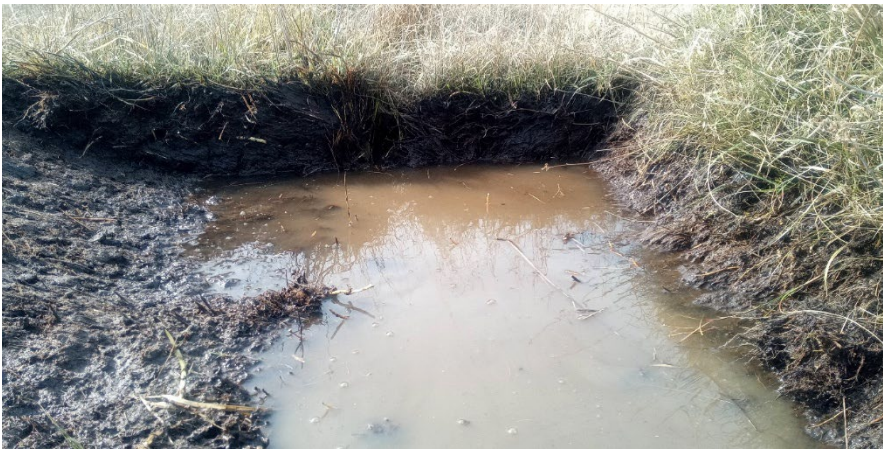
Figure 9. Dolau Isaf. A piped stream with no suitable habitat being restored to a shallow and wide profile.

This site was selected as it was known to be an important site for Southern Damselfly and all streams on the site were overgrown and "piped" apart from in a few short sections. Restoration involved opening up 517m of piped streams across the site. These streams were excavated to varying depths and profiles in order to create variety and to ensure it all does not "mature" at the same time. Any surviving patches of suitable habitat were **NOT** excavated.

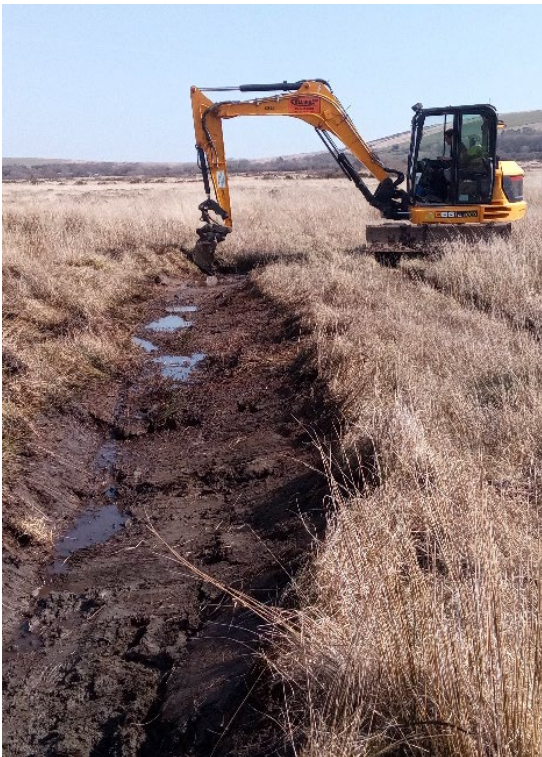
Figure 10. Dolau Isaf. Stream restoration.

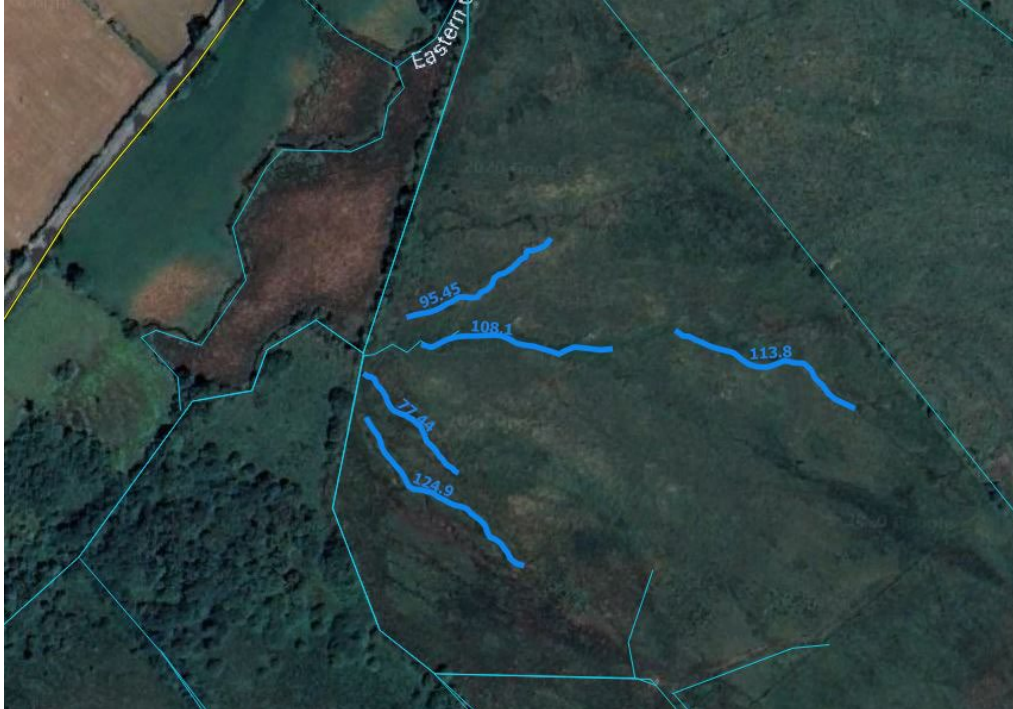
Figure 11. An aerial view showing streams on Dolau Isaf

**Brief description of works and sketch map:** Restoration of piped streams across the site. Dug to varying depths and profiles in order to create variety and to ensure it all does not “mature” at the same time.

**Length of restored habitat:** 517 m
