Water Management Strategy in Aberhirnant Welsh Government Woodland Estate

Report No: 771

Jeremy Benn Associates (JBA) Consulting

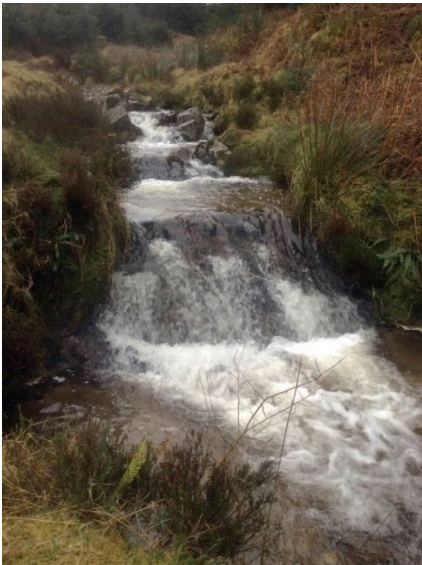
Sub-catchment 1:

Example river type and sub-catchment location

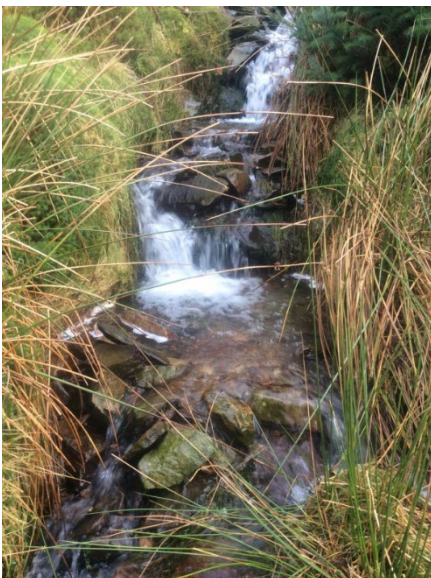
Sub-catchment 2:

The channel is steep and flows through a narrow, V-shaped valley with banks heights of approximately 4m. This topography creates high stream power following heavy rainfall events. The river has incised historically and has cut down to the bedrock layer along the channel bed. Significant vertical erosion has resulted in the formation of a stepped profile that encourages cascading, broken wave flow. This is likely to result in a well oxygenated water environment. Subsequently, channel planform is relatively straight and widths are small, ranging from 0.5m to 2m.

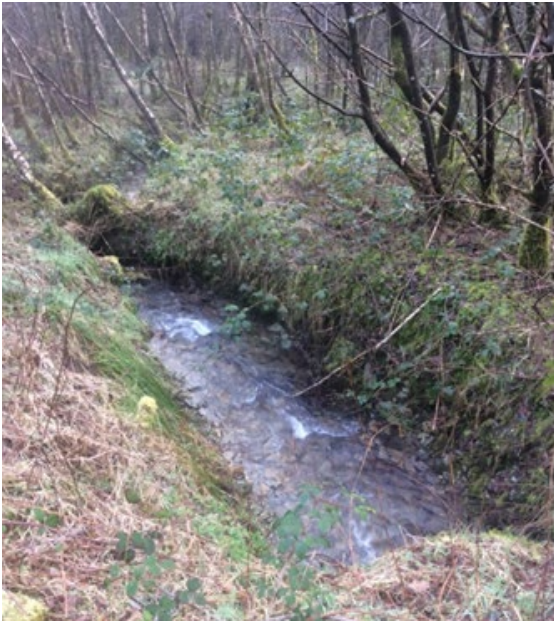
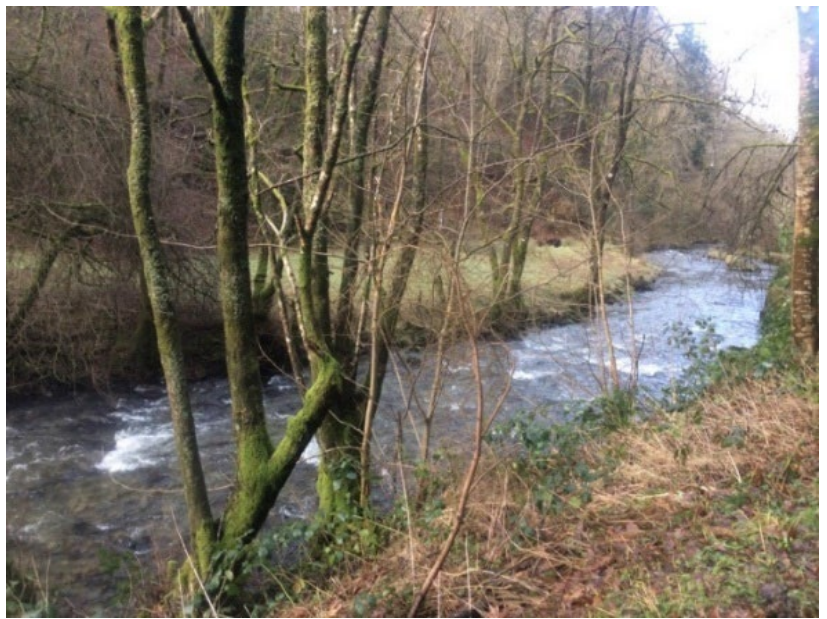
Sub-catchment 5:

The channel flows through a V-shaped valley with bank heights of approximately 2-3m. The channel is moderately steep with a slope angle of 4 degrees over 6m, which encourages high flow energy during heavy rainfall events that has caused incision and disconnection from the local floodplain. The channel is largely featureless, straight and has a fairly continuous width of 1m for the majority of its length, which encourages a run flow biotype. However, in areas where large woody material has fallen into the channel, there are localised increases in width resulting in minor depositions (due to a reduction in flow velocity) and some connectivity with the floodplain where erosion inputs small amounts of sediment into the channel.

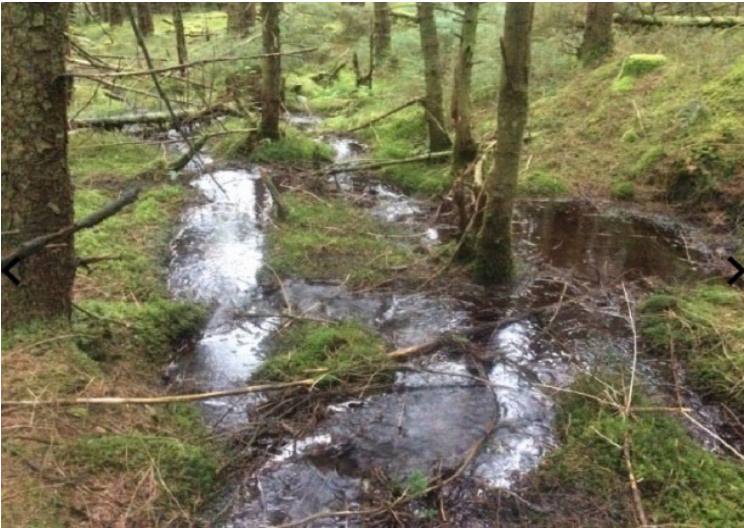
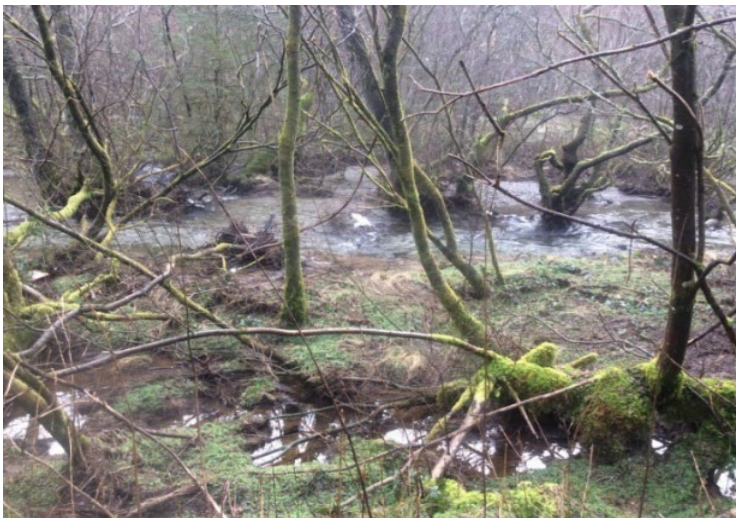
Differences in topography and hydrological regime between sub-catchments have resulted in some multi-threaded systems flowing through a V-shaped valley with a wider valley floor of approximately 20-30m along the Afon Hirnant. As a result of a less confined valley shape and a wider floor, the main channel has been able to laterally migrate and create a series of multi-thread channels at high flows that split and converge around emergent trees and islands. There are significant deposits of fine sediment (comprised of silt, sand and gravels)

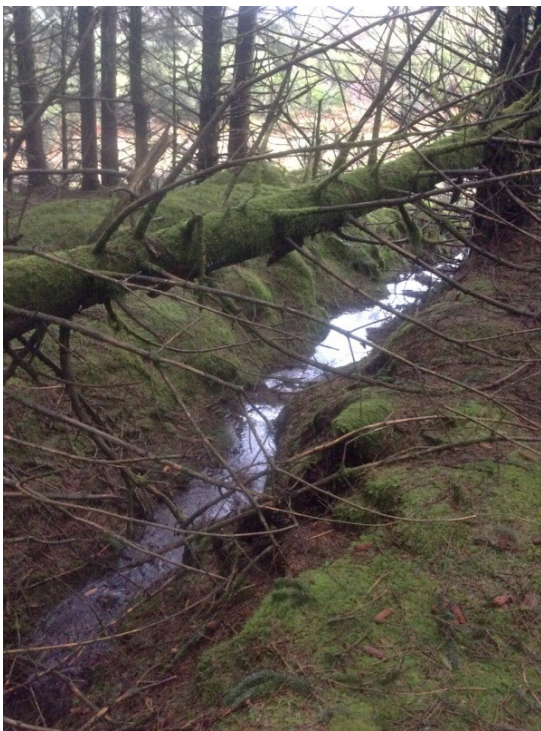
Sub-catchment 2:

This linear drainage channel has been artificially dug from the top to the bottom of the hill slope, between conifers, in order to transport precipitation and overland flow away from conifer plantation areas. These drainage channels discharge directly into a watercourse or a road drain that runs perpendicular to the slope.

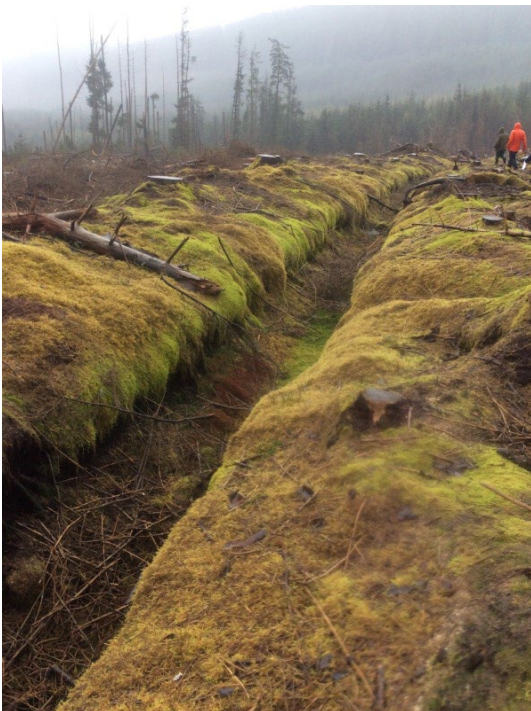
Sub-catchment 2:

This linear drainage channel has been artificially dug from the top to the bottom of the hill slope, between conifers, in order to transport precipitation and overland flow away from conifer plantation areas. The majority of these drainage channels discharge directly into a watercourse or road drain that runs perpendicular to the slope, whilst others (such as shown in Sub-Catchment 2) are disconnected and do not discharge directly into the downstream watercourse. As a result of the machinery used, the channel is very uniform, incised and trapezoidal with a width of approximately 0.5-0.8m. Subsequently, there is no flow variation within the drain resulting in a lack of in-channel features. The drainage channel is ephemeral; it is usually dry until a heavy rainfall event occurs, and a run flow biotype is encouraged.

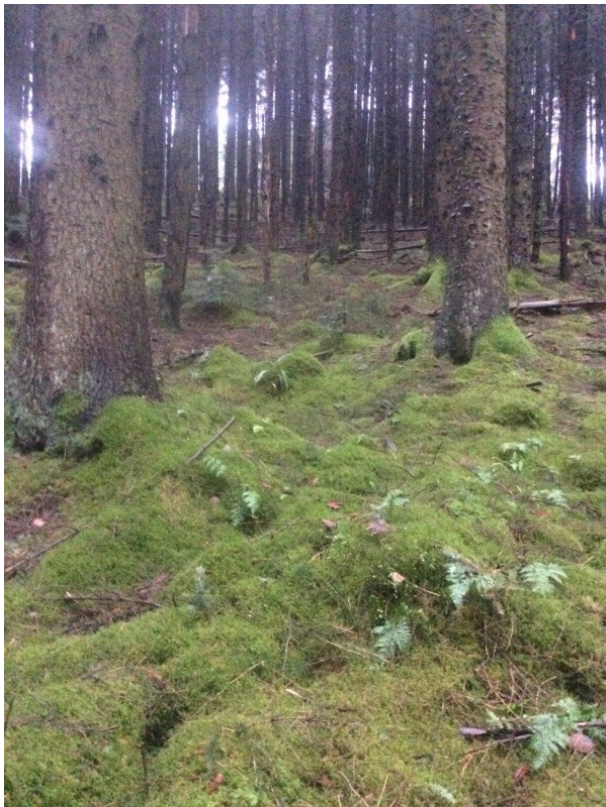
Sub-catchment 2:

Artificial drainage channels were not identified in all visited forestry coupes. Natural depressions were prevalent throughout most areas, creating natural micro-pathways and temporary storage areas for overland flow. These natural depressions help to attenuate any flow by preventing the channelisation of water downslope towards road drains and watercourses. As a result, there is more infiltration into groundwater stores. These areas were dominated by Sphagnum, due to the higher level of water being retained compared to the surrounding higher ground.

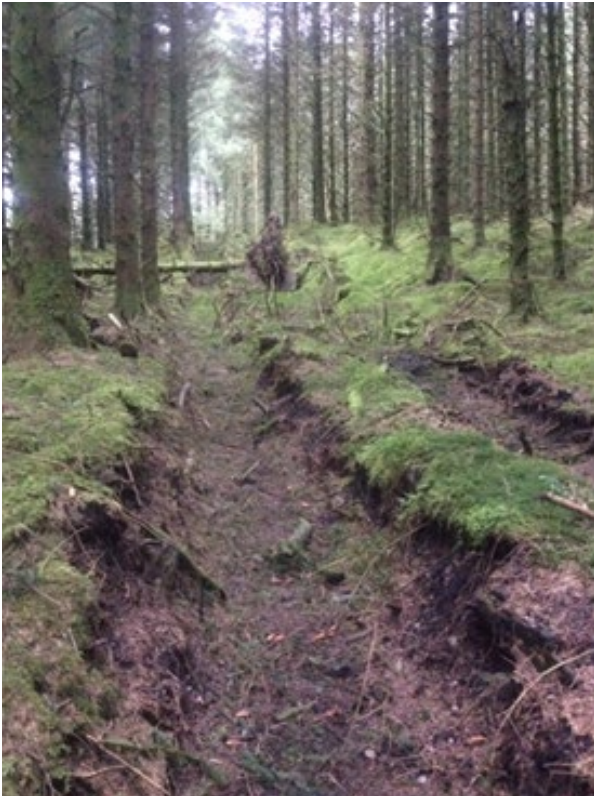
Sub-catchment 4:

Harvesting tracks were prevalent through some forestry coupe areas, created as a result of large machinery and transport frequently using these routes. Subsequently, the tracks are very uniform in their width and depth. Large amounts of tree fall across the tracks and vegetation growth within the surface depressions indicate their disuse. During heavy rainfall events, some surface runoff is likely to be channelised down these tracks, transporting flow and fine sediment quickly away from the coupe areas and towards forest road drains and watercourses.

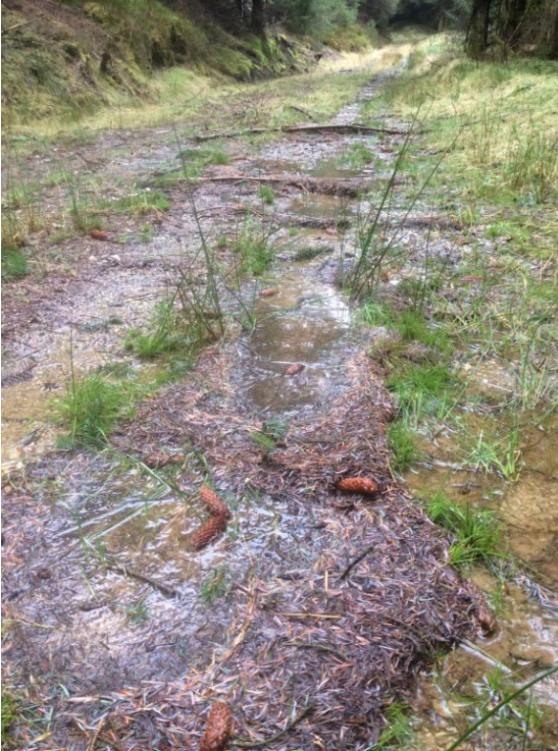
Sub-catchment 1:

The forest road is constructed on angular aggregate and are often coated in muds/clay/gravels from vehicle movements - which mainly sits on the surface. Roads are occasionally 'blinded' with a layer of fines (which may include some organics such as moss, grasses and pine needles) to provide a smoother running surface for vehicles and help seal the road, making the material more stable and less susceptible to being displaced by vehicles or heavy rainfall events.

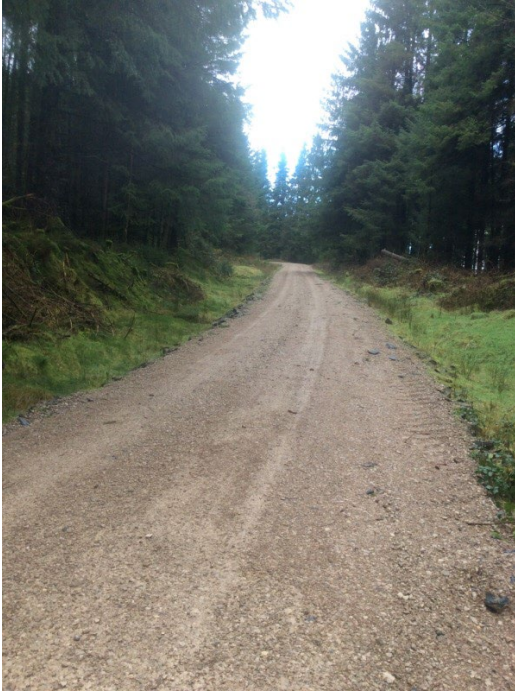
Sub-catchment 1:

The forest road is constructed of aggregate, however there may be some residual soil/clay in the mix from the excavation and processing phase.

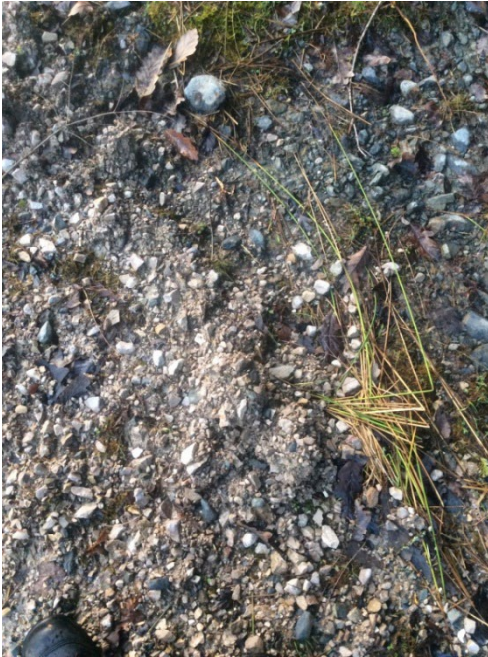
Sub-catchment 5:

The forest road is comprised of clay and gravels. As a result of significant pressure from heavy loaded vehicles using the road, the road aggregate (in areas) breaks down into loose surface stone and forms fine particles within the road formation. In the summer, this can present as dust, and in the wetter periods, this dust mixes with the rain and can cause discoloured surface water 'wash off'.

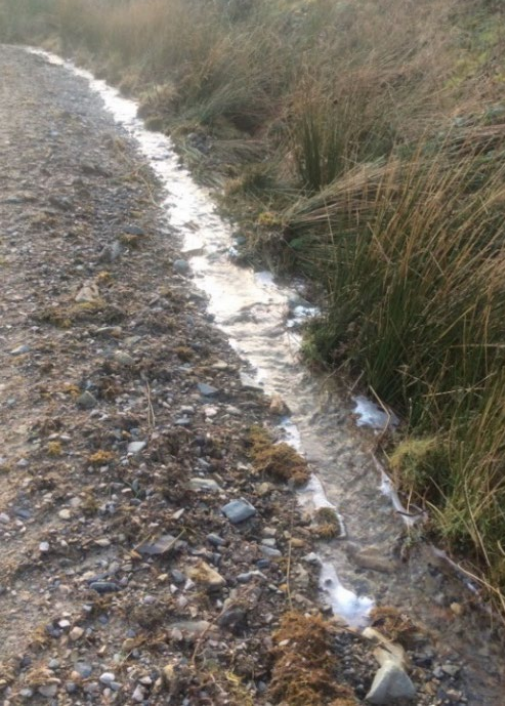
Sub-catchment 5:

Example forest road and sub-catchment location

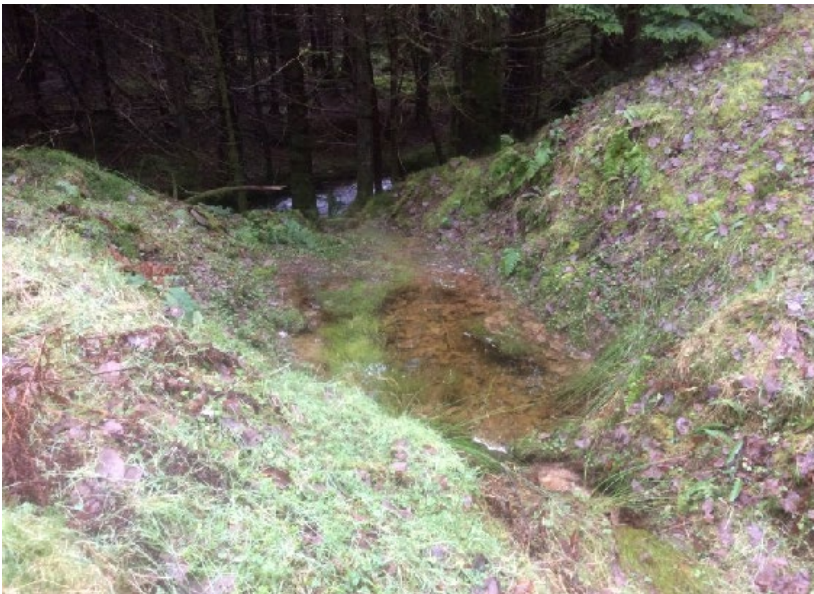
Sub-catchment 1:

A drain runs alongside the forest road, directing overland flow from the surrounding hills towards a relief culvert that flows underneath the road. Water from the culvert then spills out onto lower ground. Drains within the study area have been artificially constructed (uniform, square geometry) to match the road geometry.

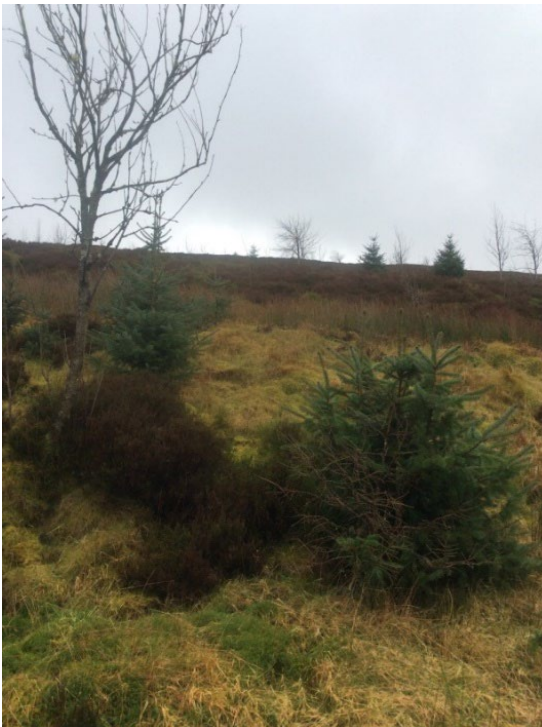
Sub-catchment 1:

Areas of open ground are found infrequently across the study area. Larger clusters are predominantly located at the top of the study area. The open ground is often covered by a dense layer of shrub vegetation including heather, tussocks of Purple Moor-grass *Molinia caerulea*, Bracken *Pteridium aquilinum* and moss, that help to bind the peaty soils. Regrowth of conifers is also common. Rainfall is intercepted by the vegetation. Natural linear depressions in the topography provide pathways for overland flow to move downslope.

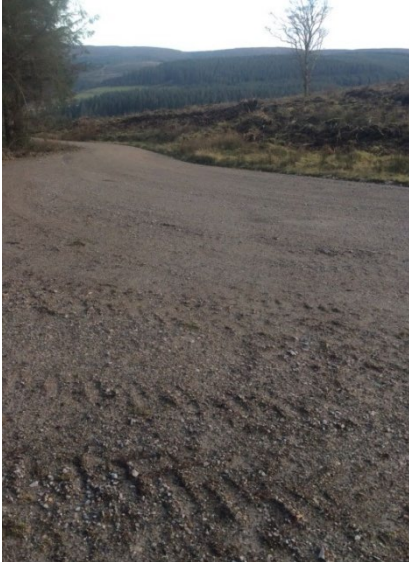
Sub-catchment 5:

Example of pressure identified through field survey

Opportunities to mitigate (see Section 7.1)

- Clear catch pits
- Add catch pit
- Add bales or geomembrane

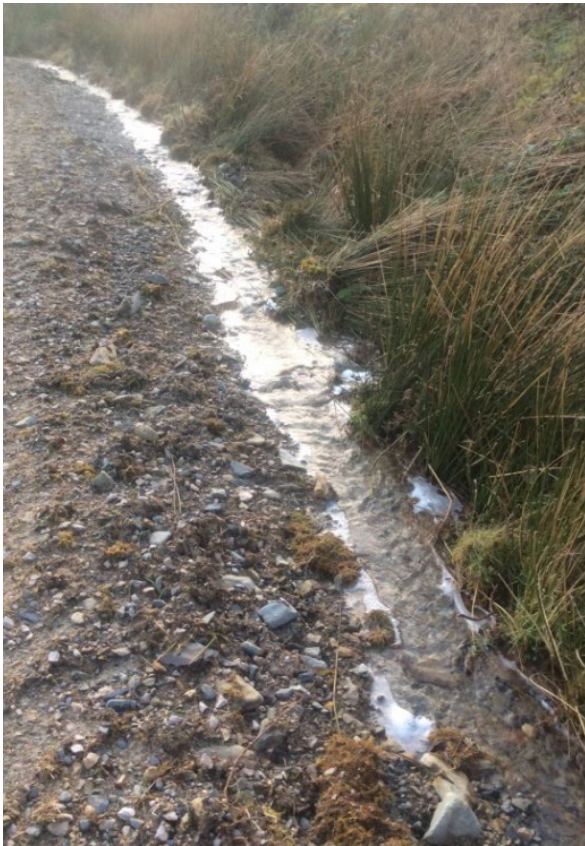
Sub-catchment 5:

Example of pressure identified through field survey

Opportunities to mitigate (see Section 7.1)

- Clear catch pits
- Add leaky barriers and woody material
- Add catch pit
- Add bales or geomembrane
- Install root wads

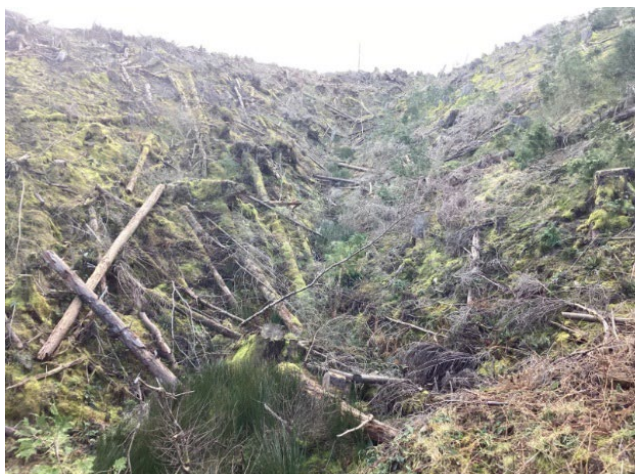
Sub-catchment 2:

Example of pressure identified through field survey

Opportunities to mitigate (see Section 7.1)

- Increase riparian vegetation
- Create buffer between watercourse and areas of conifer plantation

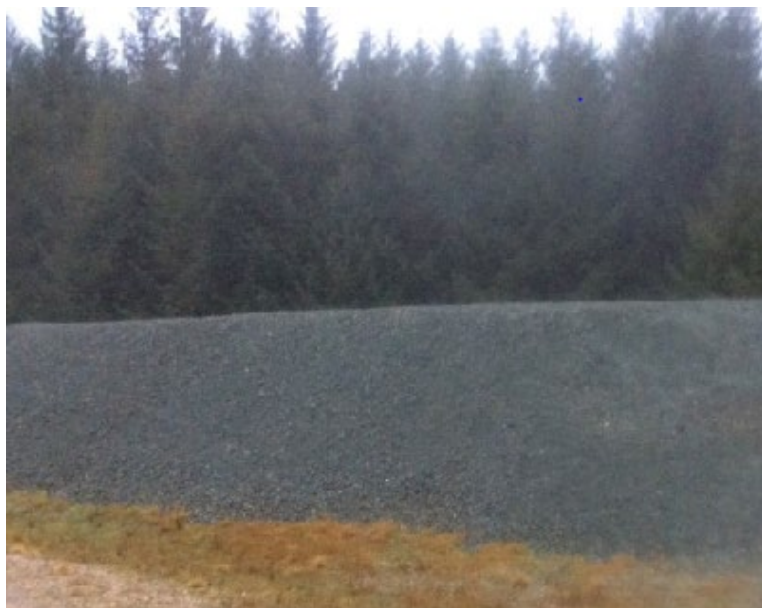
Sub-catchment 1:

Example of pressure identified through field survey

Opportunities to mitigate (see Section 7.1)

- Add leaky barriers and woody material
- Clear catch pits
- Improve placement of roadside material
- Add catch pit
- Install root wads
- Micro bund

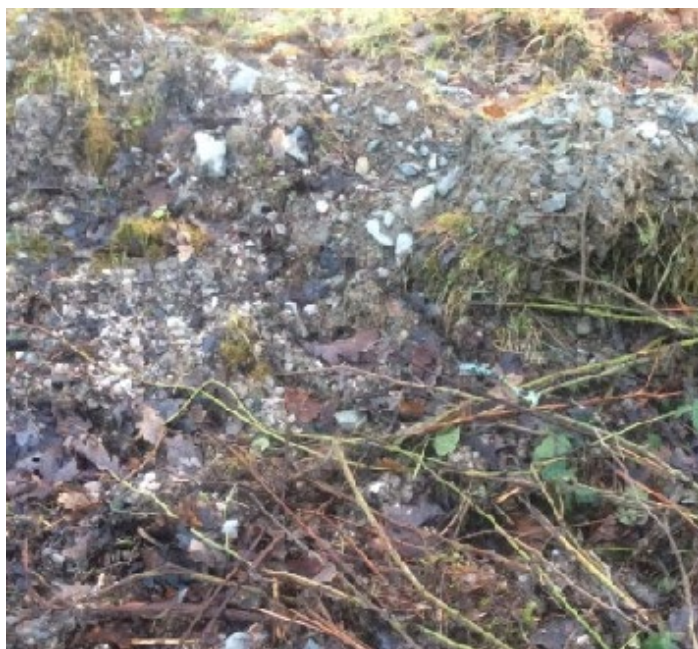
Sub-catchment 5:

Example of pressure identified through field survey

Opportunities to mitigate (see Section 7.1)

- Remove excavated material
- Add leaky barriers and woody material
- Install root wads
- Add bales or geomembrane
- Micro bund

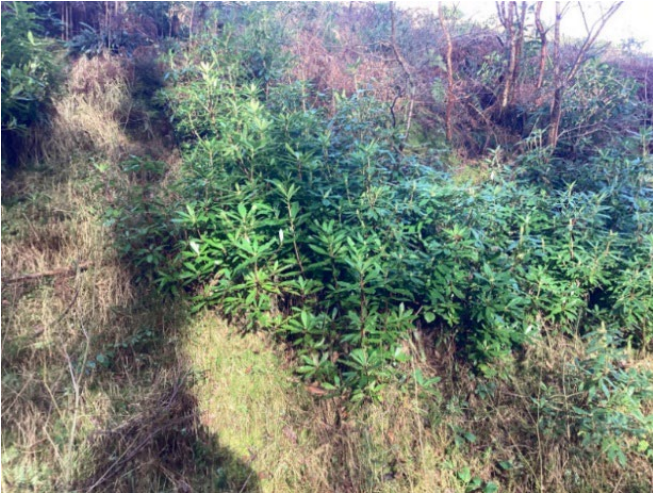
Sub-catchment 5:

Example of pressure identified through field survey

Opportunities to mitigate (see Section 7.1)

- Invasive Non-Native Species (INNS) control

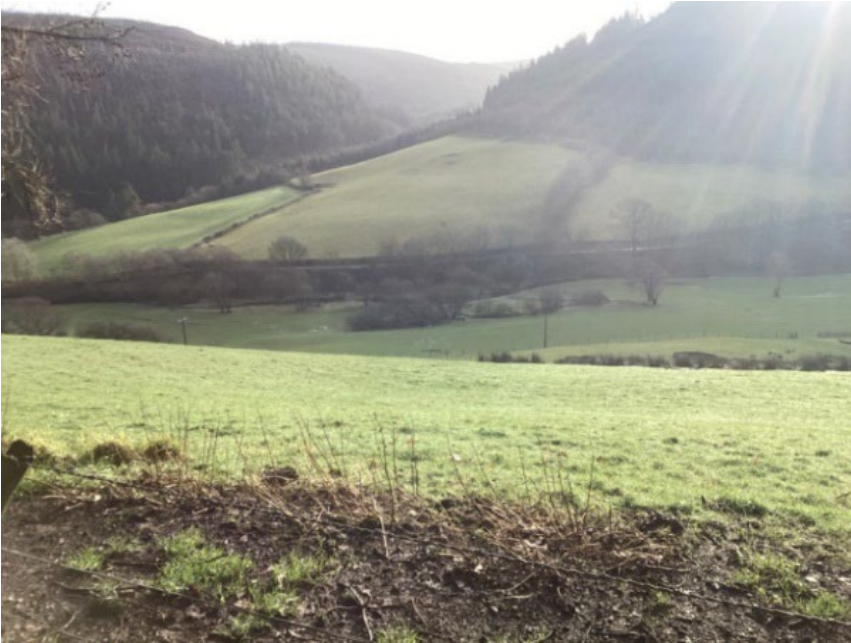
Sub-catchment 3:

Example of pressure identified through field survey

Opportunities to mitigate (see Section 7.1)

- Increase riparian vegetation
- Add leaky barriers and woody material

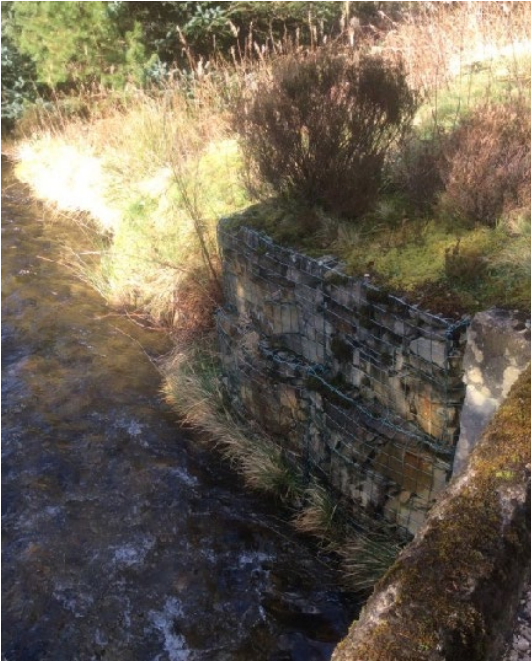
Sub-catchment 2:

Example of pressure identified through field survey

Opportunities to mitigate (see Section 7.1)

- Replacing with soft engineering options

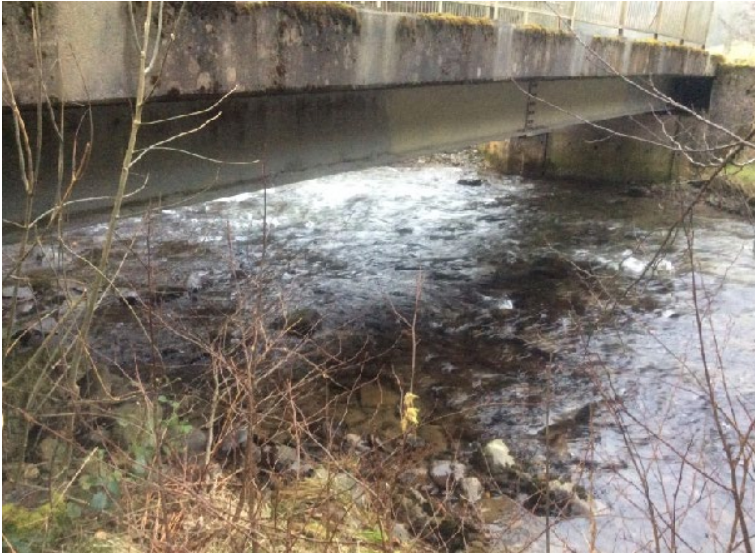
Sub-catchment 5:

Example of pressure identified through field survey

Opportunities to mitigate (see Section 7.1)

- Replacing with soft engineering options

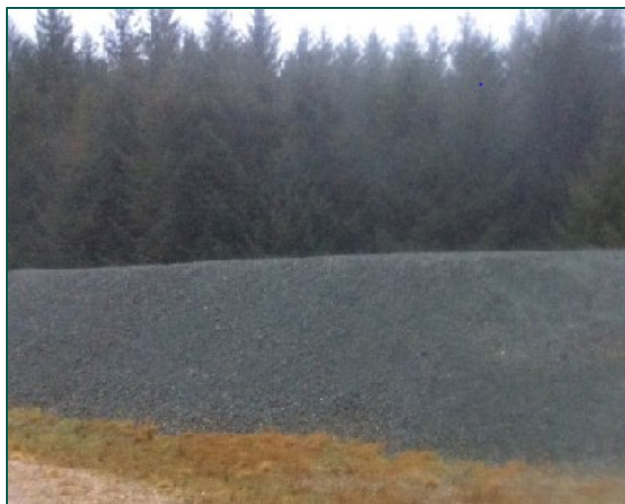
Throughout the Forestry Block, it is common practice to import type 1 aggregate in bulk preparation for road maintenance operations. Therefore, frequent deposits of this aggregate were observed on the side of roads during the walkover, particularly in areas where drainage systems are in place e.g. passing places at roadside or turning areas. Some material within the deposit is likely to become mobilised during heavy rainfall events and enter drainage channels and nearby streams and the main Afon Hirnant, resulting in decreases in water quality and increased water turbidity.

Figure 6-1: Mound of deposited roadside material. NGR: SH 96126 31719

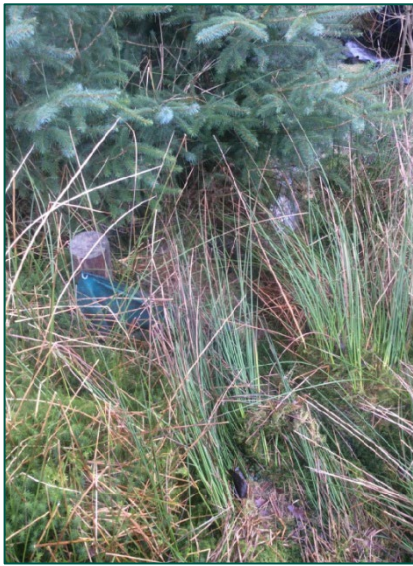
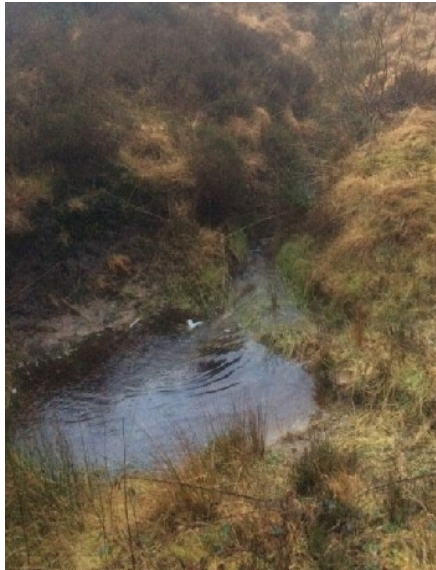
Geotextiles are often used to slow the flow during construction projects, acting as check dams, and to mitigate sediment rated pollution incidents. Normally, these are removed after operations, but the one at NGR: SH 97443 28416 has been left behind.

Figure 6-2 (left): Geomembrane across vegetated road drain. NGR: SH 97443 28416 and Figure 6-3 (right): Catch pit. NGR: SH 96020 31663

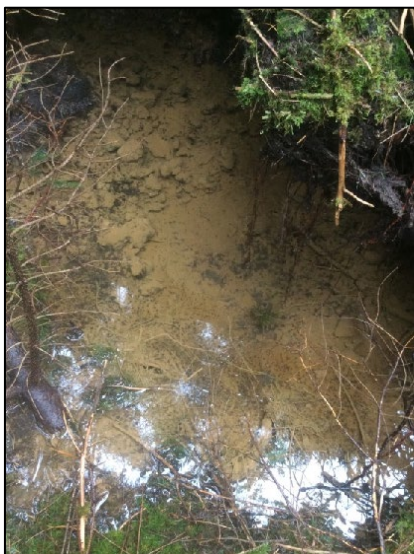
To summarise, there is evidence of natural sediment inputs into the study watercourses via hillslope erosion and localised bank erosion. Erosion is a natural process by which sediment is supplied to the river system. However, there is evidence that forestry management practices, such as felling and planting within the coupes, have exacerbated rates of erosion, leading to increased amounts of fine-grained sediment displacement. This sediment could be observed in catch pits throughout the study area, as well as behind root wads of fallen trees located on forest slopes.

Figure 6-4 (left): Silt deposition around a root wad. NGR: SH 98350 30358 and Figure 6-5 (right): Silt depositions within the multi-thread channel system.
