**PROSIECT LIFE+ CORSYDD MÔN A LLŶN
ANGLESEY AND LLŶN FENS LIFE+ PROJECT**

**Restoration of hydrological and hydrochemical
regimes at Cors Hirdre, Corsydd Llyn SAC: results of
water level monitoring and hydrological
investigations 2012-14.**

Final Report of the Anglesey & Llyn Fens LIFE Project: Technical Report No. 1.

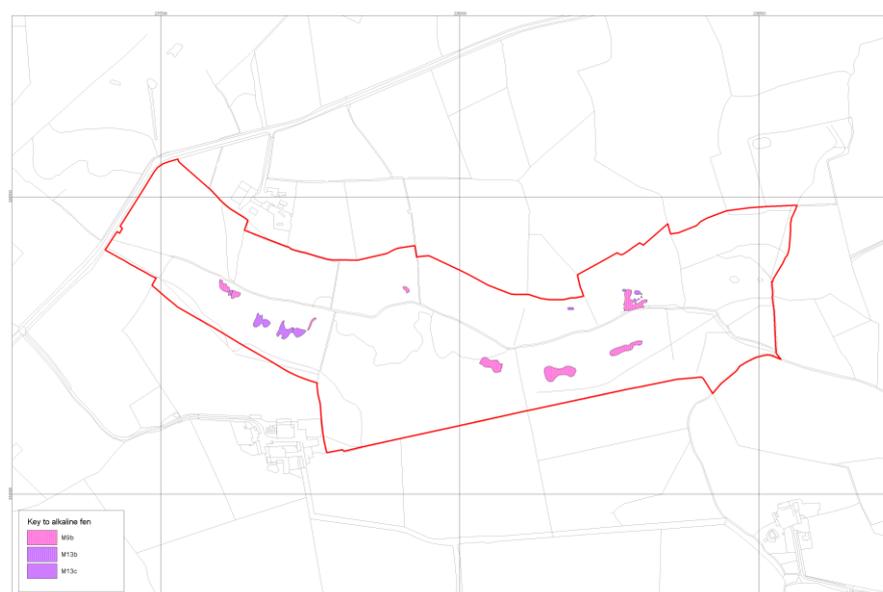
Figure 1. Location of stands of alkaline fen at Cors Hirdre SSSI: purple, M13; pink, M9. Map prepared by Kathryn Birch, NRW.

Most of the alkaline fen interest at the site occurs within 50-70 m of the ditch (Figure 1) and at a similar elevation to ditch water levels, raising the possibility that poor axial drainage might be leading to nutrient retention and possibly the spread of enrichment. The increasing amount of *Phragmites* within the stands of alkaline fen³ might be an indication of this, though the general wetness of the site would also be a contributory factor.

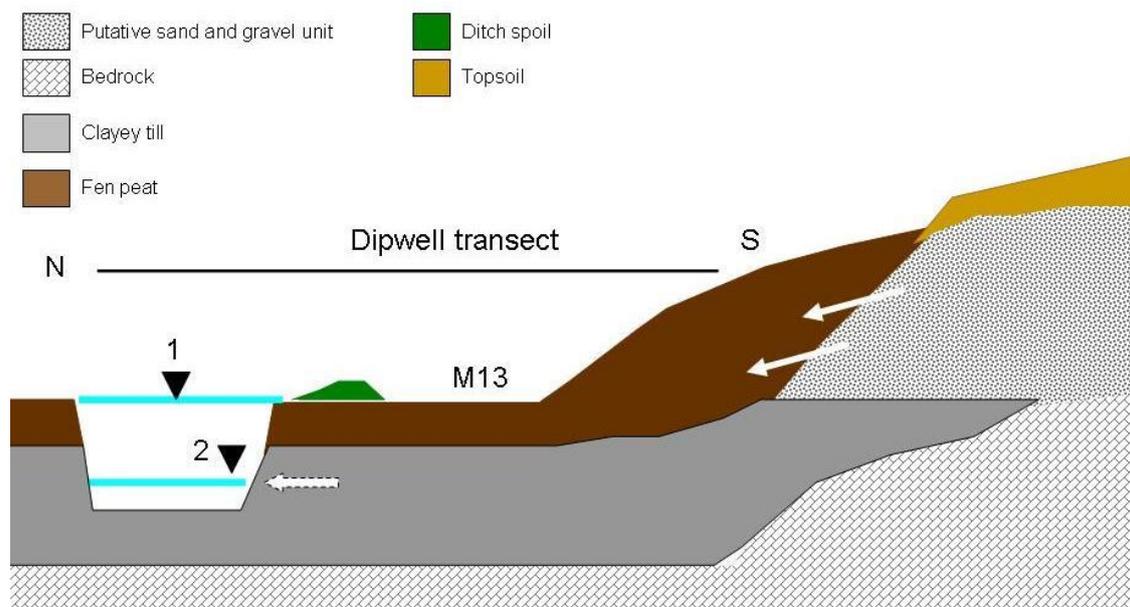
Figure 2. Diagrammatic portrayal of the possible sequence of the main stratigraphic units at Cors Hirdre. Water levels in the main ditch are shown as pre- (1) and post (2) restoration levels. Further work being undertaken by NRW will inform understanding of the sequence of deposits along the S (right-hand in this picture) margin of the site. Weak groundwater flow may occur into the ditch, with stronger seepage into the peat from the sand and gravel unit..

The axial ditch would presumably have sustained a seepage gradient from the edge to the central axis of the site, with rheo-topogenous⁵ conditions prevailing in the wet sump of the fen (including areas supporting alkaline fen) consistent with WETMEC type 13a (Seepage Percolation Surface) identified at this site by Wheeler *et al.* (2009). Occlusion of the ditch is presumed to have resulted in more obviously stagno-topogenous⁶ conditions which over time would be expected to favour *Phragmites* and possibly *Juncus subnodulosus* and *Carex acutiformis* at the expense of *Schoenus* and the open M9 expressions of the alkaline fen interest at the site. The latter community is especially significant in providing the main habitat at the site for the nationally rare *Eriophorum gracile*.

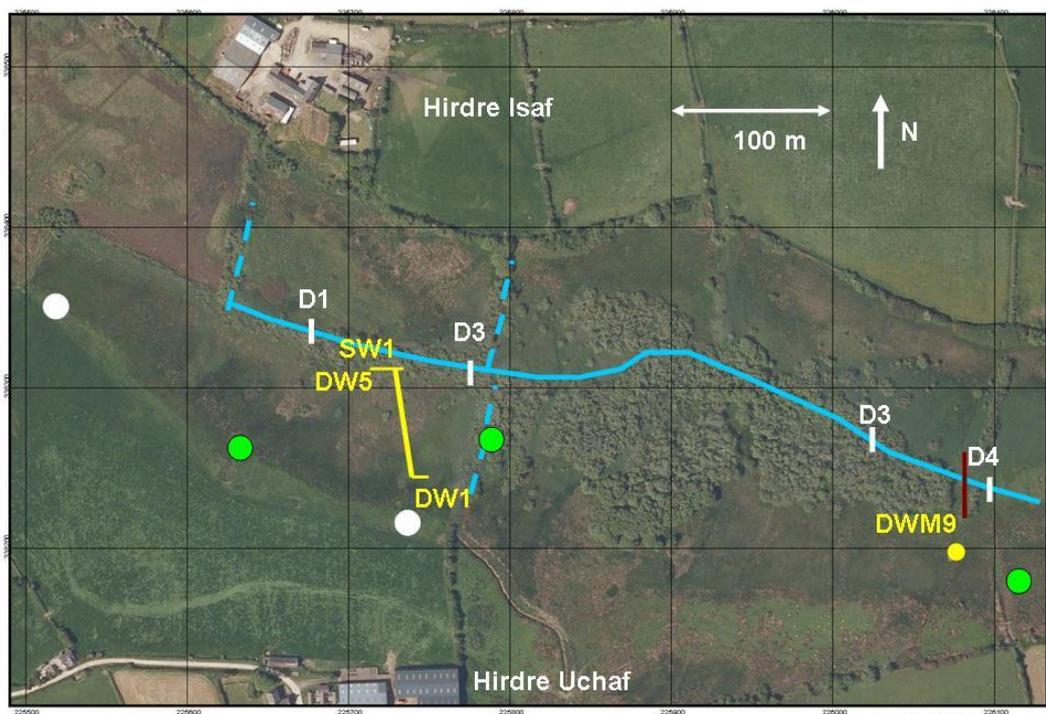
Figure 5. Aerial photograph of the western half of Cors Hirdre showing the approximate position of the main dipwell transect (DW1-5, yellow line – see also Fig. 7) cutting through the largest stand of M13, dipwell DWM9 in a stand of M9, and part of the axial ditch and side drains cleaned as part of this project (solid and dashed blue lines respectively). The white lines indicate the approximate position of the four timber dams (D1-D4) installed to adjust ditch water levels. White solid circles denote the location of piezometers installed along the southern boundary of the site by Natural Resources Wales, 19 March 2014. Green circles denote the approximate location of constructed treatment wetlands installed by the *LIFE* project. The brown line close to D4 indicates the plank bridge and boardwalk. Fine black lines represent 100 m grid lines of the British OS National Grid.

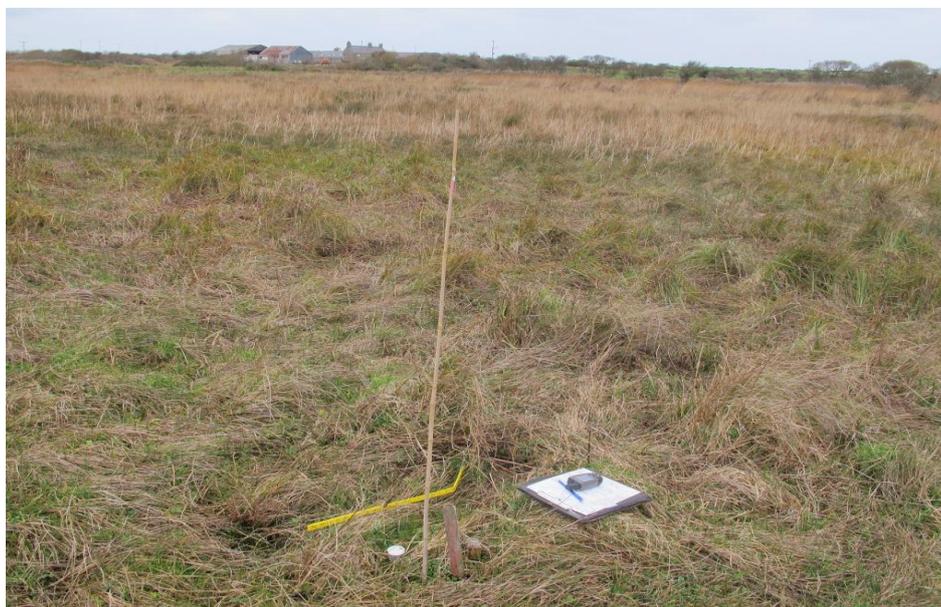
Figure 6. Looking along the main water level monitoring transect from DW1 in foreground with Hirdre Isaf in background. Transect bearing 180 degrees magnetic. Photo taken 29 November 2013.

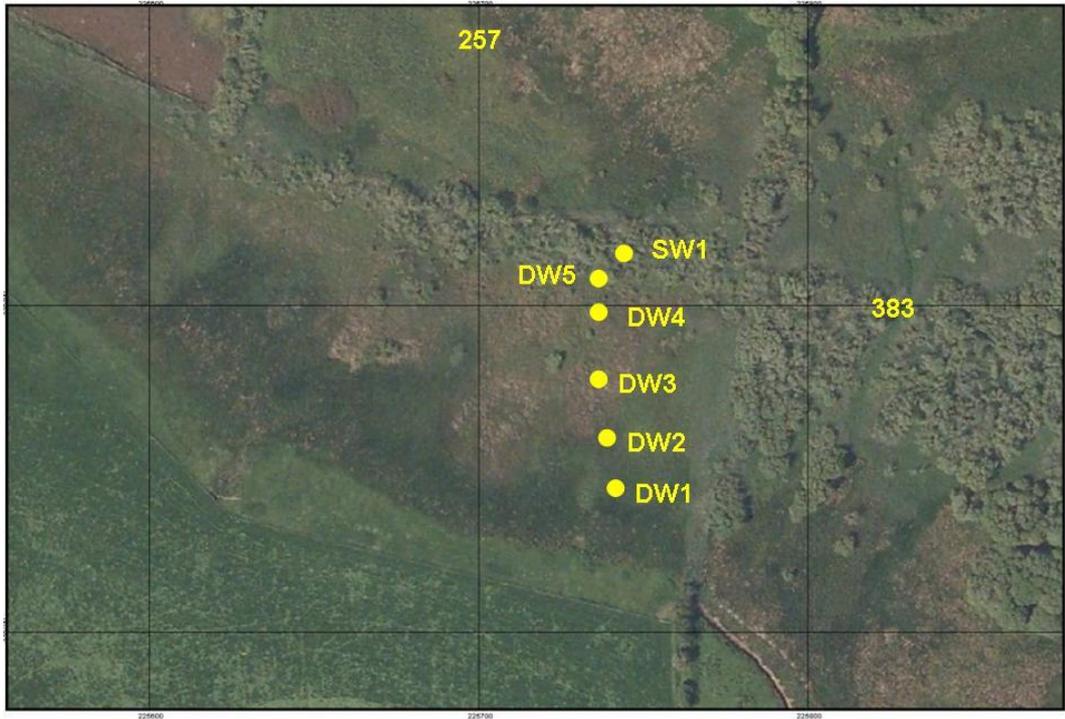
Figure 7. Aerial photograph showing location of dipwells (DW) 1 - 5 and the ditch water level monitoring station SW1 at Cors Hirdre SSSI. The fine black lines are 100 m squares of the British National Grid. 257 and 383 label easting and northing lines respectively.

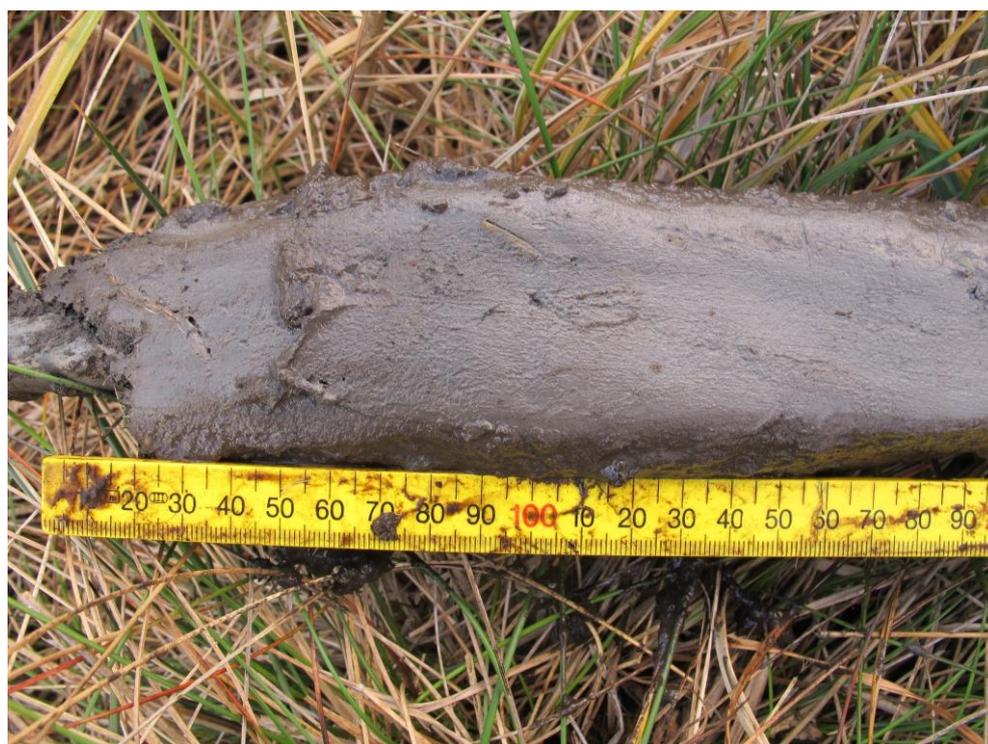
Basic information on site stratigraphy was collected to aid interpretation of the hydrological data. A core at DW3 some 36 m from the main drain (Table 3) revealed fresh loose superficial peat with increasingly humified peat at depth, with a relatively sharp boundary at the surface of the most humified (Von Post H7) at -45 cm. Clay was encountered at -70 cm, with the elevation of its surface (31.169 m aOD) being just over 10 cm deeper than the top of the clay observed in the ditch profile (31.278 m aOD, Table 7). The clay at DW3 appears to include relatively pure unlaminate clay (Figure 8) which after 20 cm or so passes at depth into a sandy clay with clasts. This latter unit is well exposed in the ditch profile (much

The extent to which the underlying clay acts as a competent aquitard is unclear, though the uppermost 20 cm of clay noted at DW3 probably would limit seepage. Seepage from sandy facies of this clay into the ditch has already been noted and its stone content is locally high to the point where the unit could almost be described as a sandy gravelly wet clay. These observations suggest that the principle of excavating the ditch no deeper than the base of the peat in the vicinity of the main stand of alkaline fen was correct, though unfortunately this was not achieved. However, the dams should aid sedimentation within the ditch profile and some replacement of ditch spoil into the channel could be considered.

Figure 8. The top 20 cm of the clay underlying the peat at DW3 (70-90 cm) based on a coring on 4 December 2013.

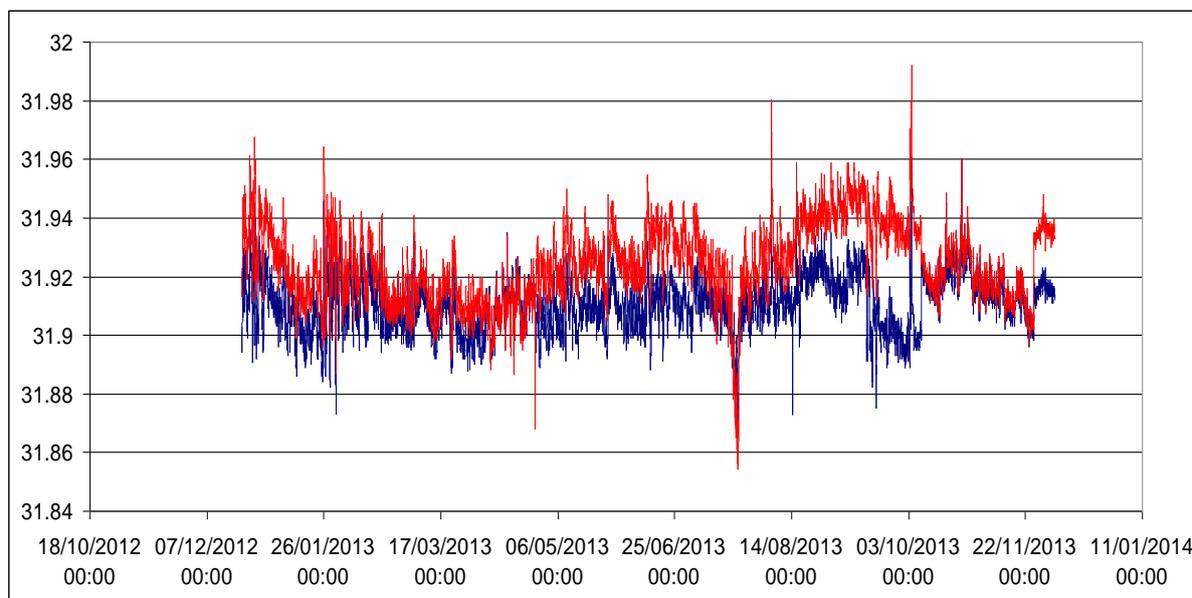
Figure 11. Comparison of hourly measurements of water table level (mAOD) at dipwells 3 (blue) and 4 (red) on the main M13 transect at Cors Hirdre. The jump in levels observed on the right-hand side of the plot on 25 November 2013 is believed to be due to the removal and subsequent replacement at a slightly different level of the respective well caps used for anchoring the suspensor cables. Ditch re-opening reached the approximate location of this transect on 11 September 2013.

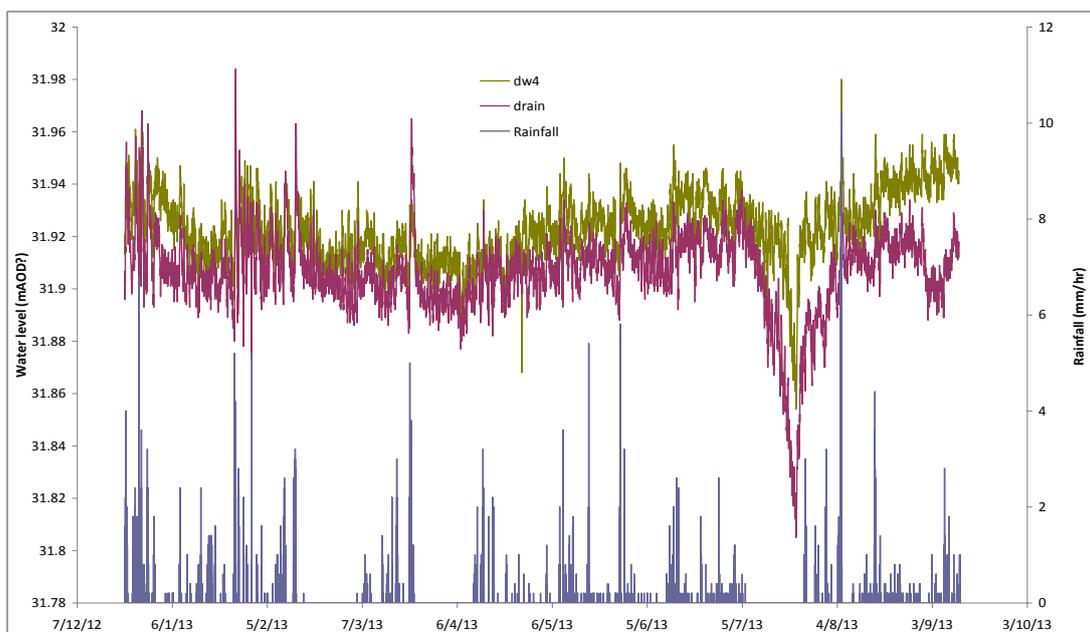
The data-logger record for the period prior to re-instatement of the ditch shows water table levels at DW4 were very slightly higher (1-3 cm) than ditch water levels for most of the time (Figure 13), but with occasional reversals during wet weather. (Figure 14). There is a trend towards late summer of a more obvious and sustained difference which might reflect the influence of evapotranspirational losses from the vigorous *Phragmites* swamp of the ditch and its margins. However, the relative stability of water levels in the main drain is notable given the relative dryness of the spring and summer of 2013. This may indicate a combination of sustained seepage income to the drain coupled with inefficient transmission of water as outflow along the drain, with the seepage apparently sufficient to partially counteract evapotranspirative losses for much of the summer.

Figure 13. Hourly water level readings for dipwell DW4 (green) and the main drain SW1 (purple) expressed as metres above OD. This plot also shows hourly rainfall totals for the NRW rain gauge at Edern (SH 27693.39235 (station no. 529571) 2.5 km NE of Cors Hirdre. The plot terminates at the point when ditch re-opening reached the approximate location of this transect (11 September 2013). Plot drawn by Dr Rob Low.

The comparison shown in Figures 13 and 14 ends on 11 September 2013 when desilting of the ditch reached the SW1 logger. The height of the original spoil bank on the S side of the ditch may have been sufficient to prevent the spread of ditch water over the adjacent fen at this particular location (or at least limit the number of overbanking events), though whether this was the case elsewhere along the ditch is unclear. However, ground (peat) surface elevation was clearly lower than the original main drain water level for several areas within the M13 stand (Figure 15), illustrating the potential for overbanking or even seepage influence out from the ditch to peripheral areas of alkaline fen vegetation.

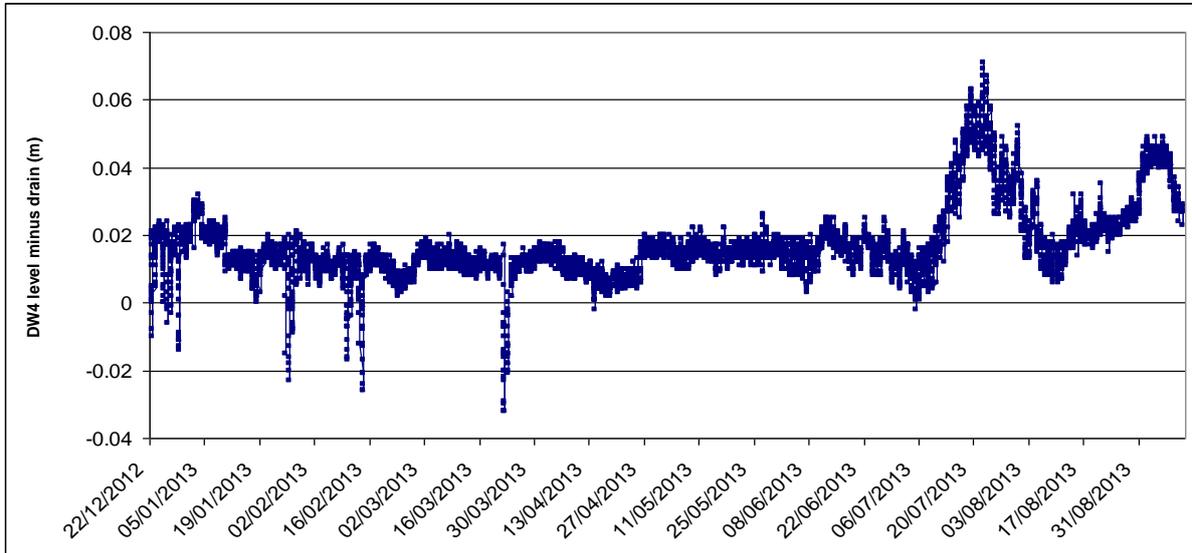
Figure 14. Re-plot of Fig. 13 showing hourly differences in water level elevation between well DW4 and the main drain. Negative numbers indicate occasions when ditch water levels exceeded water table levels at DW4.

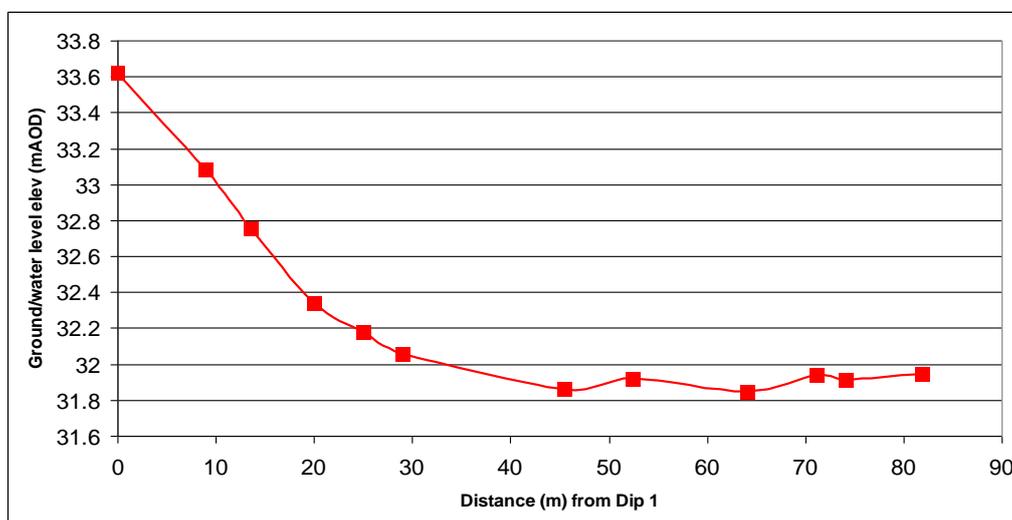
Figure 15. Variation in ground elevation along the dipwell 1 (0 m) to 5 (73 m) transect and water level elevation in the then occluded ditch at SW1 at 81.9 m. Ground level at dipwells 3 (45 m) and 4 (63 m) is lower than the ditch water level. Dipwell 2 is located at 25 m. Data for 21 December 2012.

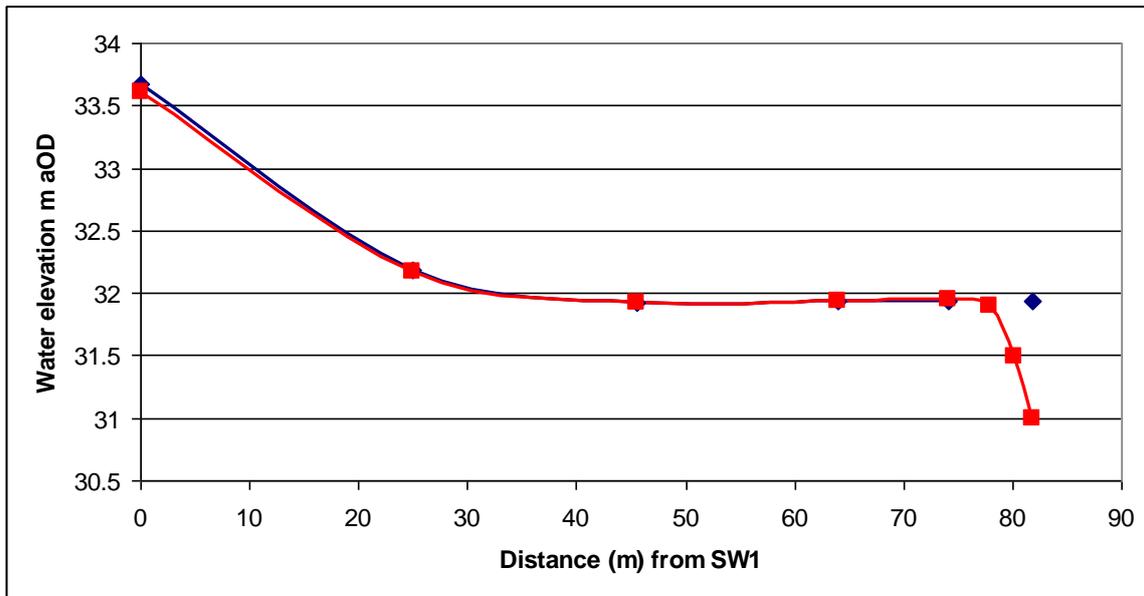
Ditch dewatering and desilting resulted in a drop in ditch water level of 94 cm at the main transect (Table 7) and 85 cm further downstream at DWM9 (Table 8), with a recovery of c. 35 cm upstream of dam D2 following measures to make it effective (namely lining with a plastic sheet). Following re-instatement of the drain and work to make dam D2 effective, the mean water level difference between DW4 and the main drain has decreased to -0.64 m (n=3, range -0.612 to -0.675m). Comparisons of water table profiles along transect DW1-SW1 before and after re-opening the main drain (Figure 16) show more or less identical profiles until within a few metres of the drain, though a potentially ecologically significant change in level of, for example, 10 cm would scarcely show at this scale. The drawdown effect may only ever be limited at this location, with seepage from upslope and rainfall sufficient to counteract any significant effect except during prolonged dry weather. This is supported by Table 6 which shows a very stable hydrological regime in the main M13 area following drain re-instatement.

Figure 16. Water table profile plot running from DW1 (left) to the main drain (right) for 21 December 2012 (blue line, pre ditch cleaning) and 25 November 2013 (red line, post reinstatement of the ditch).

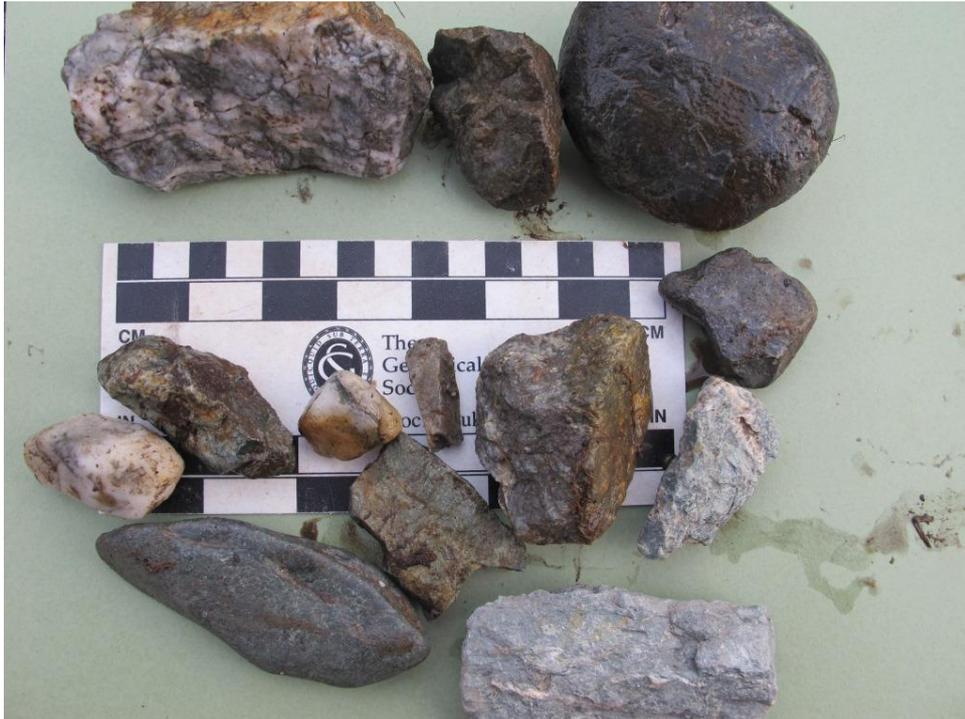
less apparent is the overlying 'pure' clay observed at DW3) and includes a very diverse clastic assemblage (Figure A.3.1). Its texture is also variable, with some sandy clays oozing water (and iron) onto the ditch face and fairly sloppy.

Figure A.3.1. Clasts retrieved from sandy clay unit underlying peat in the exposed ditch section at Cors Hirdre at SW1.

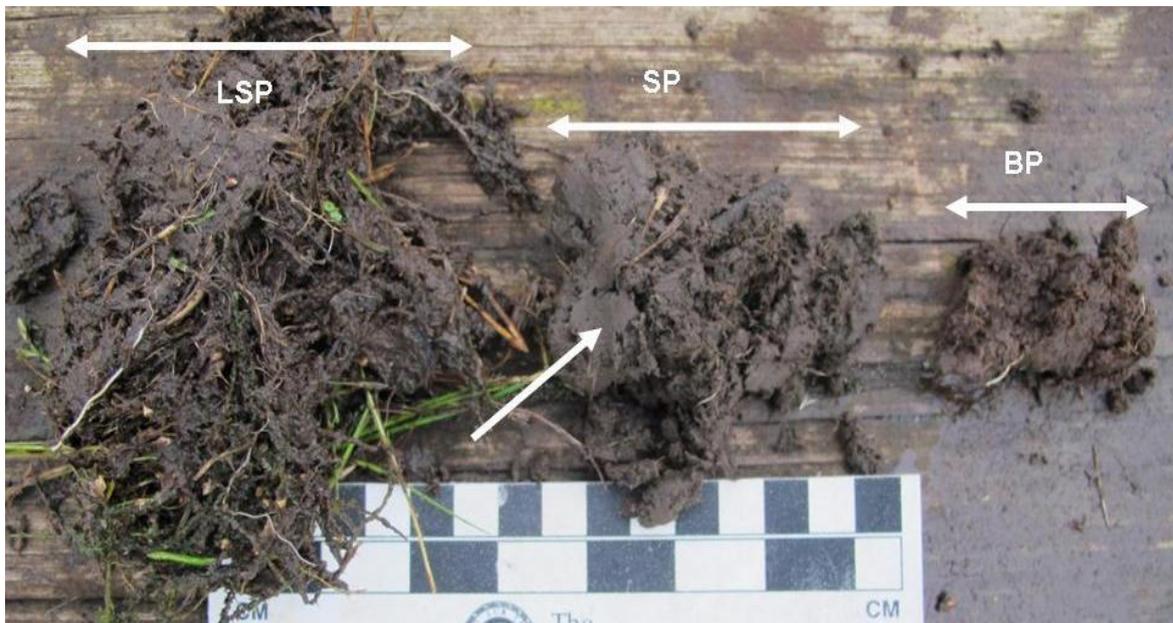
Figure A.3.2. Key organic units recorded from stratigraphic examination of M9 stand at SH 26064.38211 (see Table 5) at dipwell DWM9. Key to abbreviations: LSP, loose surface peat and vegetation raft material recorded from 0-15 cm: SP, greyish silty peat recorded from lower part of 15 – 47 cm: BP, basal peat recorded from 49 – 86 cm (see also Fig. A.3.3). The white arrow overlain on the SP sample shows a smear holding its form in this silty material. Image reference IMG_3311. Photo taken 29 November 2013.

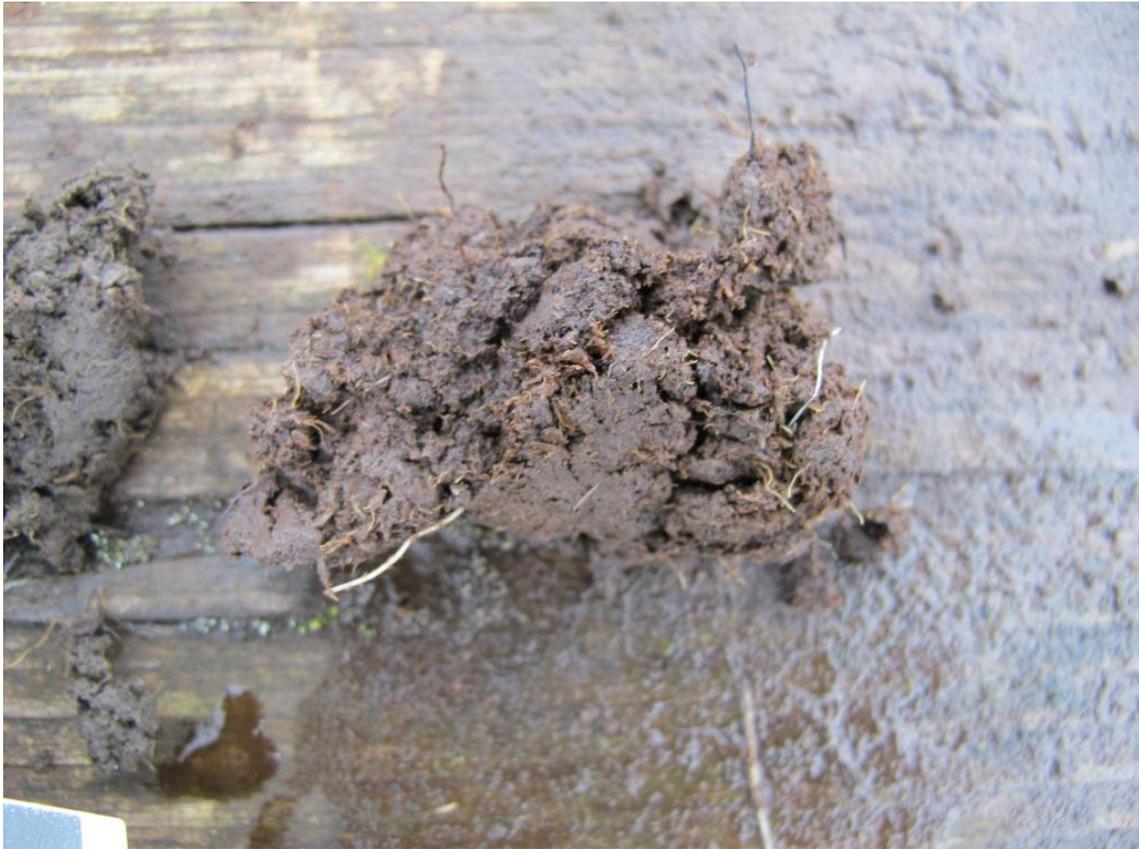
Figure A.3.3. Close up image of basal peat recovered from Cors Hirdre station DWM9 on 29 November 2013 (SH 26063.38213). Macrofossils can be seen. Horizon depth 49-86 cm below water level. Sample approximately 4 cm wide.

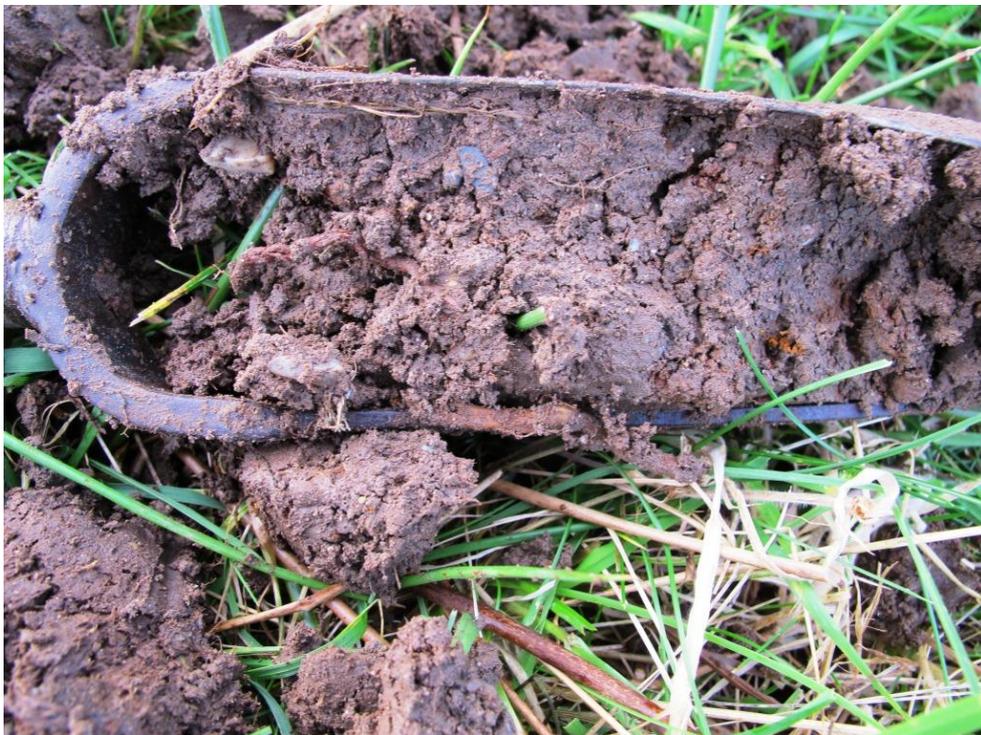
Figure A.3.4. Core sample from c. SH 2570.3823 from just S of marked break of slope above sloping wetland edge. Photo shows the sandy gravelly clay-rich brown loam recorded at this location.

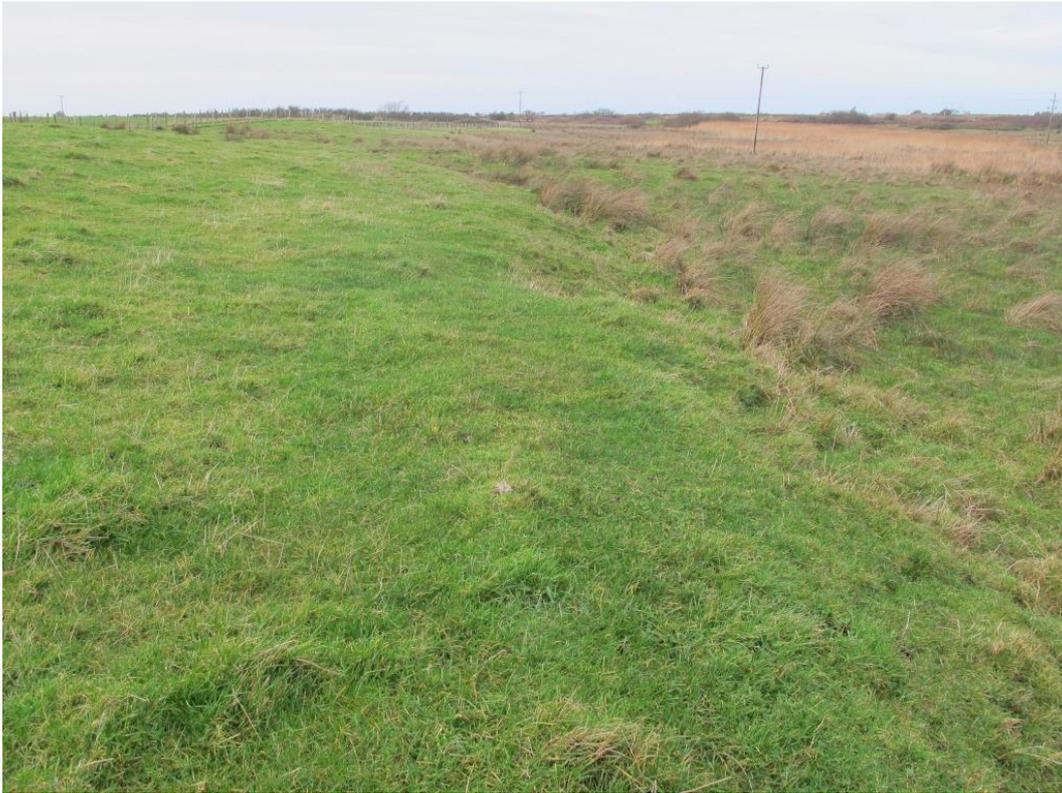
Figure A.3.7. Marked break in slope visible at c. SH 2570.3823 on S side of site looking NW. The core sample shown in Figure A.3.4 was taken close to this point.
