River Habitat Surveys (RHS) and Plant Community Surveys of the River Wye SAC (Wales) in 2024 and 2025

Report No: 967
Author name: Julie Bywater, Bywater Ecology
Author affiliation: Contractor

Report series: Evidence Report
Report number: 967
Publication date: May 2026
Contract number: RHS_Wye_2025
Contractor: Julie Bywater, Bywater Ecology
Contract manager: Francesca Sanchez, Natural Resources Wales
Title: River Habitat Surveys (RHS) and Plant Community Surveys of the River Wye SAC (Wales) in 2024 and 2025.
Author(s): J. A. BYWATER
Technical editor: F. Sanchez and S. Hearn
Quality assurance: Tier 3
Peer reviewer(s): Jennifer Owen, Melissa Lacan
Approved by: R. Thomas and R. Cardwell
Restrictions: None

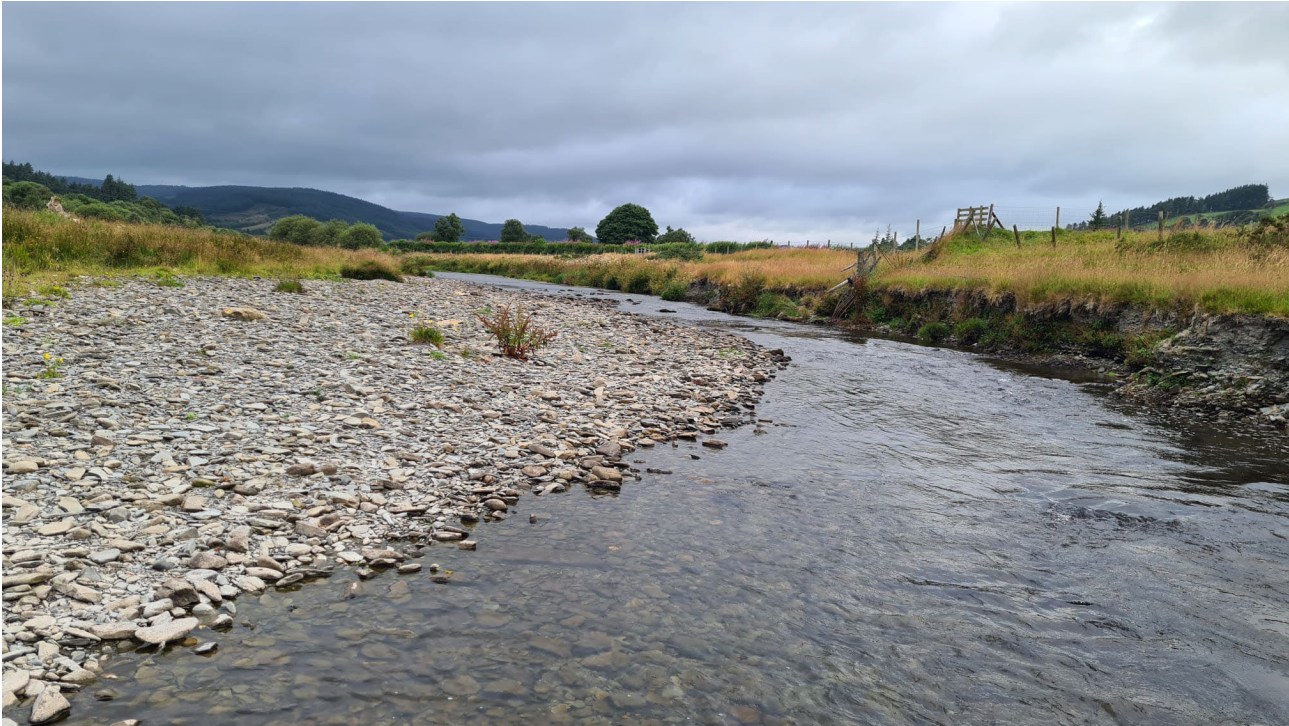
Figure 12. Photo of Wye at Llangurig at the midpoint facing upstream

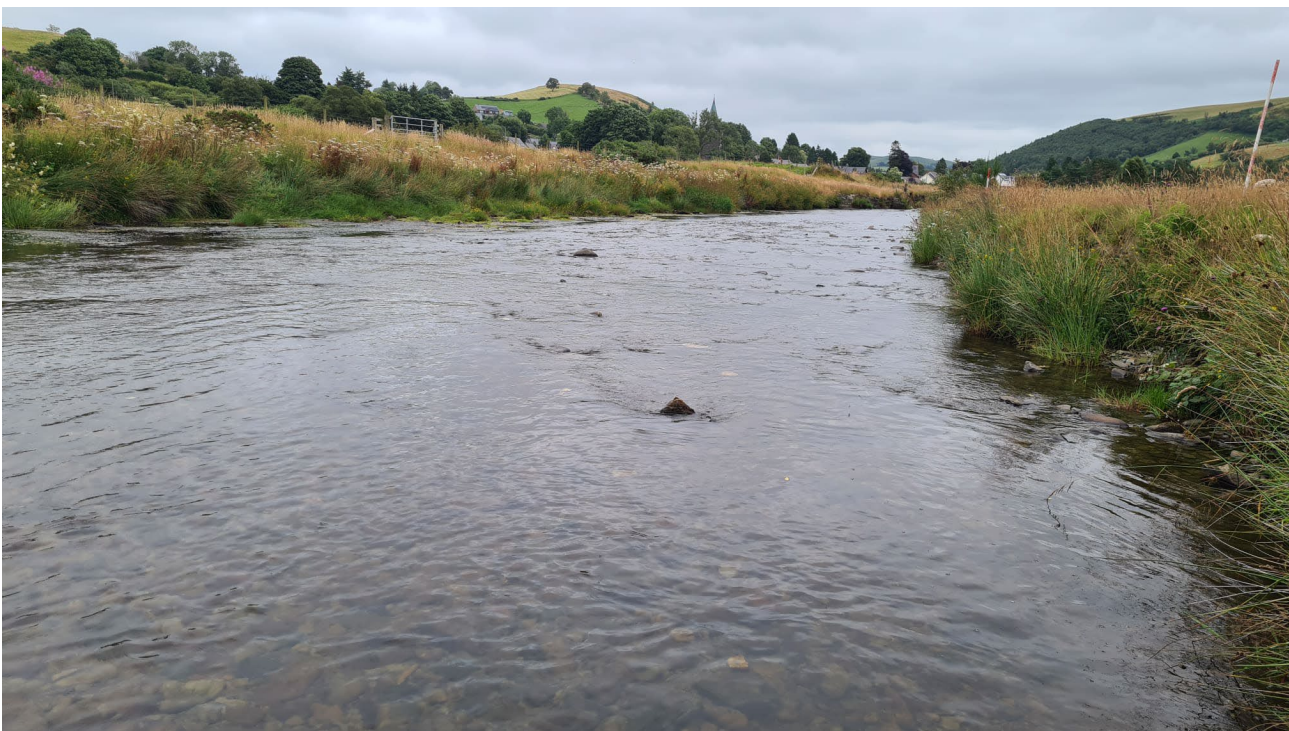
Figure 13. Photo of Wye at Llangurig at the midpoint facing downstream

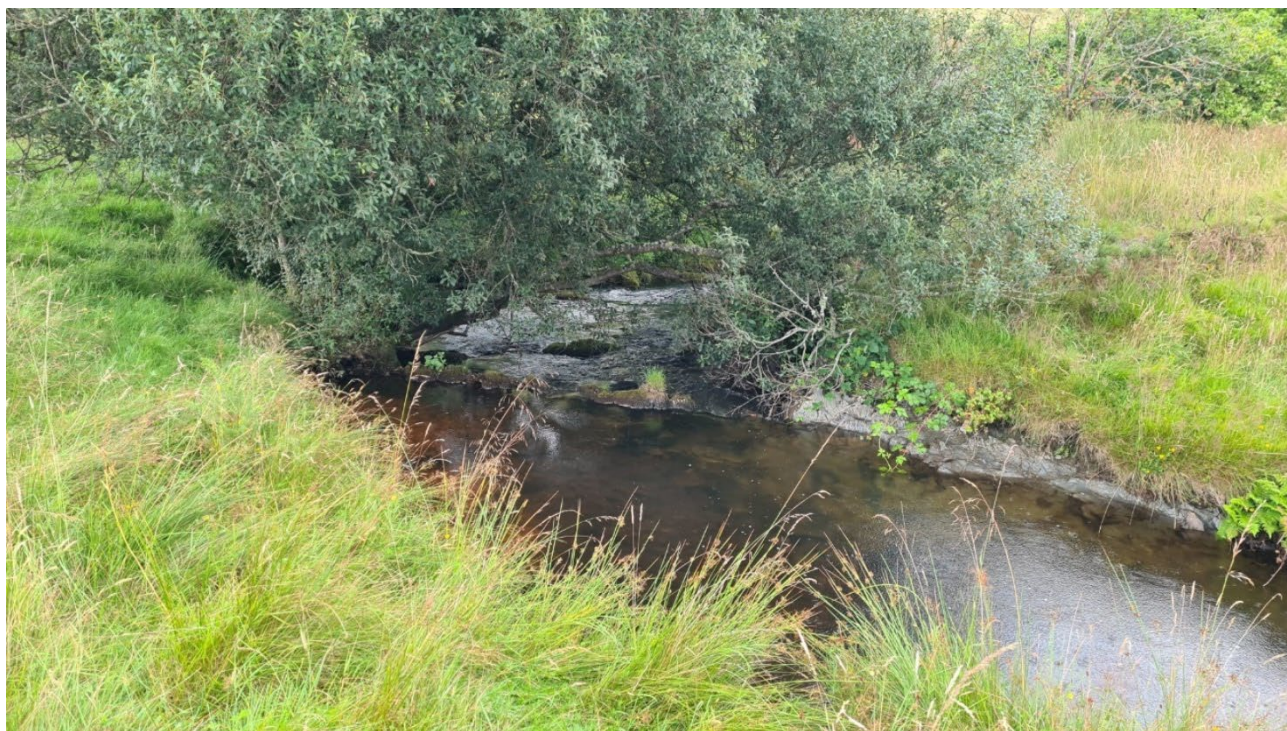
In the 500 m River Habitat Survey length, the predominant valley form was asymmetric floodplain with a distinct flat valley bottom. In the downstream section, there was historic re-sectioning noted with the right bank having a trapezoidal profile with no trees on the bank top for some of the length, and regularly spaced trees of similar species and size in the remaining. The left bank was steep and wooded in this location. The channel was deep compared to the width, but the bed was bedrock so had not been dredged. There were a number of 'kiddies weirs', where rocks had been placed across the channel, which had collapsed and were not holding the water back, so these were recorded as groynes. Further high flows would likely see these demolished and improve the habitat modification score, which was class 3, due to the presence of bridges and localised reinforced and re-sectioned banks.

Figure 20. Photo of Afon Bidno at the midpoint facing upstream

Reprofiling of previously re-sectioned banks to a more natural profile or allowing them to degrade where it is safe to do so, is recommended.

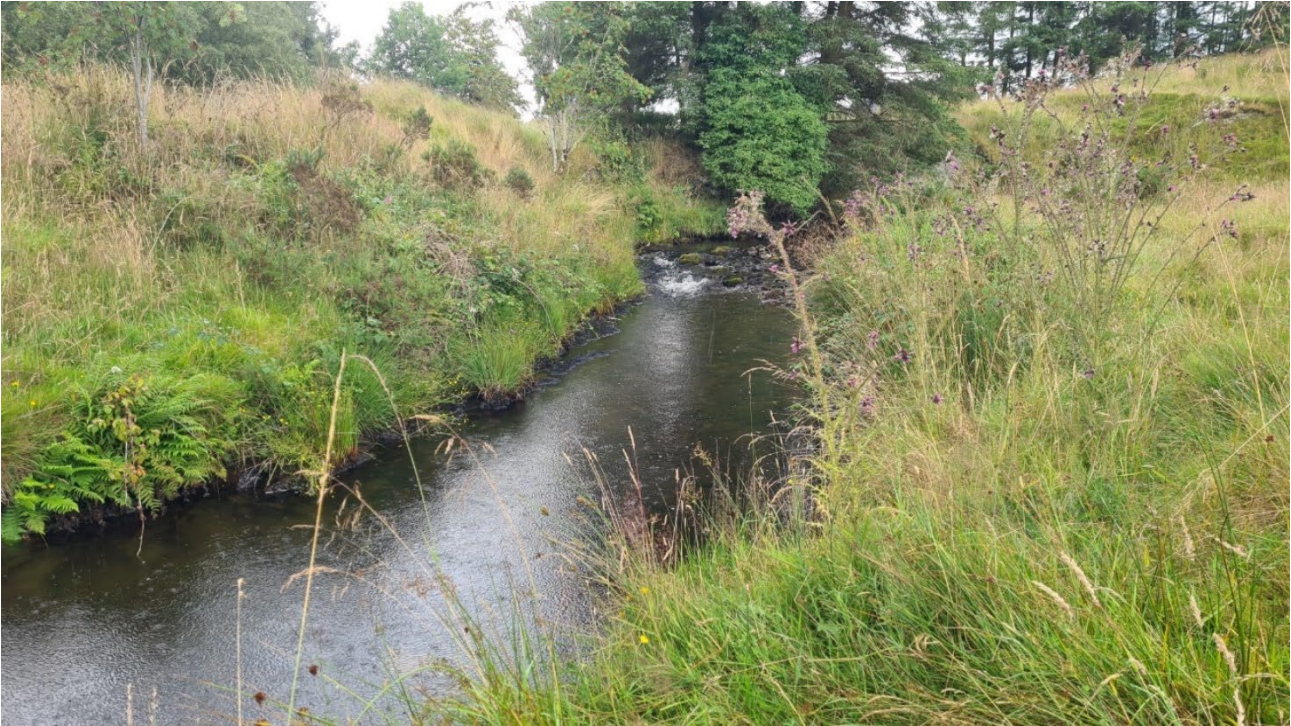
Figure 21. Photo of Afon Bidno at the midpoint facing downstream

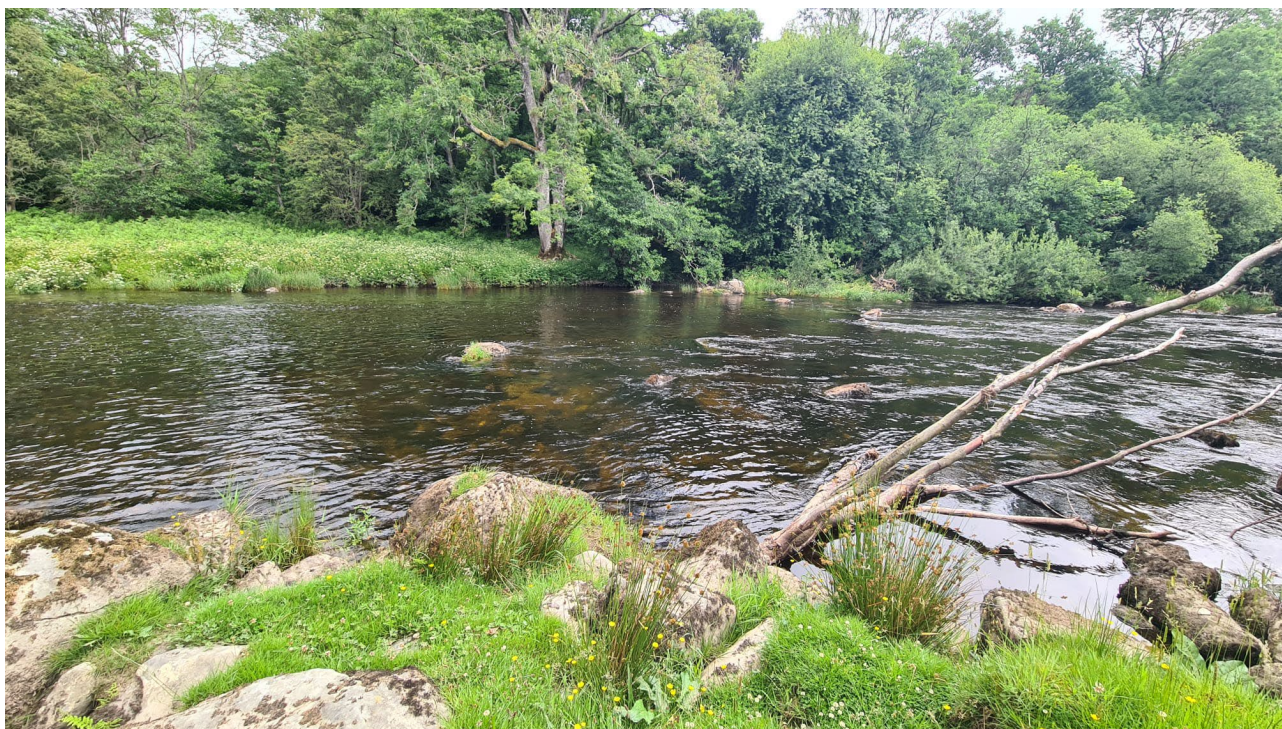
Figure 26. Photo of Wye at Llanwrthwl at the midpoint across the channel

It is recommended that the bracken is controlled where it is dominating the bank flora downstream of the bridge.

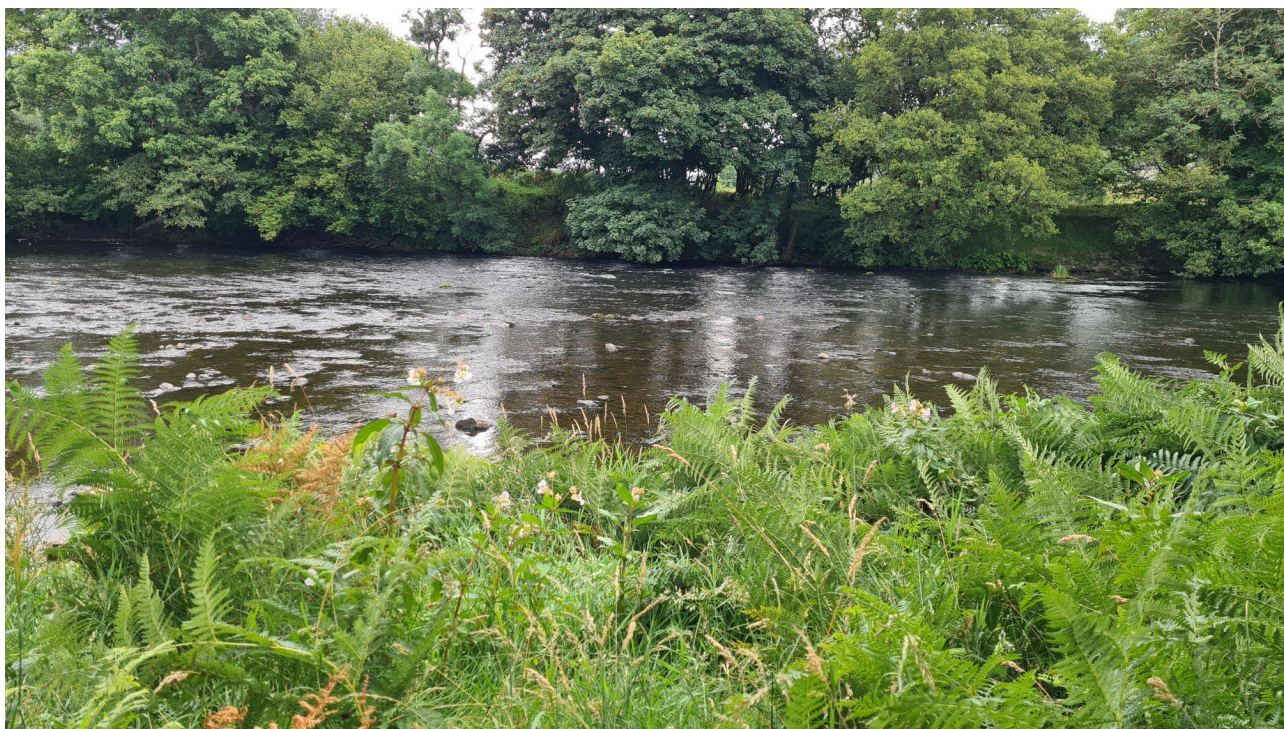
Figure 29. Photo of Wye, Treflyn, at the midpoint across the channel

Control of invasive species, Himalayan balsam and bracken on the banks is recommended for this site, with possible water quality issues to investigate with epiphytic algal cover of rocks in the RHS survey, probably due to enrichment.

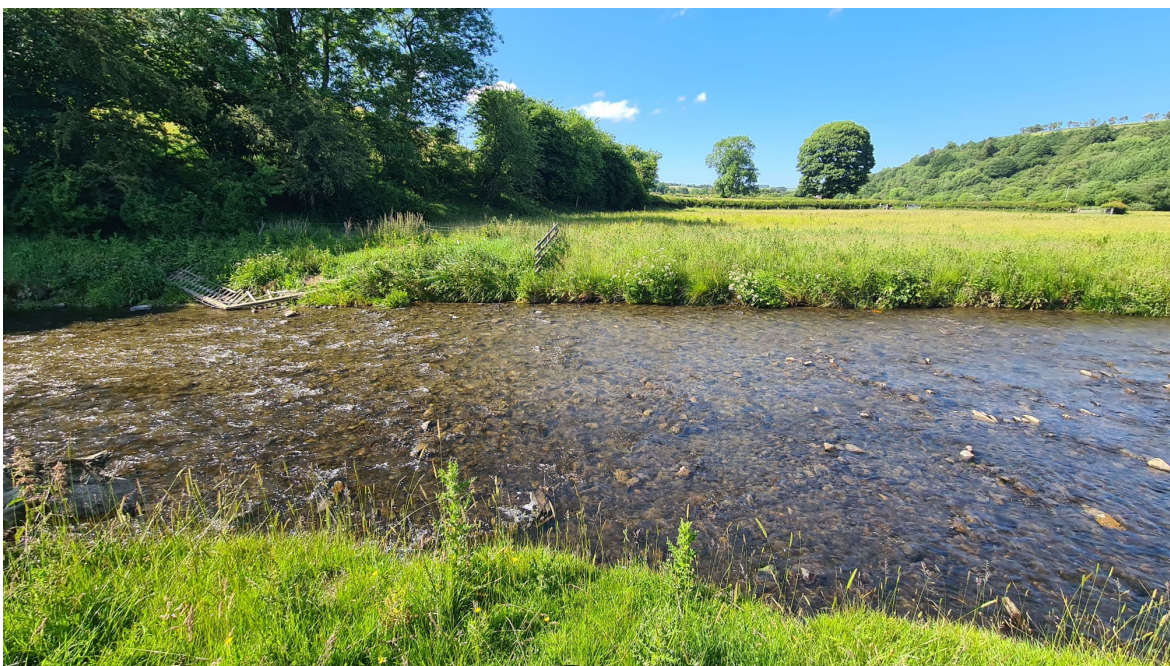
Figure 32. Photo of Ithon, Llanbadarn, at the midpoint across the channel

Creation of a wider buffer strip along the bank top is recommended to enhance the quality of the channel and protect the water quality. This is one way the watercourse could be protected from siltation, but investigation may be needed to determining the source of the silt. Trees could be planted along sections where the banks have been historically resectioned, and the banks allowed to become more natural over time. More diverse flow could be created by installing deflectors in the long, straight, slow flowing sections.

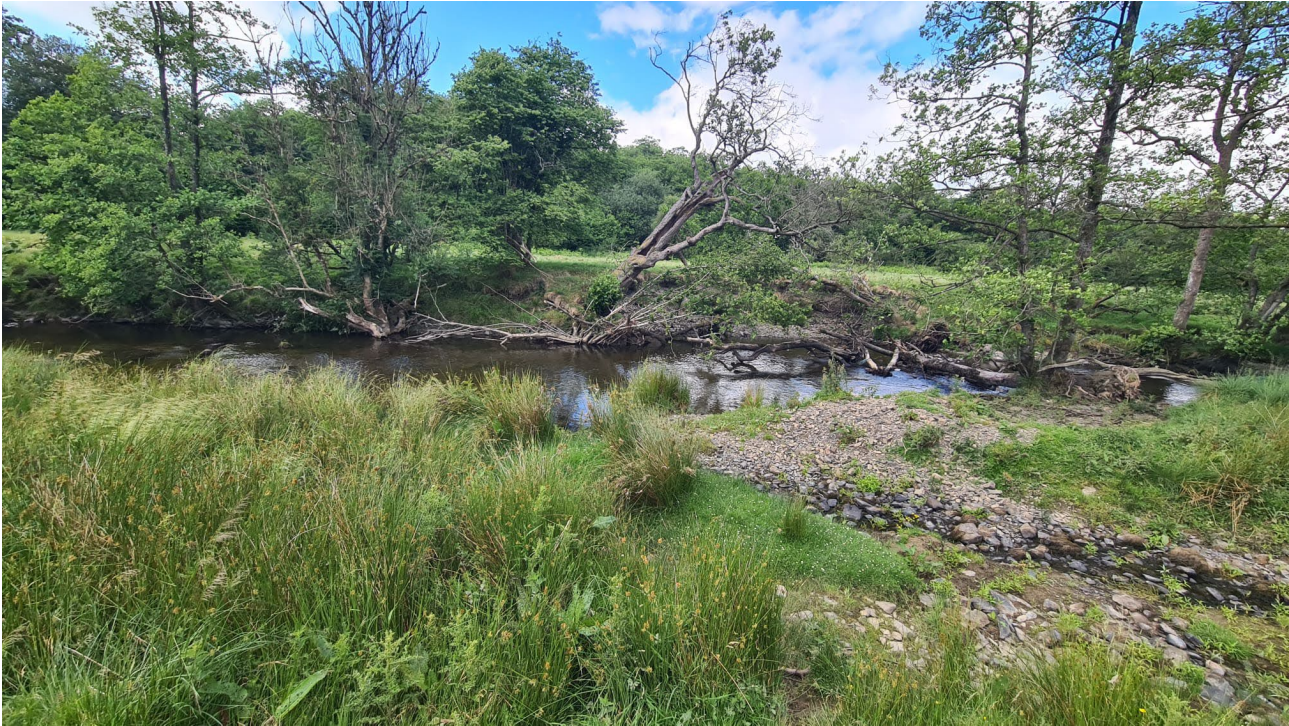
Figure 35. Photo of Ithon, Llanbister, at the midpoint across the channel

Recommendations for this site include control of the Himalayan balsam and bracken, and management of silt input into the channel as this was depositing over the bed of the watercourse.

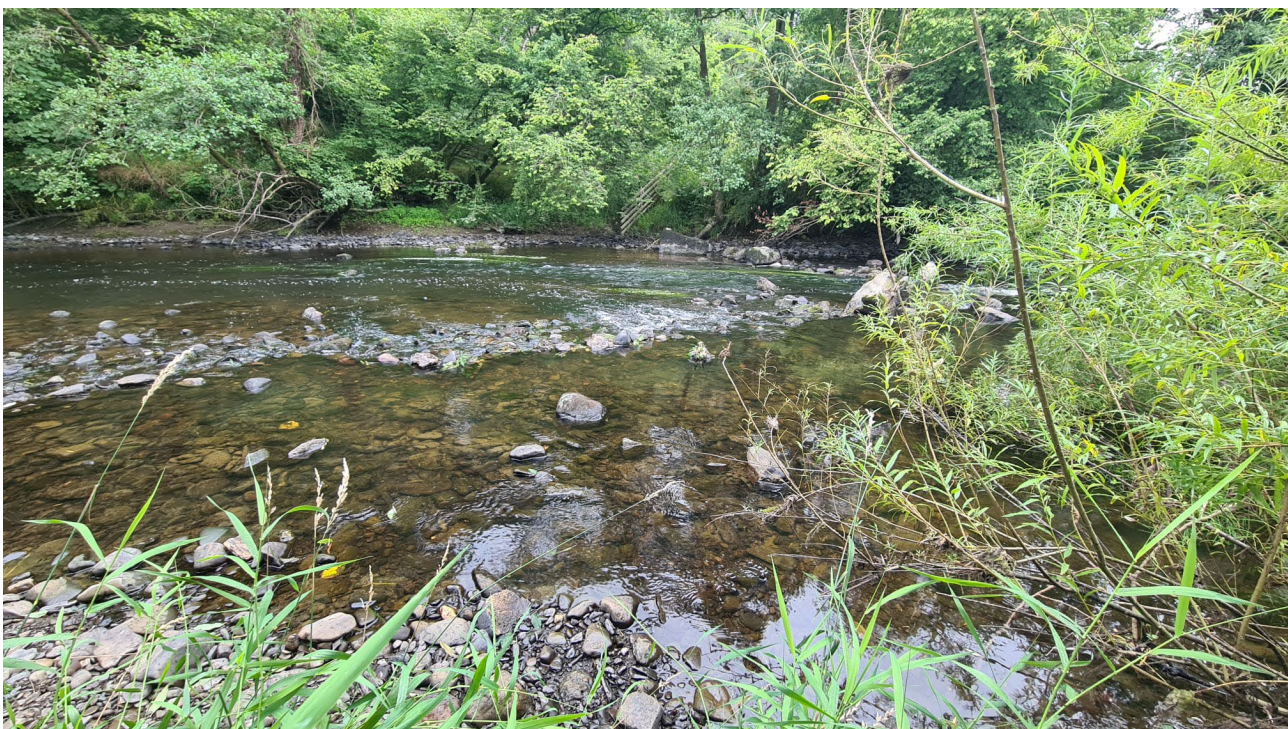
Figure 38. Photo of Ithon, Disserth, at the midpoint across the channel

Recommendations for this site include control of the Himalayan balsam and creation of a buffer strip within the caravan park where caravans and their decks are sited right up to the bank top in places. Control of the invasive Himalayan balsam is also recommended at this site.

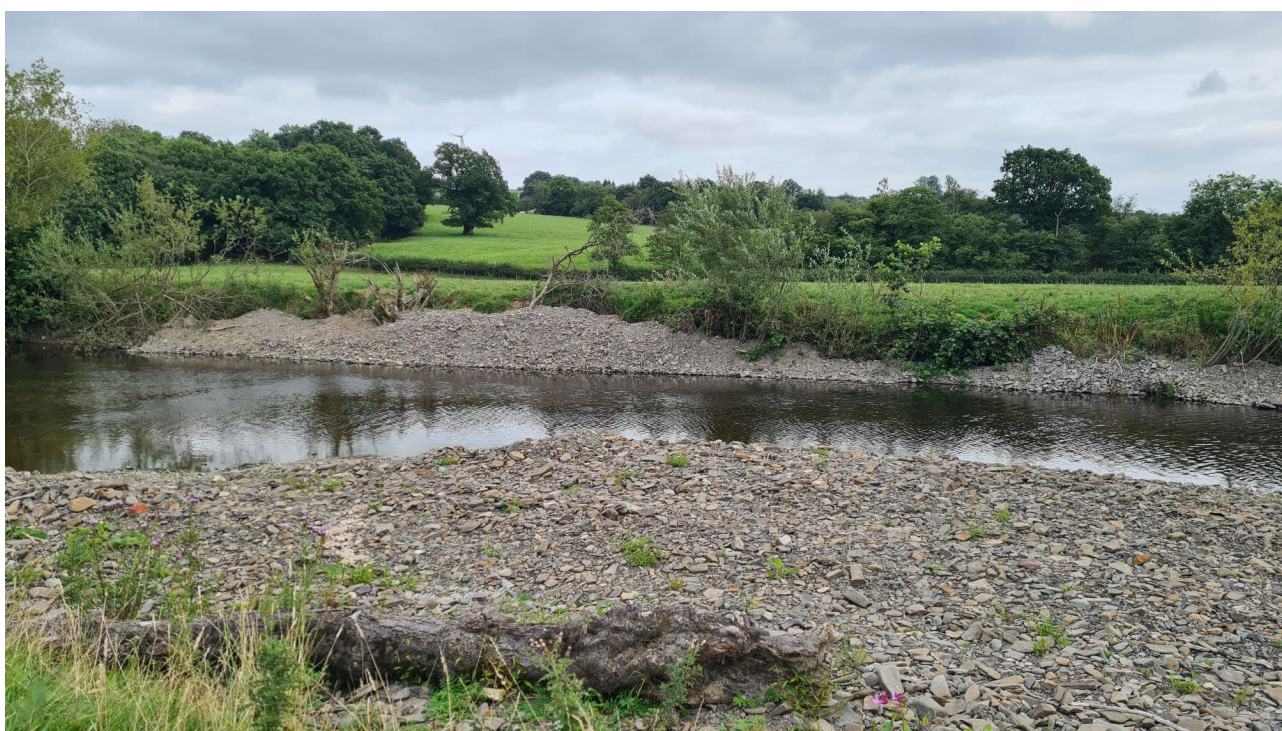
Figure 41. Photo of Ithon, d/s A485 road bridge, at the midpoint across the channel

Any unauthorised alterations to the watercourse should be investigated and remediation measures put in place. Reprofiling of previously re-sectioned banks to a more natural profile or allowing them to degrade where it is safe to do so, is recommended. Control of the invasive Himalayan balsam is also recommended, and whilst poaching was not a particular issue at this site, the vegetation was grazed up to the bank top so fencing set away from the bank top would allow creation of a buffer strip.

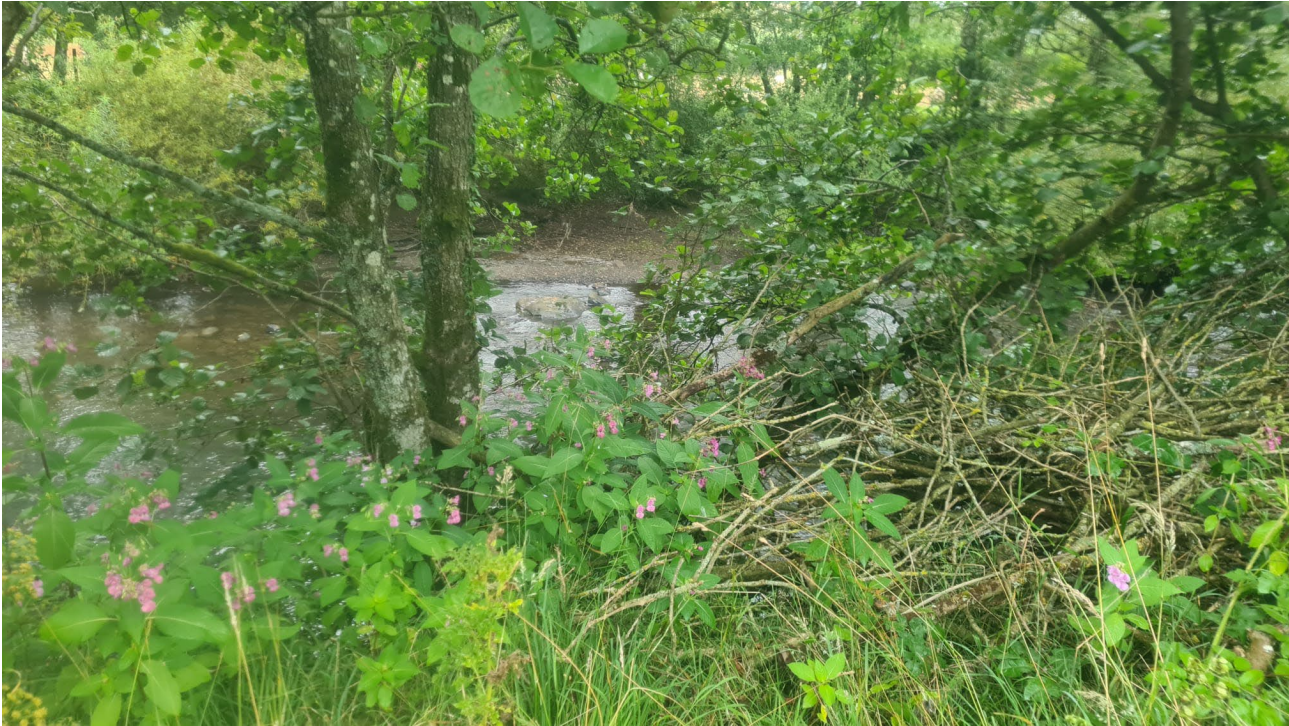
Figure 44. Photo of Ithon, Dolberthog, at the midpoint across the channel

Creation of a wider buffer strip along the bank top is recommended to enhance the quality of the channel and protect the water quality. Control of the invasive Himalayan balsam is also recommended at this site.

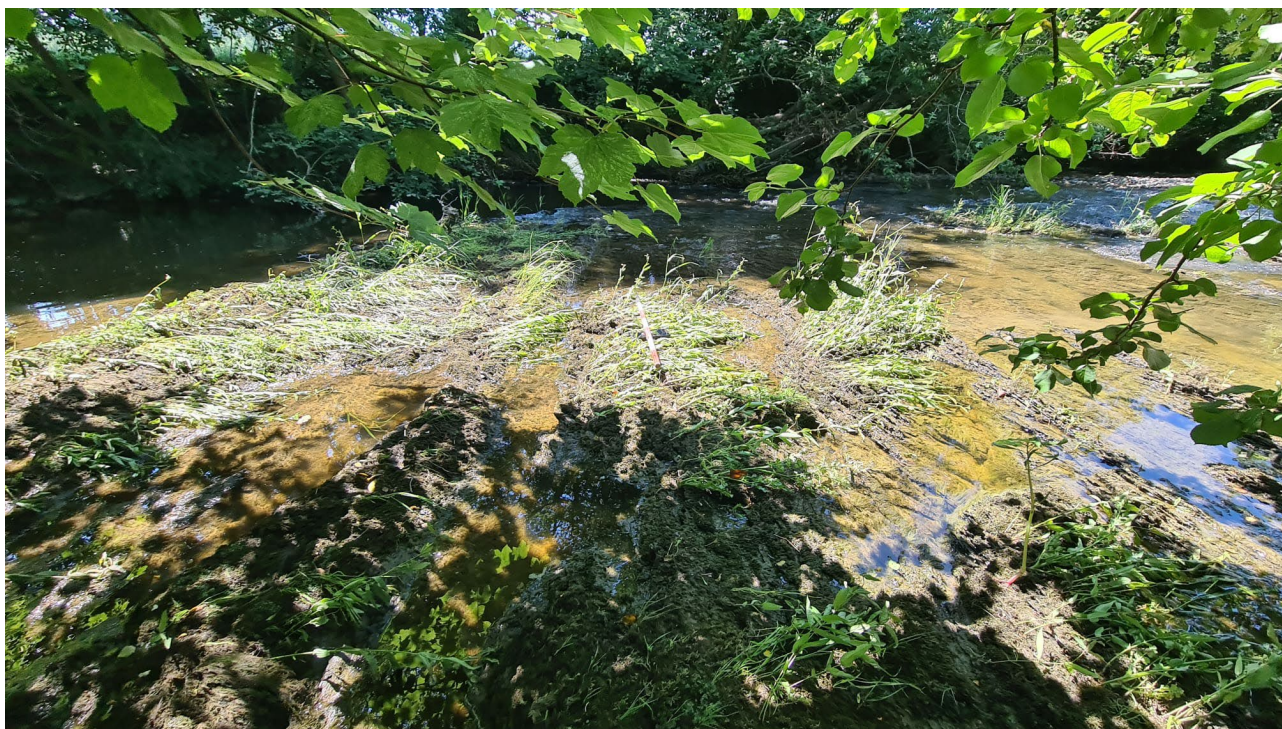
Figure 47. Photo of Ithon, Trelowgoed, at the midpoint across the channel

Recommendations for this site are to limit silt pollution from upstream and increase the buffer strip between the river and agricultural land use. The landowners at the Mill have planted trees and allowed the understory to develop in a field along the right bank, and have trees in the meadow in the next field. This is a good example of buffering for the channel and should be retained. The flow in the straighter sections could be varied by installing deflectors, but there are already good depositional features along the survey length. Control of the invasive Himalayan balsam is also recommended.

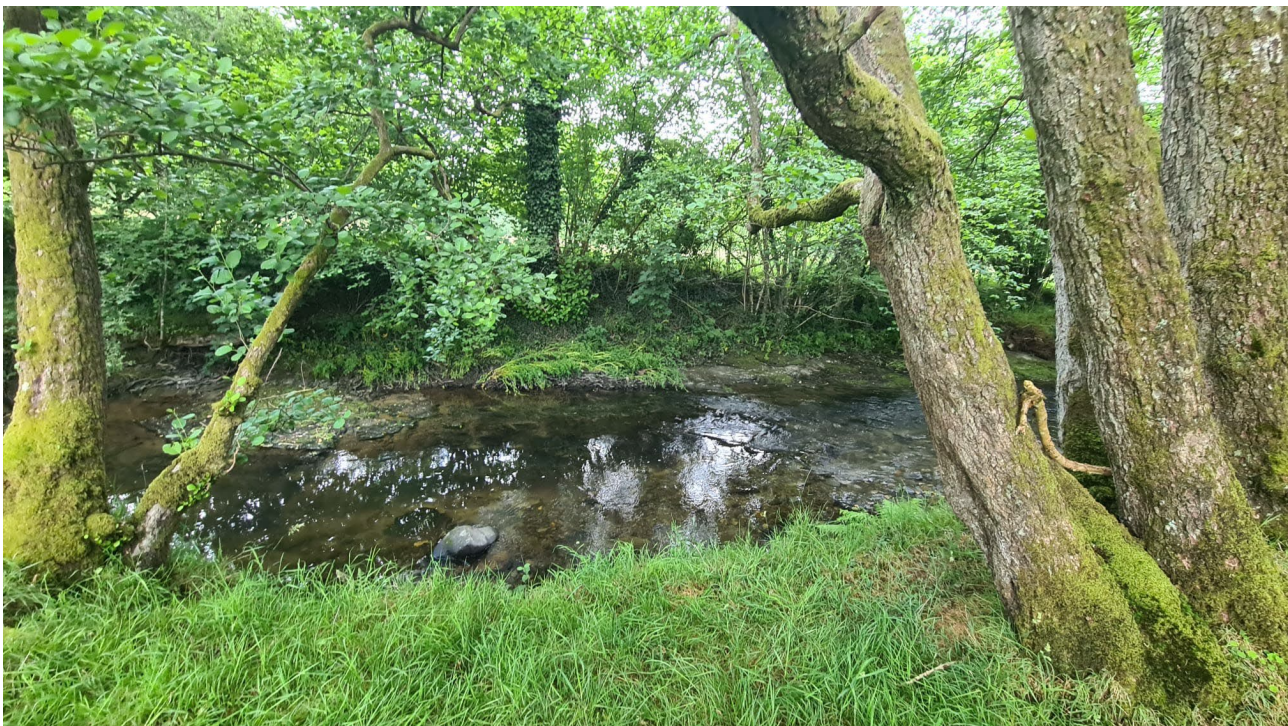
Figure 50. Photo of Clywedog, Brynlllygoed at the midpoint across the channel

Reprofiling of previously re-sectioned banks to a more natural profile, or allowing them to degrade where it is safe to do so, is recommended, along with movement of fencing away from the bank top in the downstream section of the RHS to allow a more natural vegetation to establish and create a buffer zone. Another recommendation would be to manage run-off within the catchment upstream to reduce peaks in flow which are likely to scour out the aquatic flora.

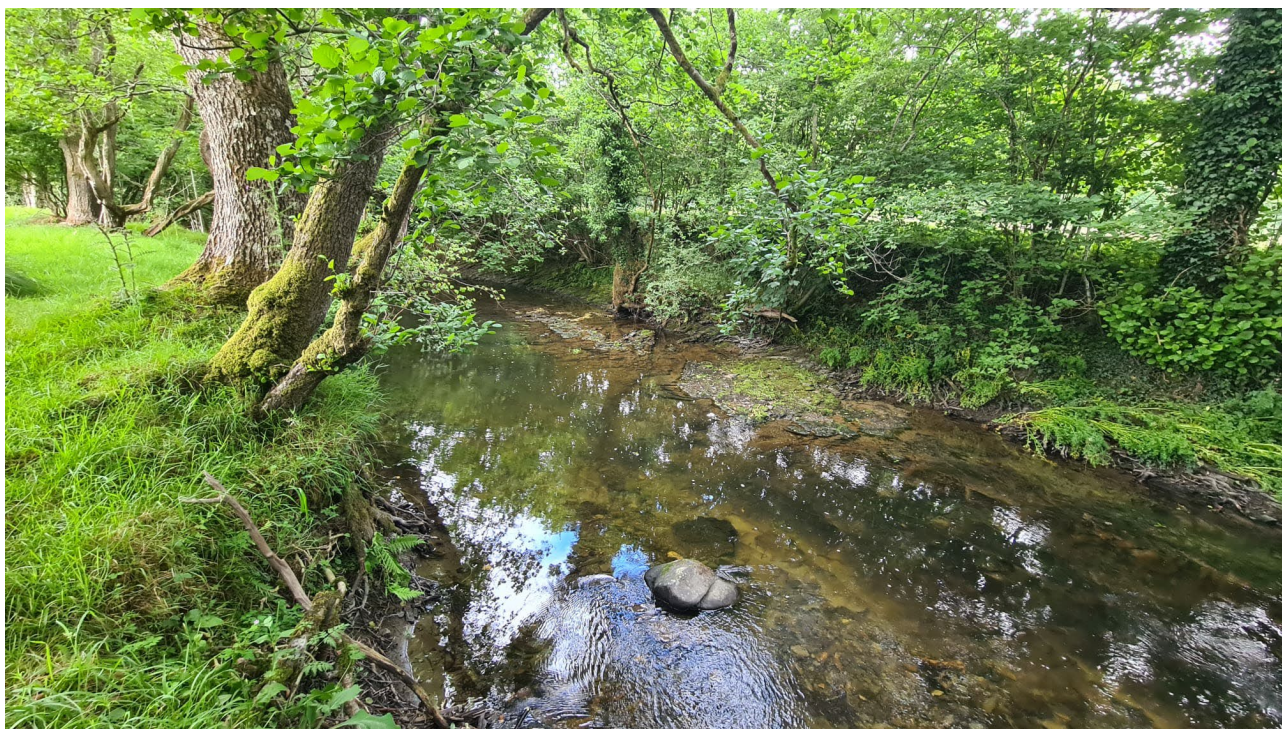
Figure 51. Photo of Clywedog, Brynlllygoed at the midpoint facing upstream

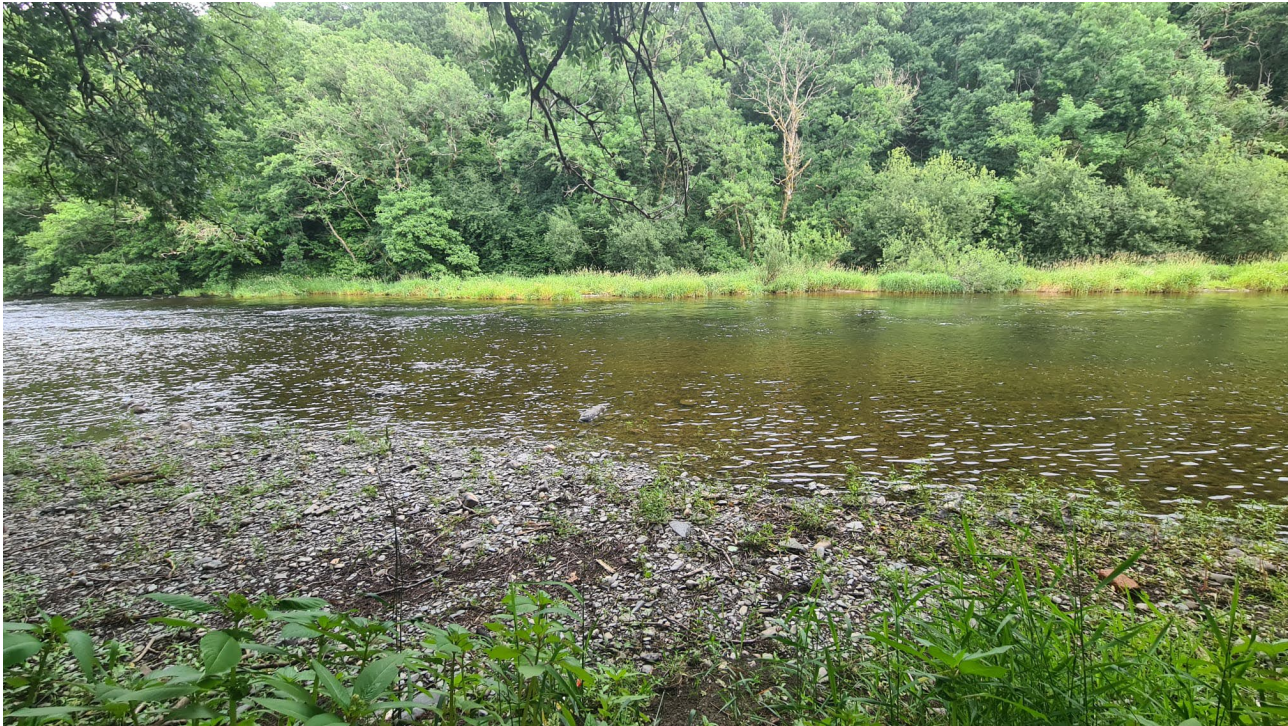
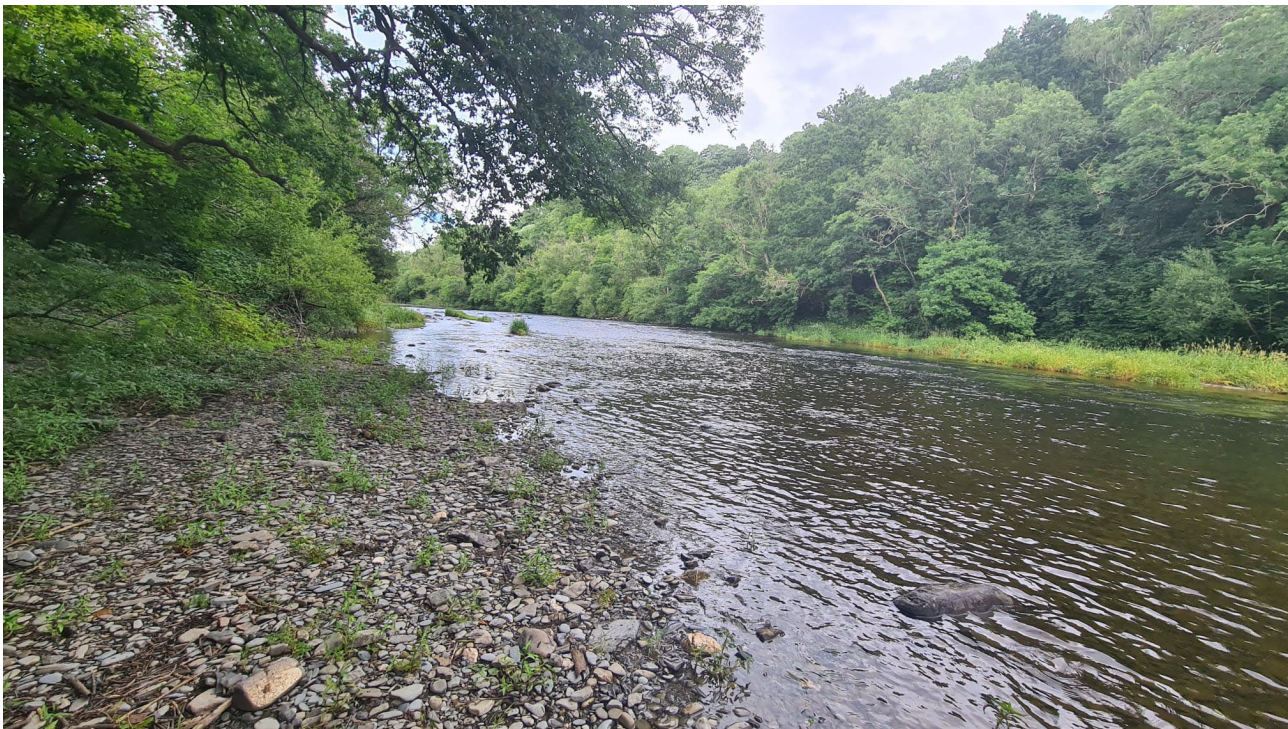
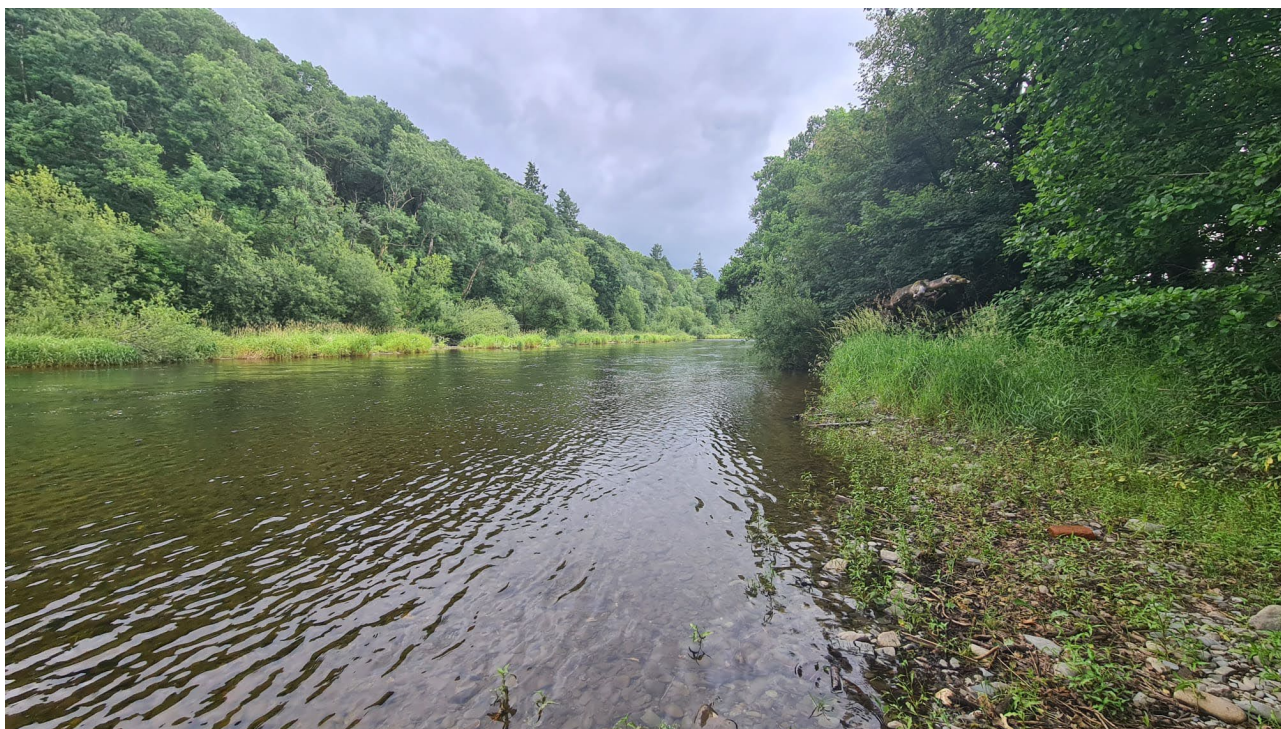
Figure 53. Photo of Wye, confl Ithon, at the midpoint across the channel

The midpoint of this site on the Wye was approximately 500 m downstream of the confluence with the Ithon at grid reference SO0110055900. This is a fairly straight reach within a meandering sinuous section of the River Wye in a wide flat-bottomed valley with hills rising up beyond large fields on either side. The left bank is high, steep and wooded, and there are continuous trees along the right with arable land behind a footpath and narrow strip of hazel trees on the bank face. The surrounding land use was agricultural with crops and sheep grazing. Photographs taken at the midpoint facing across the channel, upstream and downstream are presented in figures 53, 54 and 55 respectively.

The substrate was estimated to be 45 % bedrock in the 100 m macrophyte survey site, with a mix of mainly boulder/cobble and gravel/pebble elsewhere. The left bank was steep and tree covered and was completely shaded by trees with a mixture of broken and dense shade, whilst 20 % of the right bank was unshaded. There were vegetated sidebars on the right bank and there was a marginal strip of the emergent marginal plant reed canary grass (*Phalaris arundinacea*) along the left bank.

and narrow strip of hazel trees on the bank face. The surrounding land use was agricultural with crops and sheep grazing. The mean ECS Score for SAC Unit 7728 (including one other site at Wye Built Rd) was 3, the middle category.

Recommendations for this site include control of the invasive Himalayan balsam and creation of a wider buffer strip along the bank top where appropriate.

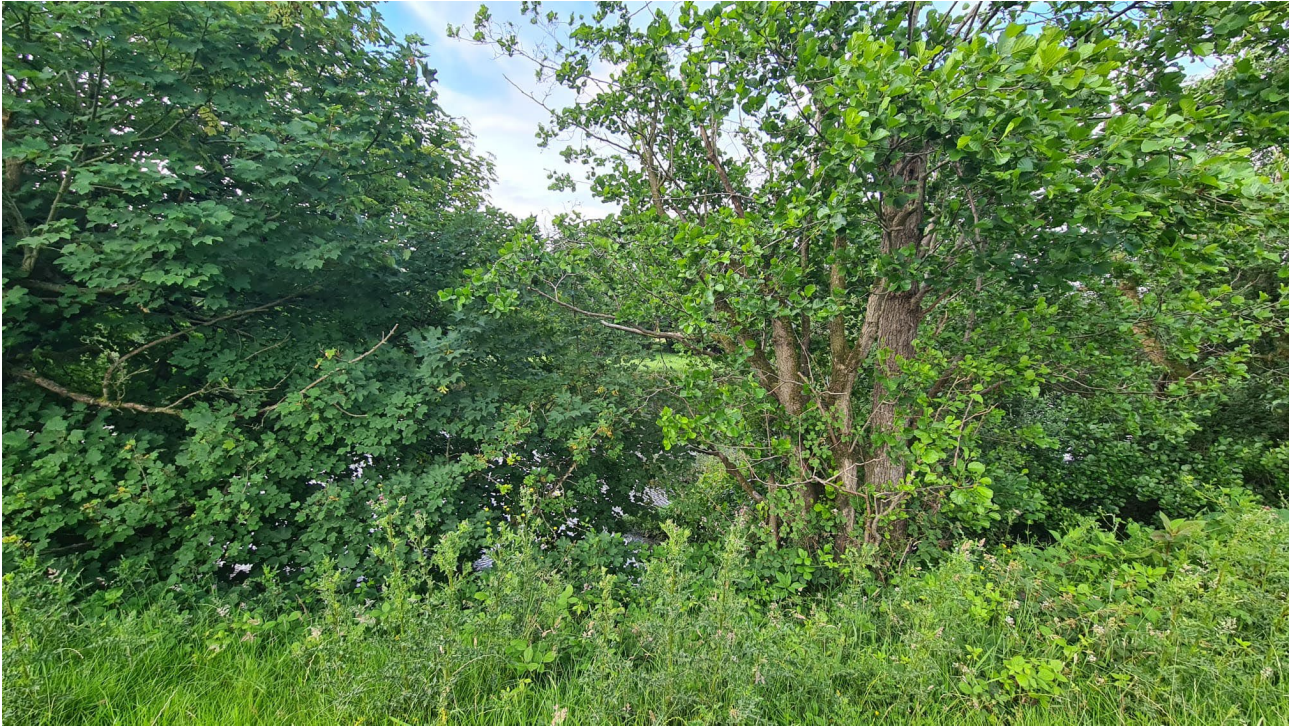
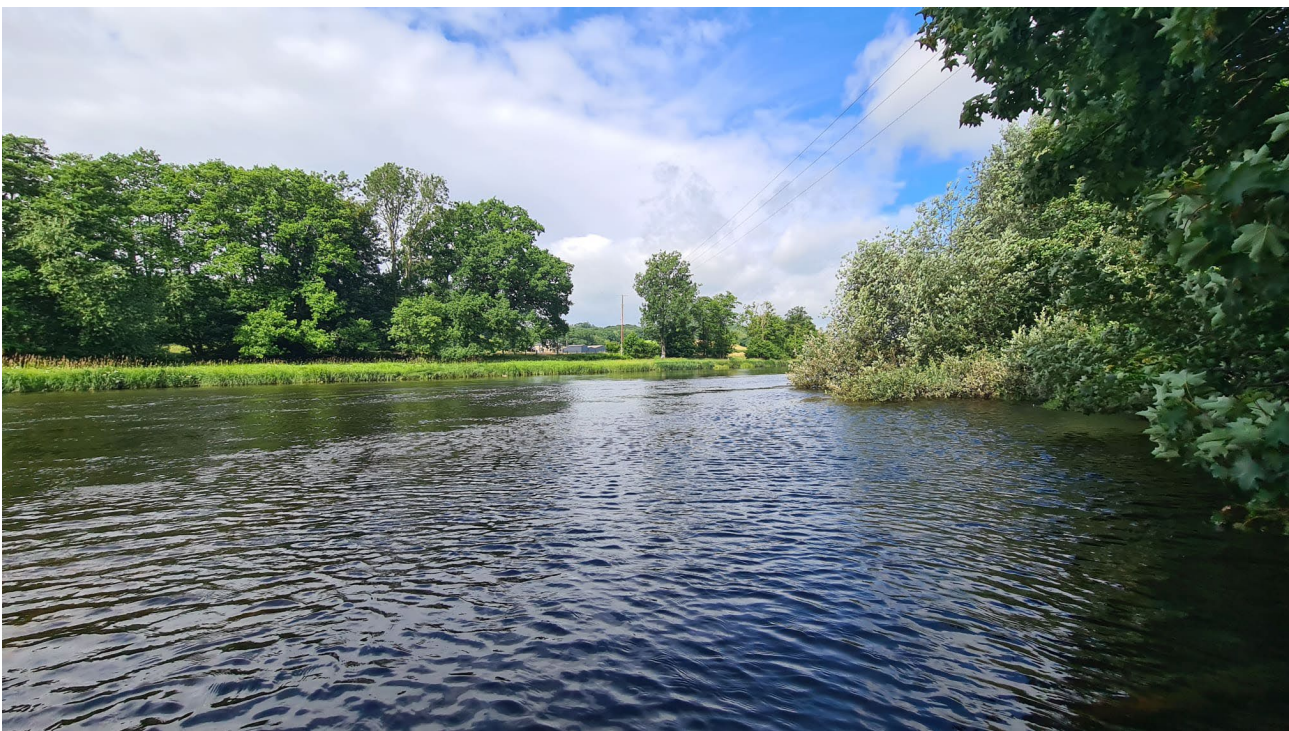
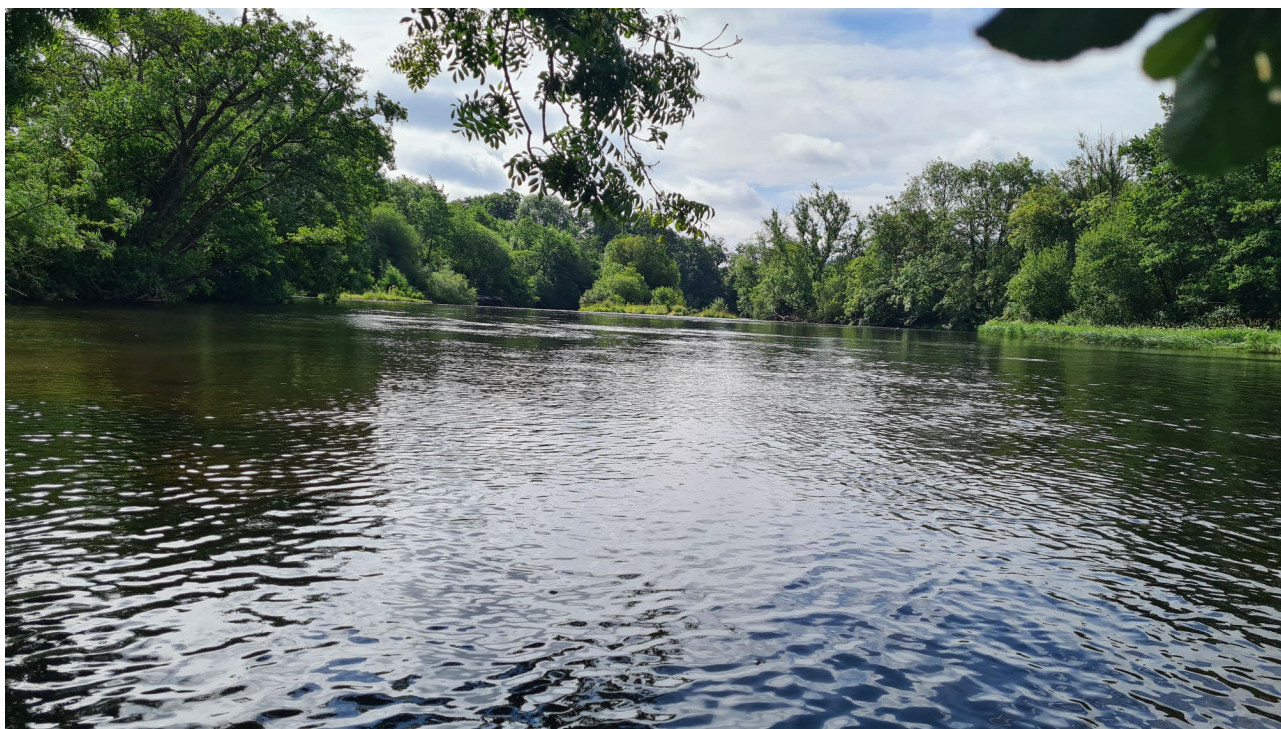
Figure 56. Photo of Wye, Builth Rd, at the midpoint across the channel.

The midpoint of this site on the River Wye was approximately one kilometre upstream of a railway bridge at grid reference SO0182553453. This is a fairly straight low energy reach of the River Wye in a wide flat-bottomed valley, curving gently around Builth Road as it flows south west towards Builth Wells, with large fields on either side. Both banks are low with fairly continuous trees and patches of woodland, and the surrounding land was used for sheep grazing. Previously in 2024, the river was surveyed from the right bank, but access was not possible on this occasion so the river was surveyed from the left bank. Photographs taken at the midpoint facing across the channel, upstream and downstream are presented in figures 56, 57 and 58 respectively.

The water was approximately 50 m wide with an additional 15 m berm / sidebar within the channel which had a predominantly cobble and gravel/pebble substrate. The left bank had predominantly broken shade, whilst the right bank was mostly unshaded. The main flow type in the macrophyte 100 m survey was 'run' with slack areas. Whilst the water depth was mostly in the 0.25 – 0.5 m

The SERCON score was 3, the middle category of the simplified phase one habitat survey due to the dominance of improved and poor semi-improved grassland on both banks along with semi-natural woodland. The mean ECS Score for SAC Unit 7728 (including one other site at Wye confluence) was 3, the middle category.

This site is therefore impacted by agricultural use, historic bank re-sectioning and embankment. Recommendations at this site are to control the invasive Himalayan balsam and allow the re-sectioned banks to degenerate naturally, or reprofile to a more natural shape as appropriate. As mentioned at other sites, fencing should ideally be set back away from the bank top to allow more natural vegetation to create a buffer strip.
