River Habitat Surveys (RHS) and Plant Community Surveys of the River Wye SAC (Wales) in 2024 and 2025

Report No: 967
Author name: Julie Bywater, Bywater Ecology
Author affiliation: Contractor

Report series: Evidence Report
Report number: 967
Publication date: May 2026
Contract number: RHS_Wye_2025
Contractor: Julie Bywater, Bywater Ecology
Contract manager: Francesca Sanchez, Natural Resources Wales
Title: River Habitat Surveys (RHS) and Plant Community Surveys of the River Wye SAC (Wales) in 2024 and 2025.
Author(s): J. A. BYWATER
Technical editor: F. Sanchez and S. Hearn
Quality assurance: Tier 3
Peer reviewer(s): Jennifer Owen, Melissa Lacan
Approved by: R. Thomas and R. Cardwell
Restrictions: None

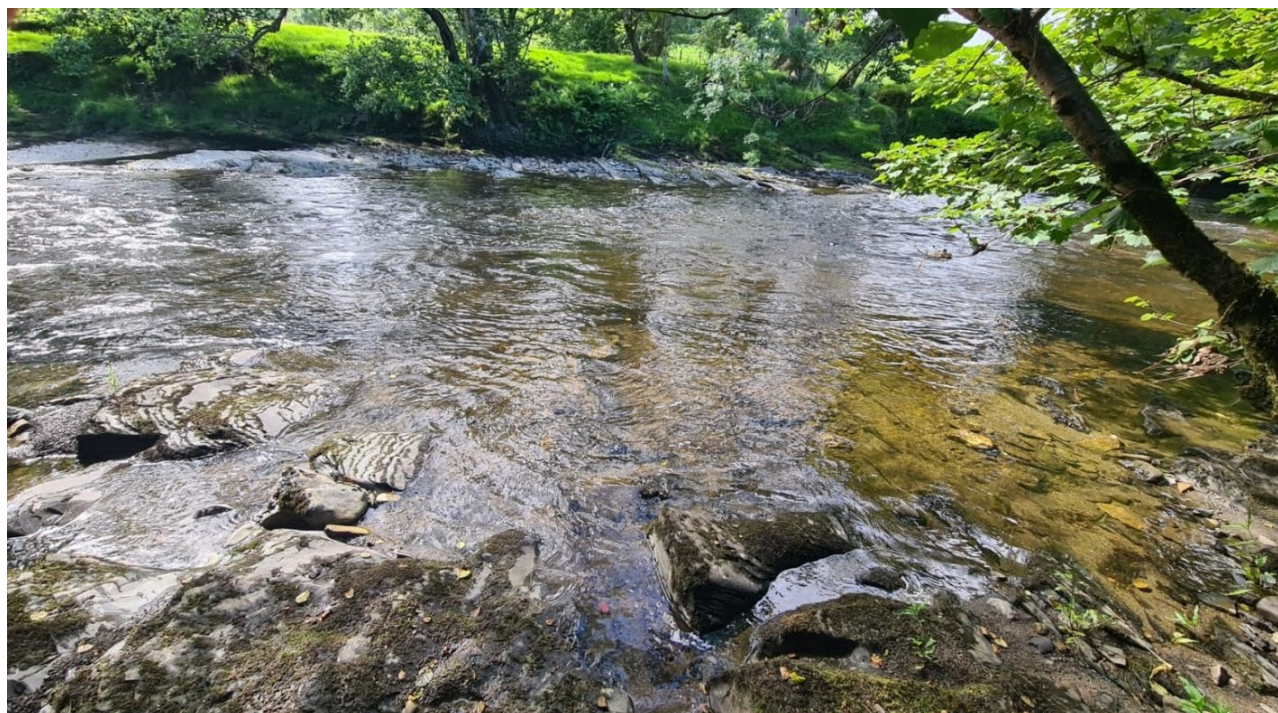
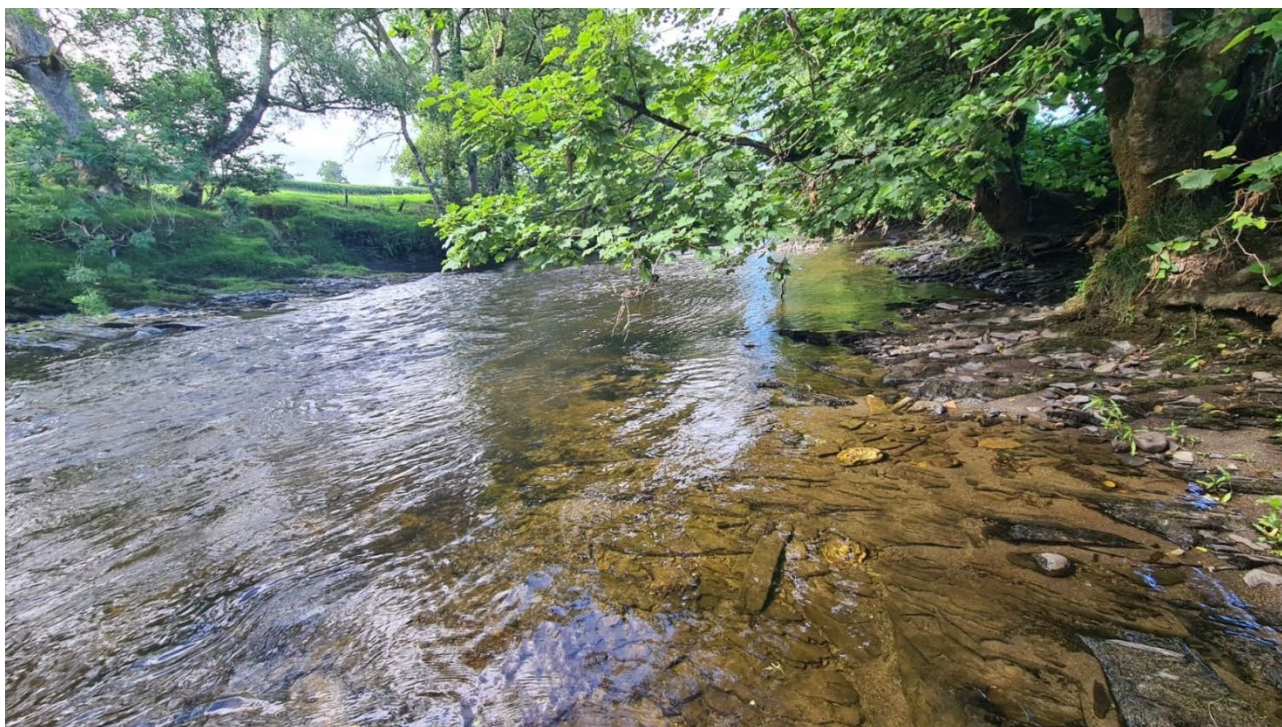
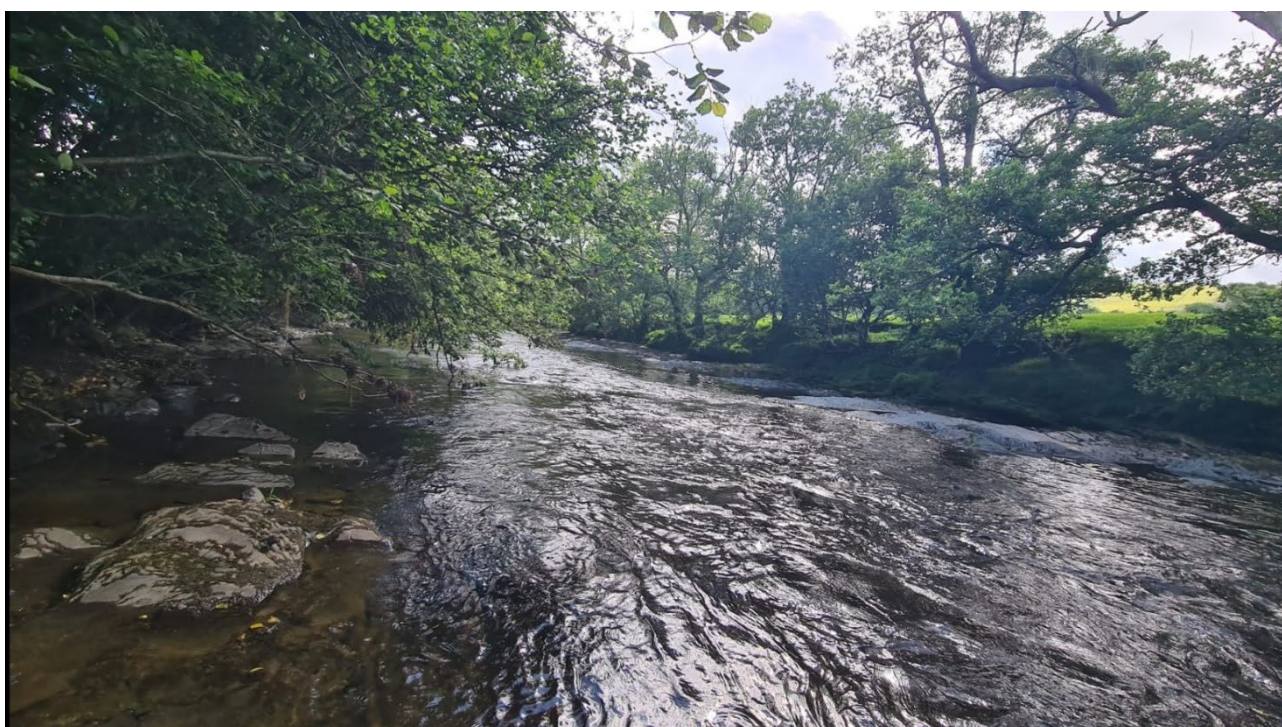
Figure 59. Photo of Irfon, Llangammarch, at the midpoint across the channel

This site midpoint was located on the River Irfon, approximately 800 m downstream of the Llangammarch Wells road-bridge, at grid reference SN9422847632. The Irfon is a major tributary of the River Wye flowing west to east in a wide, flat-bottomed valley with its confluence on the right bank. The watercourse is mostly tree lined with fields either side and patches of woodland, some on steep banks just downstream of this site, and the surrounding land was used for grazing sheep, with some wooded areas. Photographs taken at the midpoint facing across the channel, upstream and downstream are presented in figures 59, 60 and 61 respectively.

In the RHS, it was noted that the left bank was heavily poached and bare in places. The right bank had some reinforcement. The non-native invasive species Japanese Knotweed was present on the bank top and bank face, and another, Himalayan Balsam, was present on the bank face. Major impacts noted were agriculture and bank poaching.

The surrounding land was used for grazing sheep, and low scoring poor semi-improved grassland dominated the simplified phase one survey bank, with some wooded areas and good semi-improved grassland on the right bank, so the score was 2, the second lowest for the simplified Phase 1 survey. The mean ECS Score for SAC Unit 7743 (including two other sites at Irfon Halfrena and Irfon Caer Beris Builth Wells) was 3, the middle category. This unit therefore failed the target for bank vegetation naturalness.

Recommendations for this site are to control the invasive species Japanese Knotweed and Himalayan balsam, and allow the historic re-sectioning to degrade and become more naturalised, a process which is already happening at this site. Fencing set away from the left bank top if possible is also recommended to protect the bank from the heavy poaching observed.

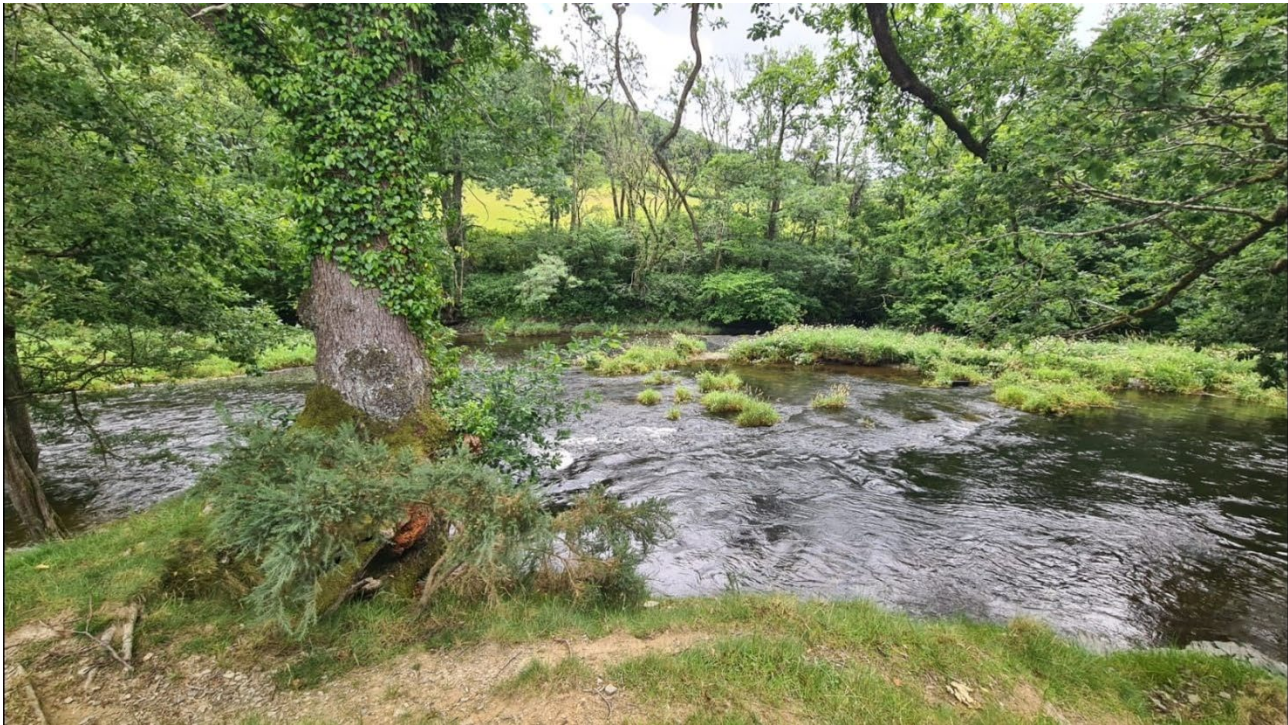
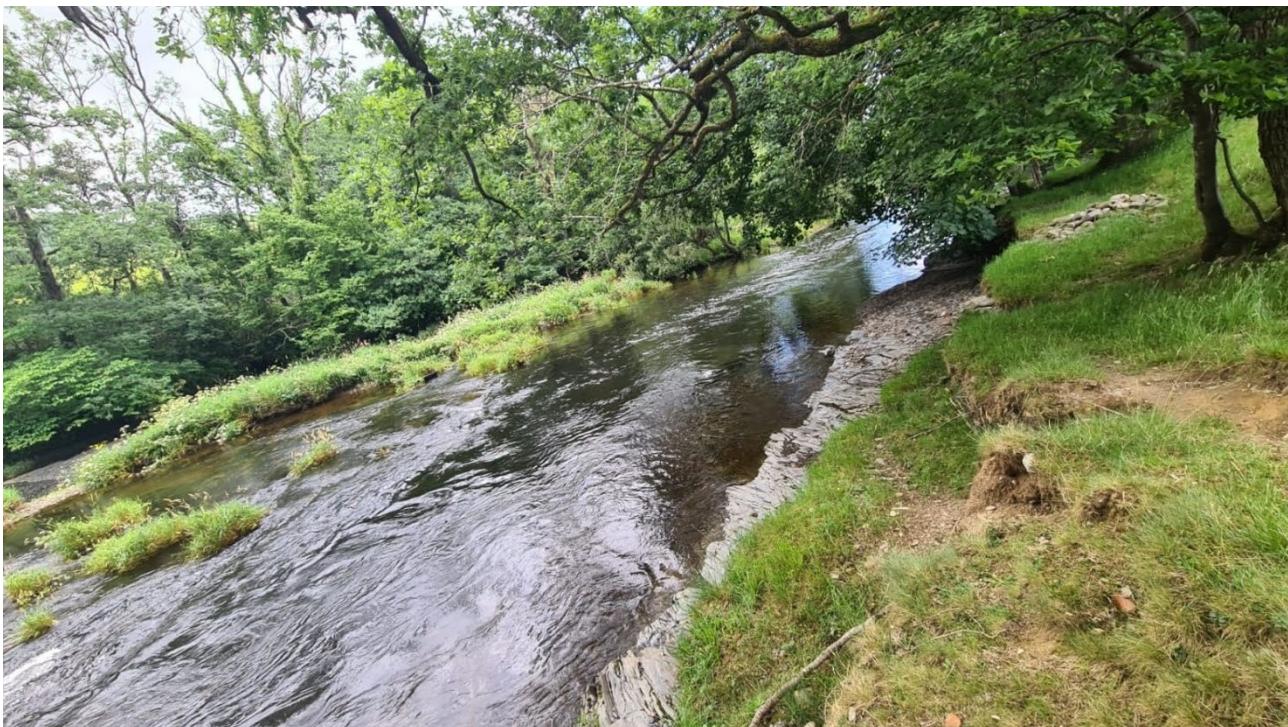
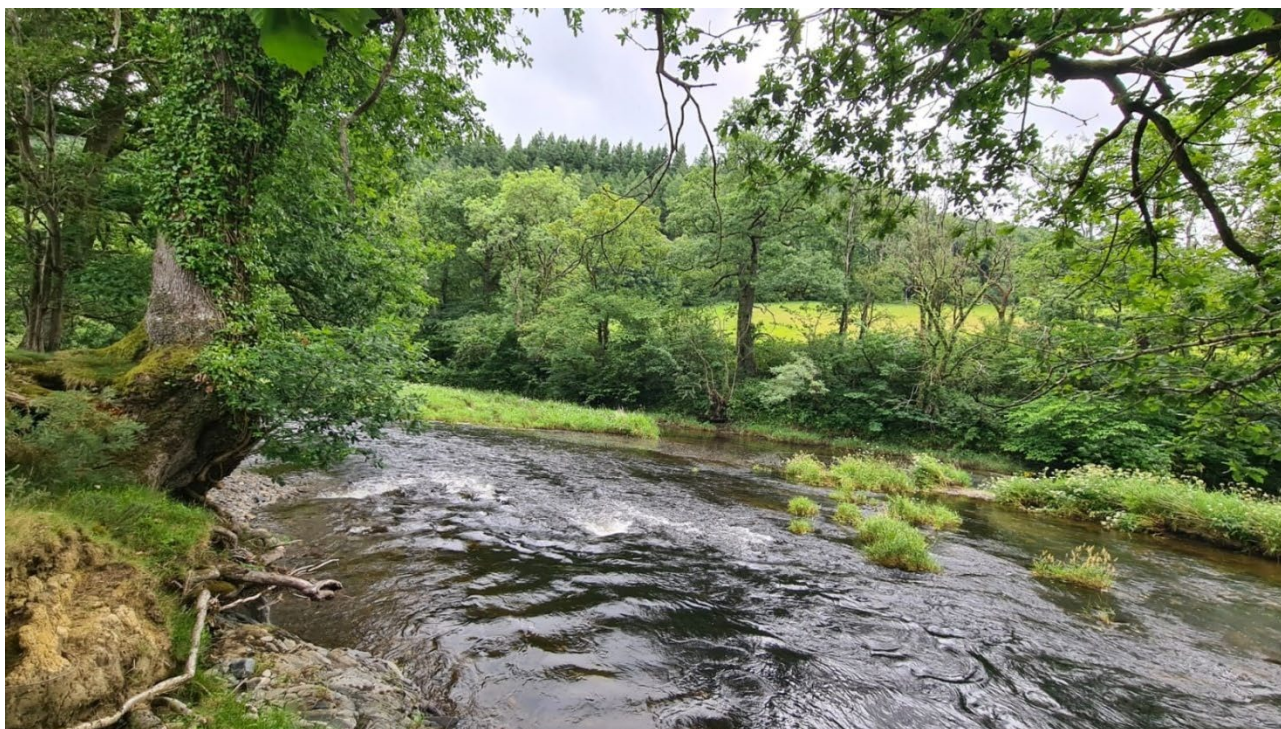
Figure 62. Photo of Irfon, u/s Halfrena, at the midpoint across the channel

The midpoint of this site was located on the River Irfon, at grid reference SN9795049195, approximately 1.5 km from the Halfrena entering the Irfon on the left bank. This site is similar in character to the previous site at Llangammarch approximately 6 km upstream. The surrounding land was used for grazing sheep, and semi-improved grassland dominated landscape on the left bank, with broadleaved woodland dominating the right bank. The water was clear compared to the previous visit in 2024 when the water was brown making viewing the bed and submerged macrophytes difficult. Photographs taken at the midpoint facing across the channel, upstream and downstream are presented in figures 62, 63 and 64 respectively.

In the RHS, the banks were recorded as natural, not re-sectioned, although the left bank may have been reshaped in the past, but there was some poaching in places. No artificial features were present. The non-native invasive species Japanese Knotweed and Himalayan balsam, were present on the bank face. Agriculture was noted as a major impact. At spot check 9, fine sediment had deposited out of suspension over the bedrock, gravel and sand. Much of channel had shallow bedrock along left bank with a deep channel in the centre. The HMS class was 2, due to poaching of the banks.

The surrounding land was used for grazing sheep, and low scoring poor semi-improved grassland dominated the simplified phase one survey on the left bank, with broadleaved woodland dominating the right bank, so the score was 3, the middle category of the simplified Phase 1 survey. The mean ECS Score for SAC Unit 7743 (including two other sites at Irfon Llangammarch and Irfon Caer Beris Builth Wells) was 3, the middle category. This unit therefore failed the target for bank vegetation naturalness.

Recommendations for this site are to control the invasive species Japanese Knotweed and Himalayan balsam, and allow the historic re-sectioning to degrade and become more naturalised, a process which is already happening at this site. Fencing, set away from the bank tops if possible, is also recommended to protect the bank from the heavy poaching observed. In addition, management of run off into the catchment is recommended to reduce the sediment load in the watercourse.

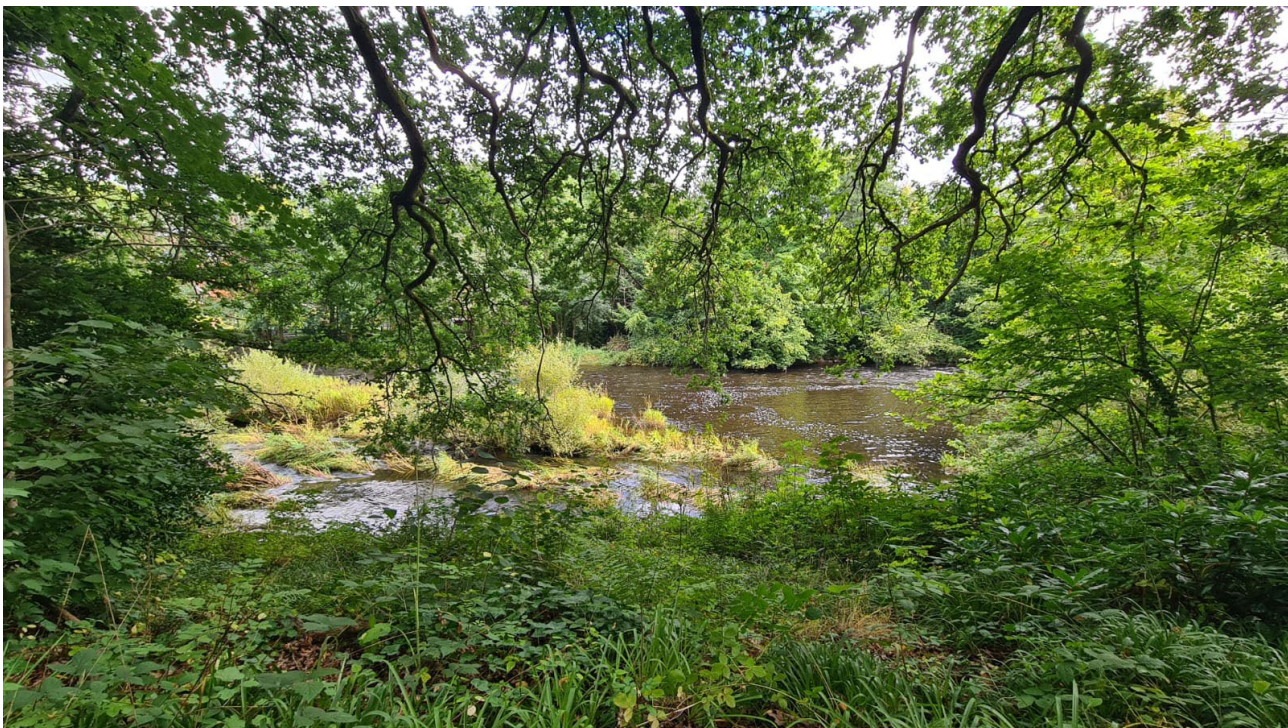
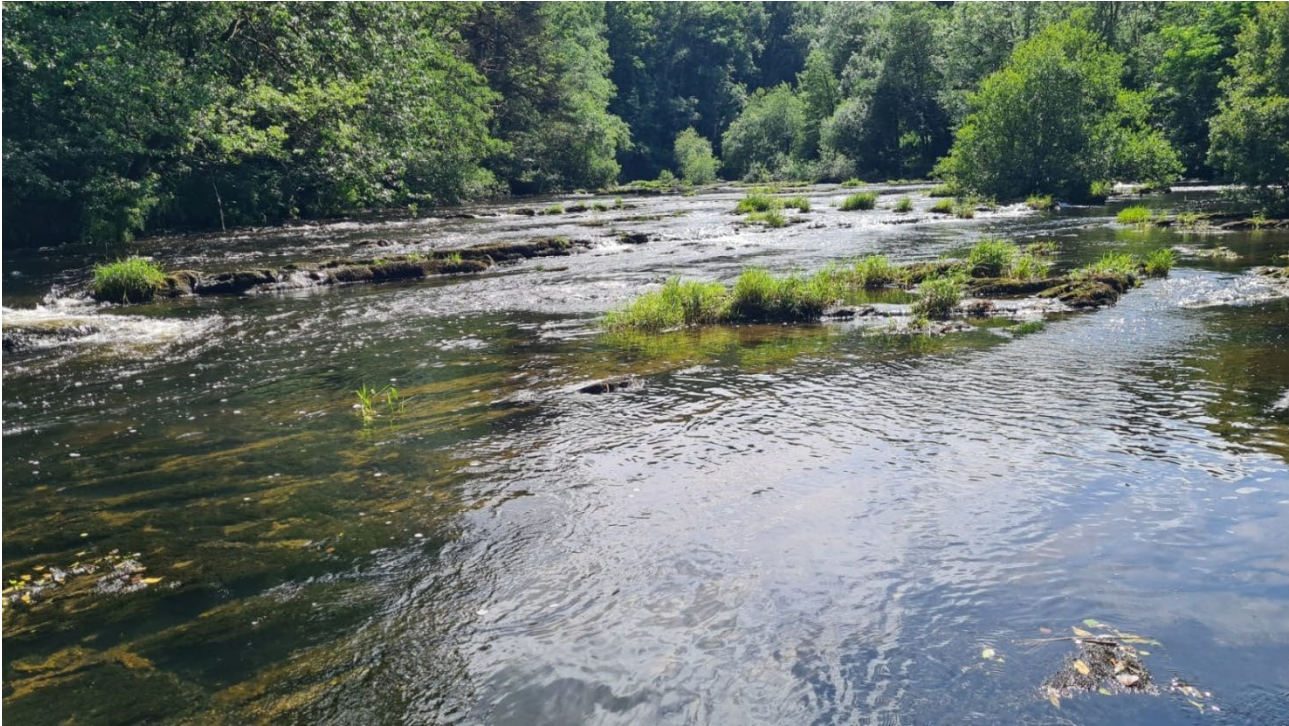
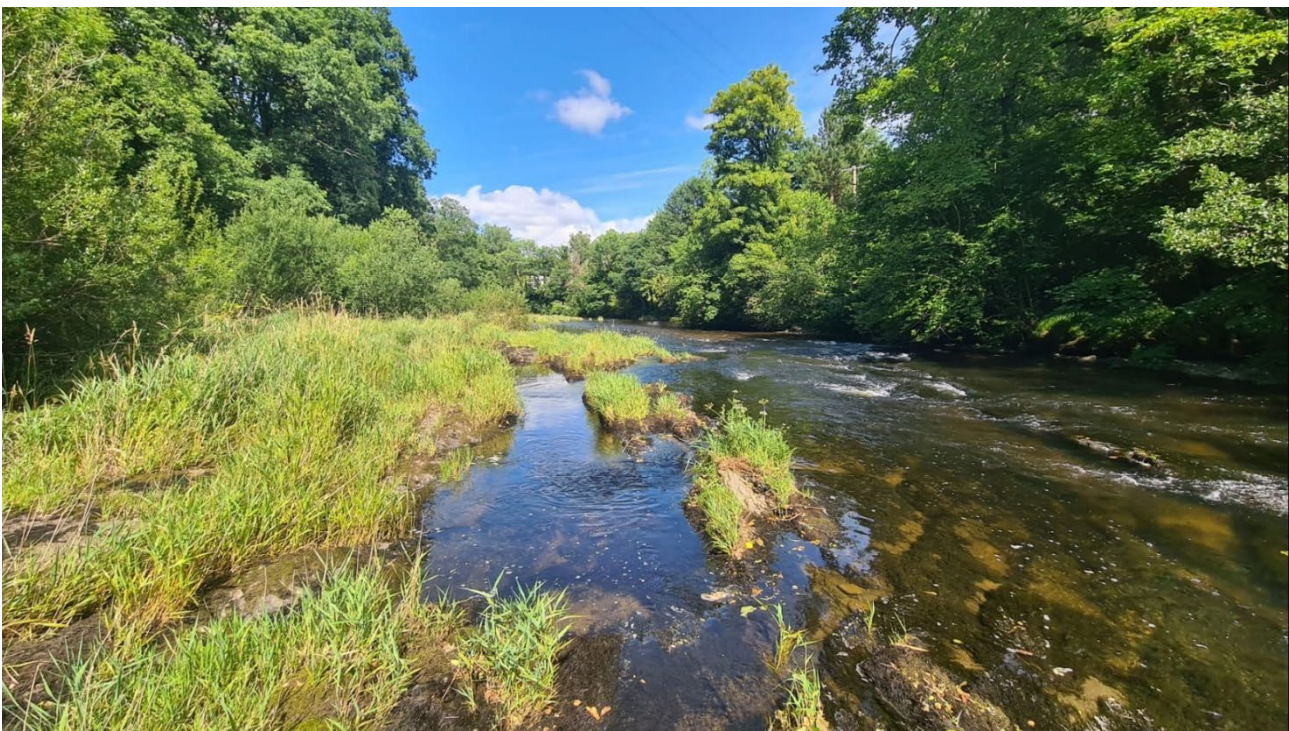
Figure 65. Photo of Irfon, Caer Beris Builth Wells, at the midpoint across the channel

This site midpoint was located on the River Irfon, at Caer Beris to the west of Builth Wells, at grid reference SO0309250698. There were wooded areas on the banks with amenity grassland beyond this in addition to the urban encroachment of Builth Wells around this sinuous section in the lower reaches of the watercourse which had areas of exposed bedrock. Photographs taken at the midpoint facing across the channel, upstream and downstream are presented in figures 65, 66 and 67 respectively.

In the 500 m RHS, the banks were mainly recorded as natural, not re-sectioned, although the left bank may have been reshaped in the past, but there was some poaching in places and a small amount of re-sectioning and reinforcement at the downstream end resulted in an HMS class of 2, although no artificial features were present. The alien invasive species Japanese Knotweed and Himalayan balsam were present on the bank face. Agriculture was noted as a major impact.

Broadleaved woodland dominated both banks, so the score was 5, the highest category of the simplified Phase 1 survey. However, beyond this, both banks had amenity grassland in the upstream section of the survey, and there was suburban development on the right bank in the downstream section. However, the mean ECS Score for SAC Unit 7743 (including two other sites at Irfon Llangammarch and Irfon Halfrena) was 3, the middle category. This unit therefore failed the target for bank vegetation naturalness.

Recommendations for this site are to control the invasive species Japanese knotweed and Himalayan balsam.

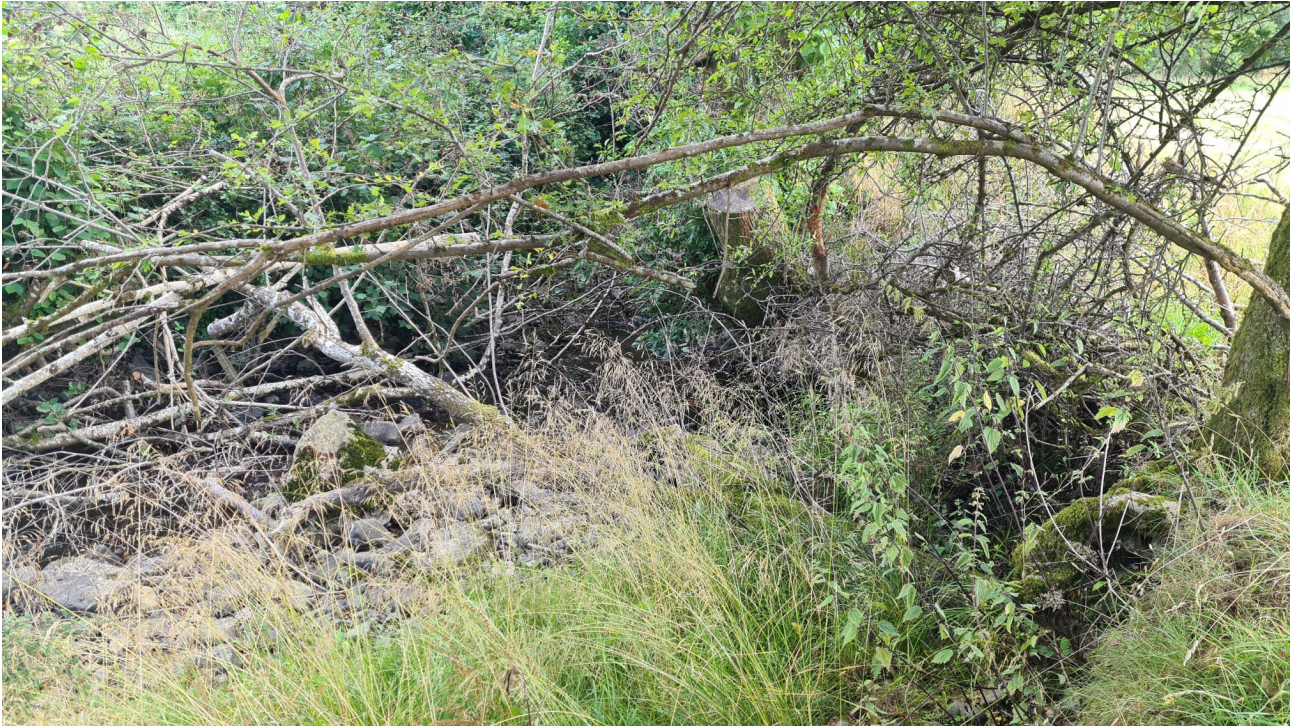
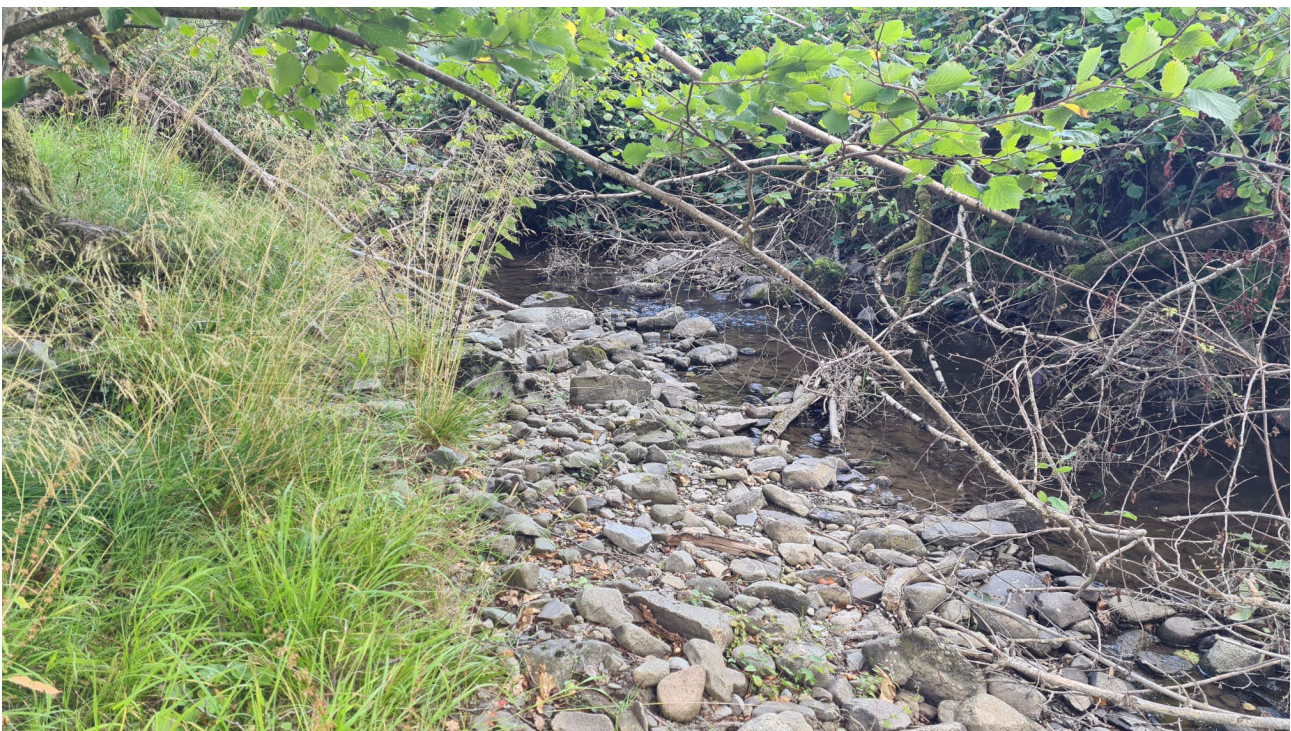
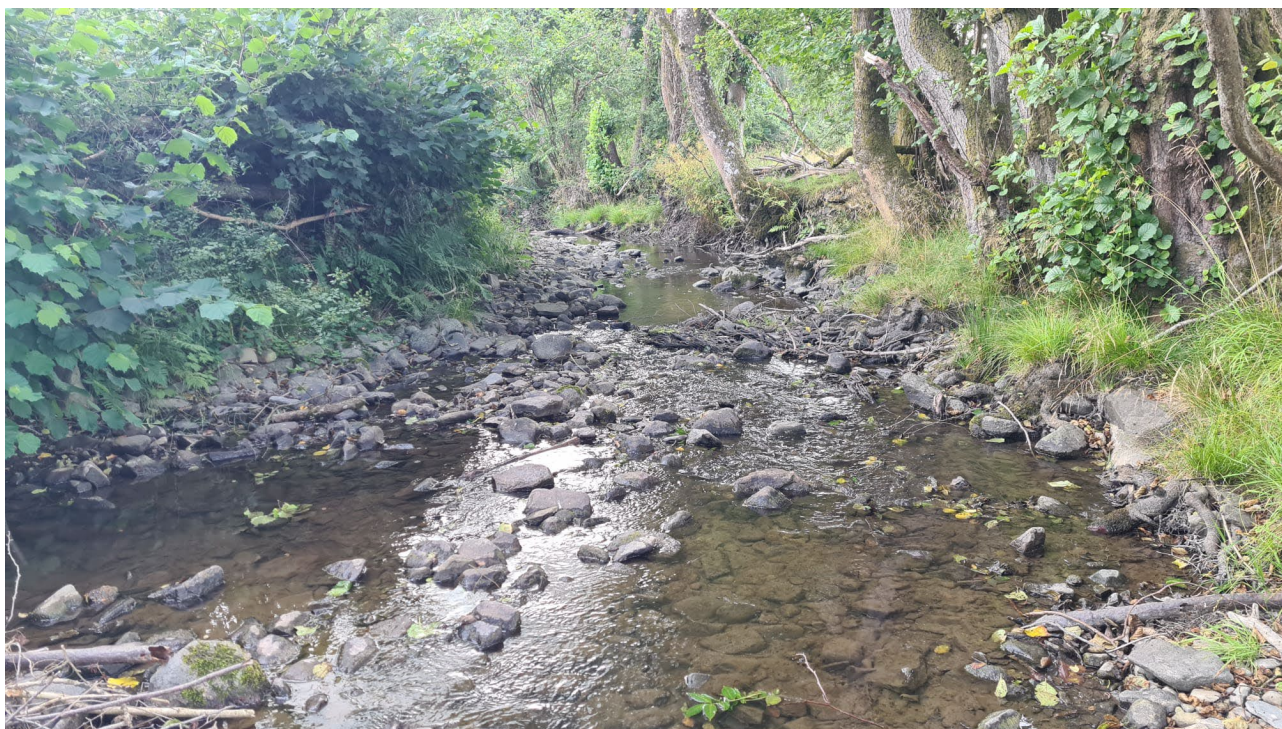
Figure 68. Photo of Dulas Brook, Cwmbach, at the midpoint across the channel

This site was located approximately 300 m upstream of Cwmbach Bridge on the Dulas Brook, a tributary of the River Wye, at grid reference SO0313254121. The brook is small with a boulder/cobble bed flowing mainly through woodland in this reach with tree lined banks where it flows through fields. There is a railway running alongside to the west of the brook and a few scattered farm buildings. Photographs taken at the midpoint facing across the channel, upstream and downstream are presented in figures 68, 69 and 70 respectively.

The banks had mainly broken shade with some dense shade from tree cover on the right bank but only 30 % broken and dense shade combined on the left bank. There was woody debris from tree cutting dumped in the channel at the midpoint of the survey. The surrounding land was used for pasture with some farm buildings.

Fine silt and diatoms were noted coating rocks and the channel bed in a fine layer so the form of the substrate could still be seen beneath. There were very little filamentous algae, some moss, but no higher plants in channel although some narrow leaved and broad leaved macrophytes were present on the sidebar and bank face. Six species of bryophyte were recorded and five types of algae including a red thalloid algae (*Hildenbrandia rivularis*).

In the RHS survey, artificial features included a minor bridge, a minor weir and a ford. There was some localized bank re-sectioning noted, an area of embankment, and poaching of the banks was recorded, with bare bank in places, but most of the bank was considered to be natural with various features including stable and eroding cliffs, sidebars and point bars. The HMS class was 3, mainly due to the artificial features recorded.

The surrounding land is used for agriculture, and the presence of poor improved grassland and some bracken meant the simplified Phase 1 score was 3, moderate, despite the presence of broad-leaved woodland. As this site was the only survey in the SAC Unit 7734, the mean ECS Score was also 3, the middle category. This unit therefore failed the target for bank vegetation naturalness.

Fencing in places, set away from the bank top to allow a natural strip of vegetation would reduce the bank poaching, and maybe also reduce the siltation seen in the channel.

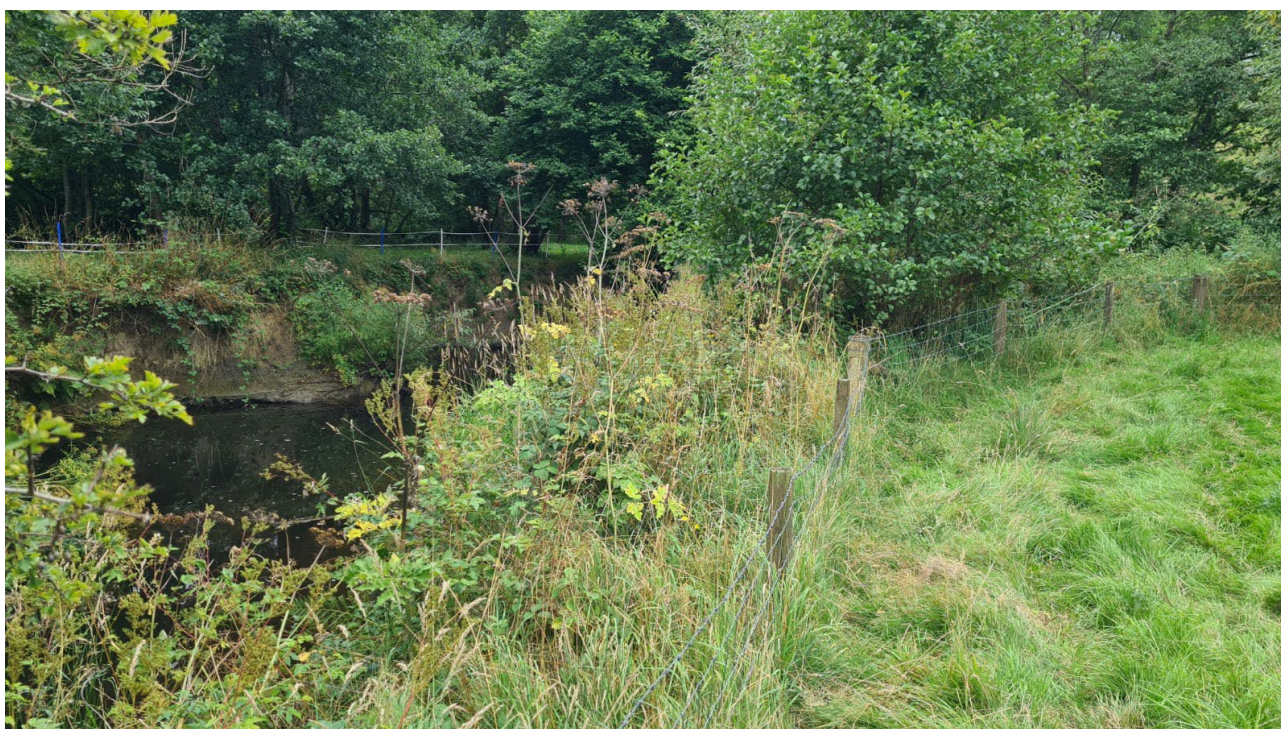
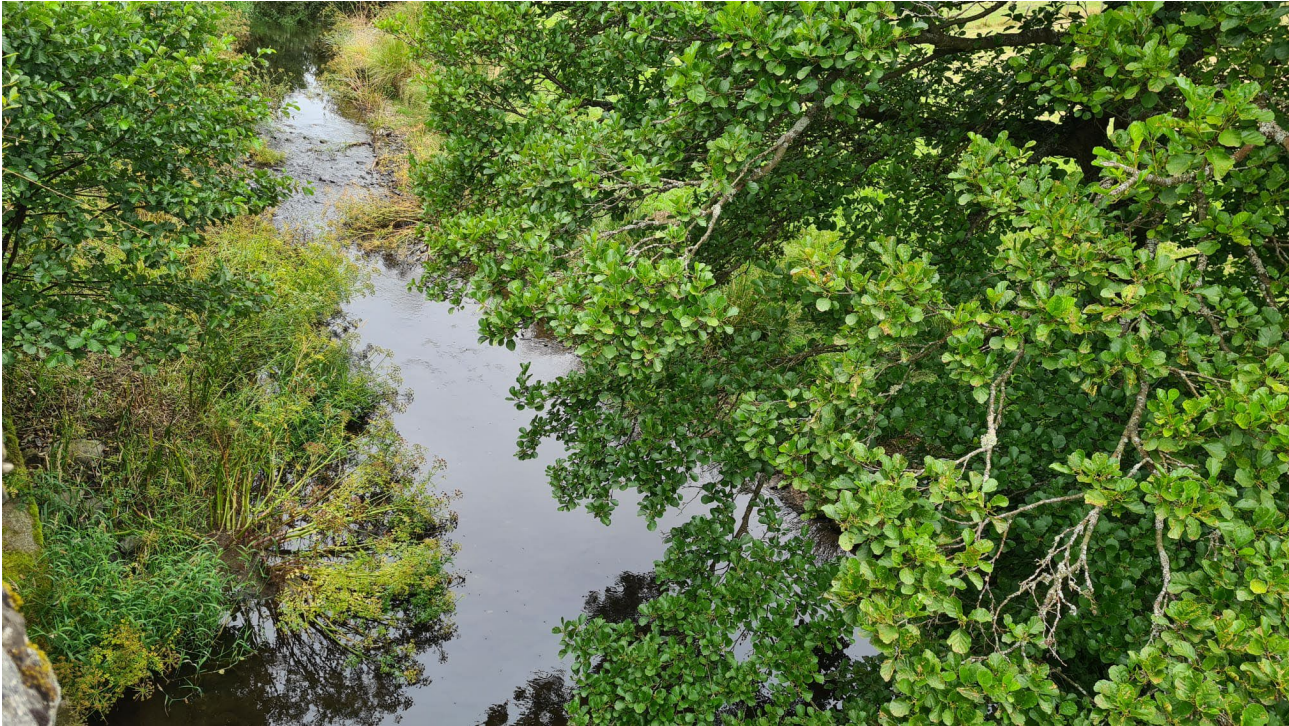
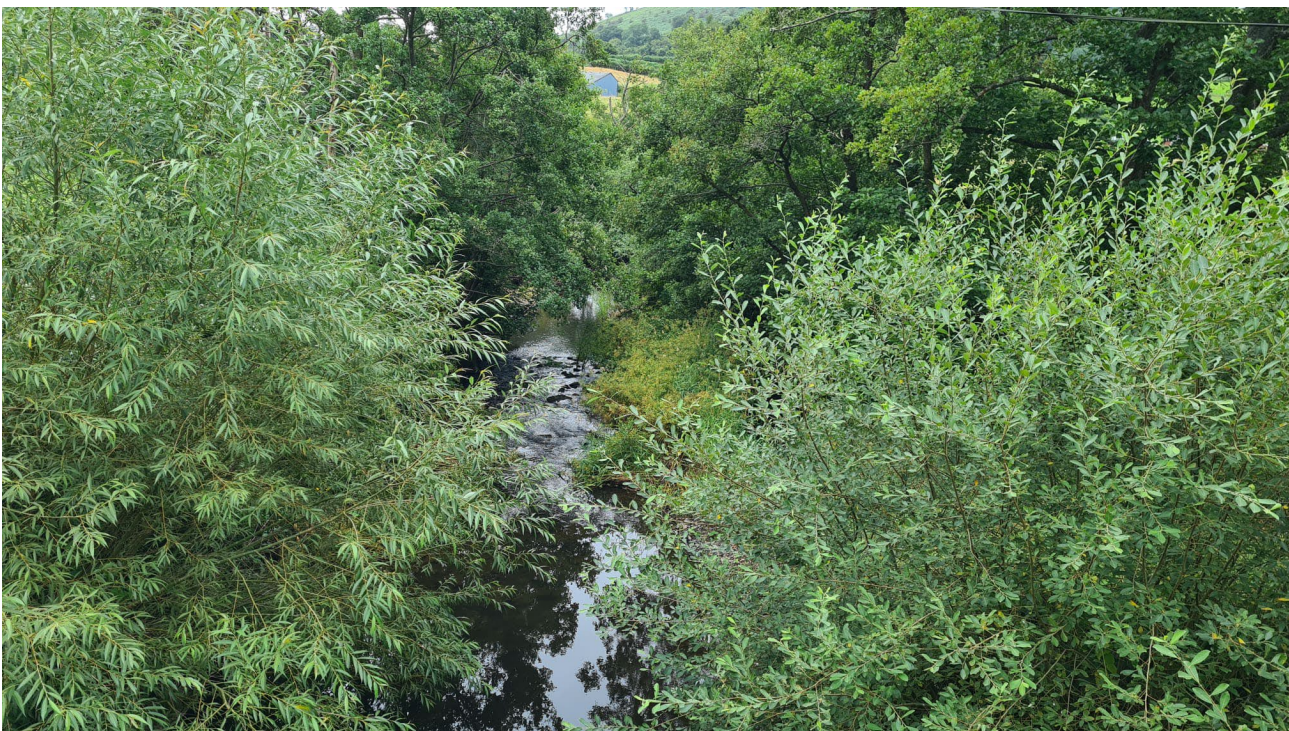
Figure 71. Photo of Edw, Cregrina, at the midpoint facing downstream

The proposed monitoring site midpoint was located approximately 200 m upstream of a road bridge at grid reference SO1248252989. This location was used as the midpoint for the RHS, but the macrophyte monitoring site was moved to the downstream end of the survey length to grid reference SO1245753167 because the site monitored in 2012 was fenced on both banks and had steep eroding cliffs, which combined with high flows meant access was not possible. The Edw is a small sinuous tree-lined watercourse in a field covered sloping valley with mountains further out either site. It flows into the Wye on the left bank. Photographs taken at the midpoint facing downstream, and from the road bridge facing upstream and downstream are presented in figures 71, 72 and 73 respectively.

bank. The banks were mostly unshaded with some broken and dense shading on the left, and 50 % broken and dense shading on the right. There was very little macrophyte cover, with low cover of 6 species of bryophytes including St Winifrid's moss liverwort (*Chiloscyphus polyanthos*), but no water crowfoot (*Ranunculus sp.*) or other submerged vascular plants. There were a few emergent tall grasses and herbs, mainly hemlock water-dropwort (*Oenanthe crocata*). There was a low cover of filamentous algae observed in the monitoring site, approximately 4 % and the red algae *Hildenbrandia rivularis* was present.

In the longer RHS reach, the banks were considered to be natural with the only re-sectioning associated with a minor road bridge which was the only artificial feature recorded. No poaching of the banks was observed, probably due to the fencing. The vegetation groups present were bryophytes, emergent broad-leaved herbs, emergent reeds/sedges/rushes, free floating and filamentous algae. Himalayan balsam was present on both the bank face and the bank top. The HMS class was 2 due to the presence of a road bridge with its associated bank reinforcement. Historic re-sectioning at the downstream end was considered to be re-naturalised.

In the simplified Phase 1, the Evaluated Corridor Section (ECS) Score was 4, the second highest category because of the presence of trees, and unimproved and semi-improved grassland, but there was also some poor semi-improved grassland. The surrounding land was used for sheep grazing. As this site was the only survey in the SAC Unit 7737, the mean ECS Score was also 4, the second highest category. This unit therefore passed the target for bank vegetation naturalness.

Whilst there is fencing at this site and consequently no bank poaching was present, creation of a wider river corridor by moving the fencing away from the bank top to allow ungrazed vegetation to grow would be considered beneficial.

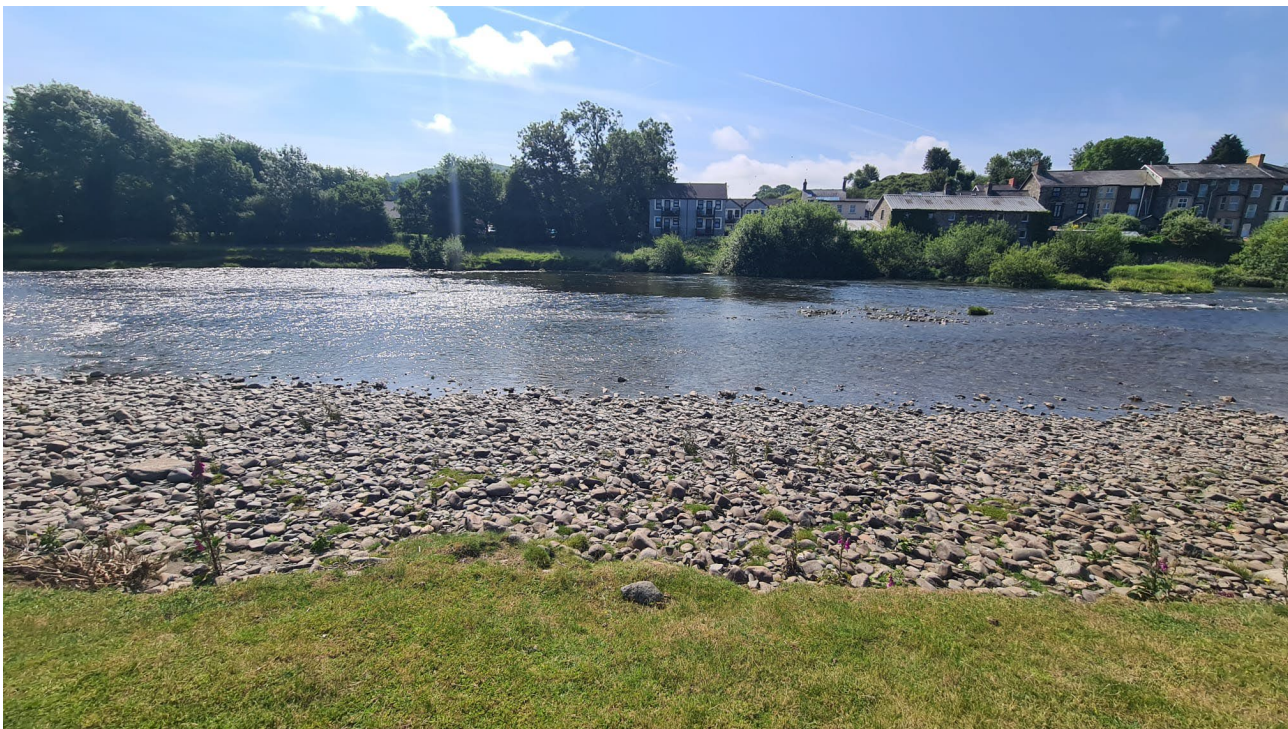
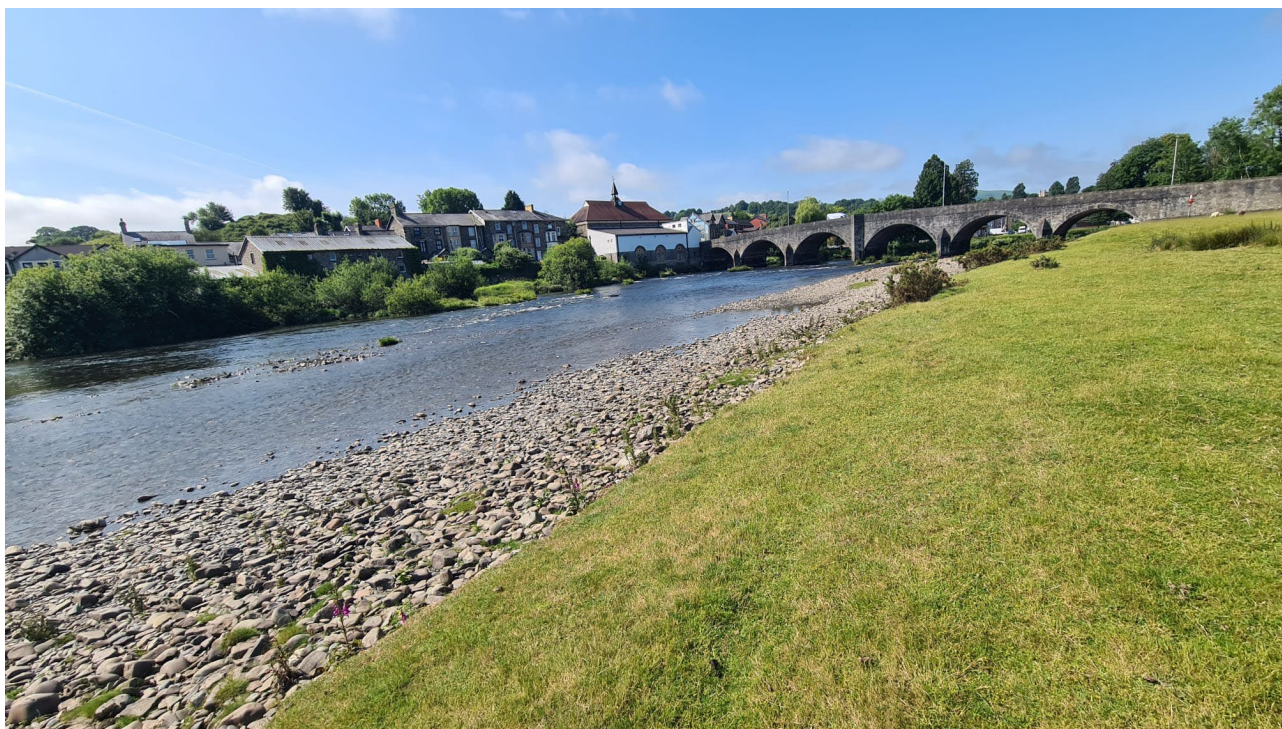
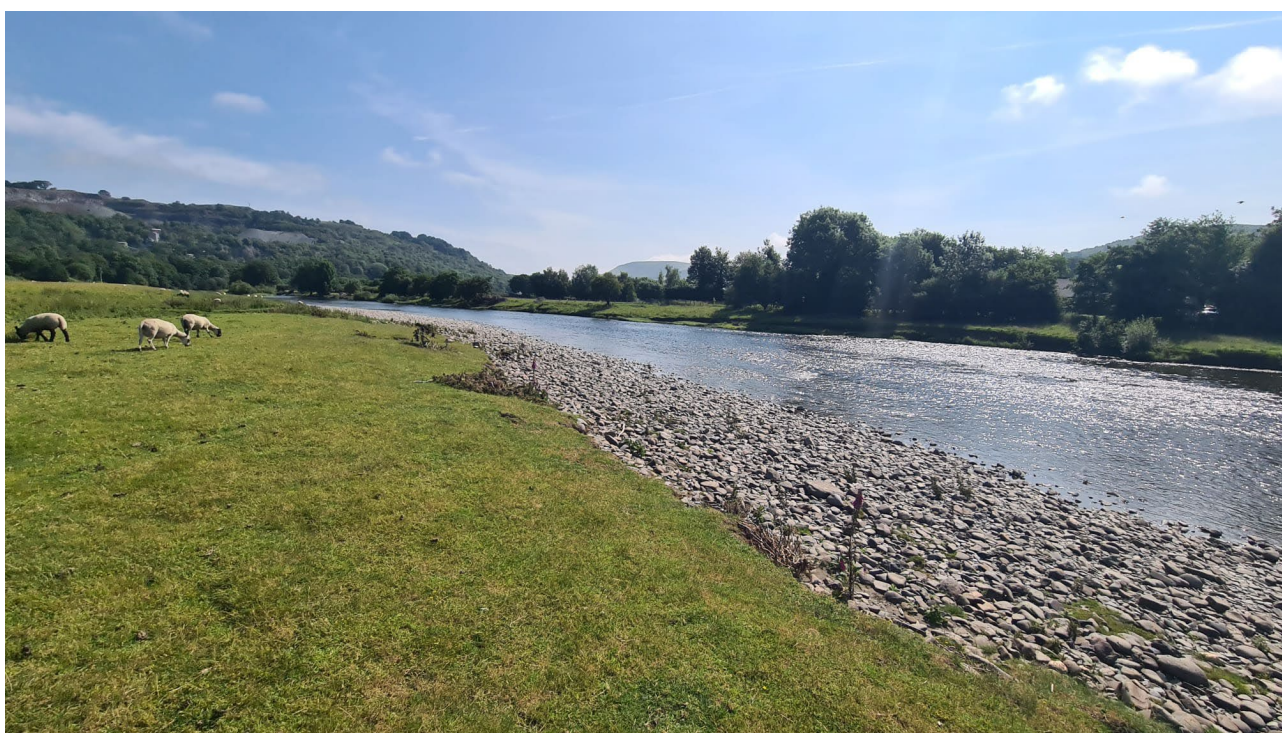
Figure 74. Photo of Wye, Builth Wells, at the midpoint across the channel

The midpoint of this survey site was located approximately 450 m downstream of the A483 road bridge on the River Wye and 1.3 km downstream of the Irfon confluence, at grid reference SO0450051500. The Builth showground is to the north and Builth Wells is to the south west. This section of the River Wye in mid Wales appears to have been straightened. The surrounding land was used for sheep grazing, with a sewage treatment works on the right bank, and urban development including a road bridge just upstream. Photographs taken at the midpoint facing across the channel, upstream and downstream are presented in figures 74, 75 and 76 respectively.

The channel in the 100 m macrophyte survey was approximately 65 m wide with no trees shading the left bank but some broken shade on the right bank. The river bed was dominated by a cobble, gravel/pebble, the flow was mainly run habitat with riffle flow, and the water was clear with no turbidity or discolouration observed. There was a vegetated mid-bar in the channel from downstream of the midpoint to beyond the downstream limit. The water was mainly in the less than 0.25 m and 0.25 – 0.5 m depth categories, lower than when the site was visited in 2024, and most of the channel was wadable.

Filamentous algae was observed covering approximately 2 % of the channel, with two large patches observed, one at the upstream end near the left bank, and one in a shallow area adjacent to the mid bar. The red algae (*Hildenbrandia rivularis*) was present and there were a few species of bryophyte. A number of small stands of stream water-crowfoot (*Ranunculus penicillatus* subsp. *pseudofluitans*) were establishing throughout the survey area upstream of the mid bar. Nine species of emergent macrophyte were present along the left bank in a thin strip and there were a few patches on right bank. Himalayan balsam was present.

The channel was probably over widened but the bed was fairly natural, so it was not recorded as re-sectioned in the River Habitat Survey. Brown diatoms/algae were noted as covering most of channel, but there was very little filamentous algae or *Ranunculus* sp. seen throughout the 500 m length. Emergent reeds/grasses sedges were present all along the left bank in a thin strip and there were patches on right bank. There was ungrazed grass on the left bank face with tall herbs, and short grass on bank tops for most of survey length. Himalayan balsam was present on the bank face and the bank top at this site. The HMS class was 3 due mainly to historic realignment of the channel. The banks were considered to be becoming naturalised despite the presence of historic re-sectioning, and there were no artificial features or bank reinforcement recorded.

In the simplified Phase 1 the score for this site was 1, as the surrounding land was used for sheep grazing, with a sewage treatment works on the right bank, and urban development including a road bridge just upstream. The mean ECS Score for SAC Unit 7729 (including four other sites at Wye Erwood, Wye Llanstephan, Wye Boughrood and Wye Glasbury) was 3, the middle category. This unit therefore failed the target for bank vegetation naturalness.

Recommendations for this site are to control the invasive Himalayan balsam, and allow the historic resectioning to degrade and become more naturalised, or recreate a more varied bank profile as appropriate.
