River Habitat Surveys (RHS) and Plant Community Surveys of the River Wye SAC (Wales) in 2024 and 2025

Report No: 967
Author name: Julie Bywater, Bywater Ecology
Author affiliation: Contractor

Report series: Evidence Report
Report number: 967
Publication date: May 2026
Contract number: RHS_Wye_2025
Contractor: Julie Bywater, Bywater Ecology
Contract manager: Francesca Sanchez, Natural Resources Wales
Title: River Habitat Surveys (RHS) and Plant Community Surveys of the River Wye SAC (Wales) in 2024 and 2025.
Author(s): J. A. BYWATER
Technical editor: F. Sanchez and S. Hearn
Quality assurance: Tier 3
Peer reviewer(s): Jennifer Owen, Melissa Lacan
Approved by: R. Thomas and R. Cardwell
Restrictions: None

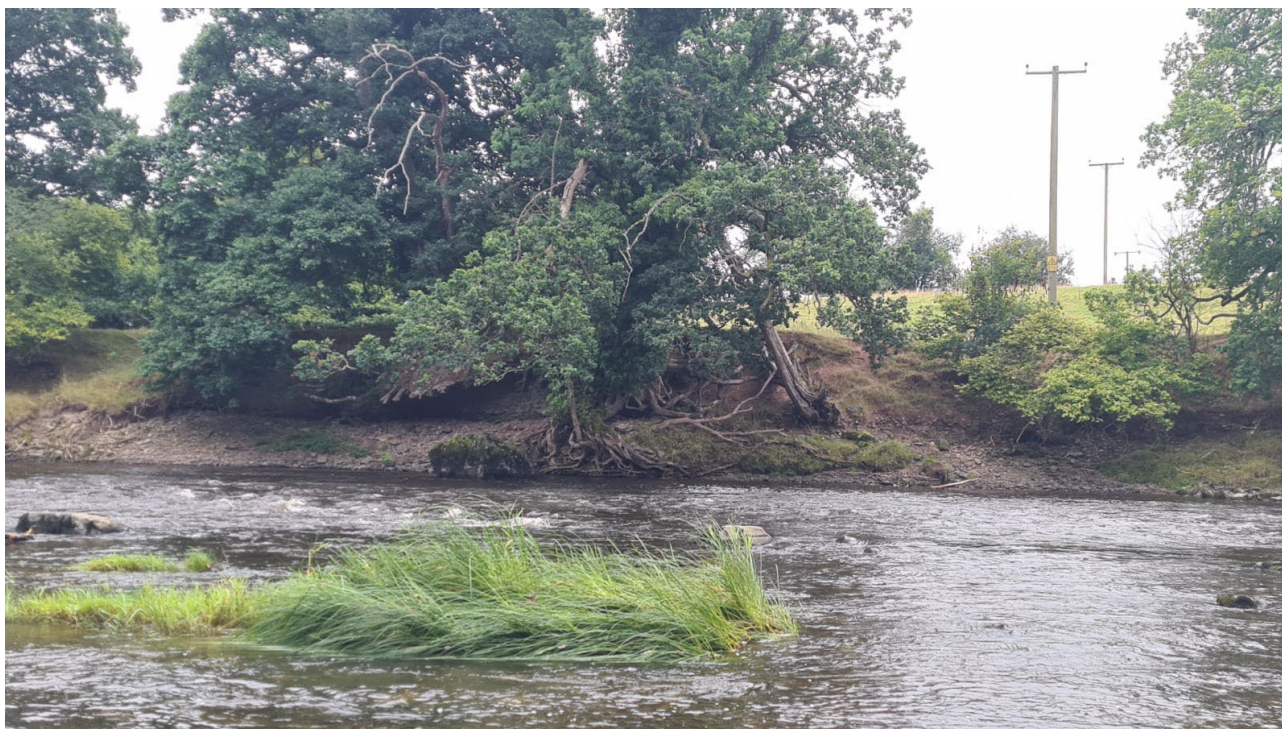
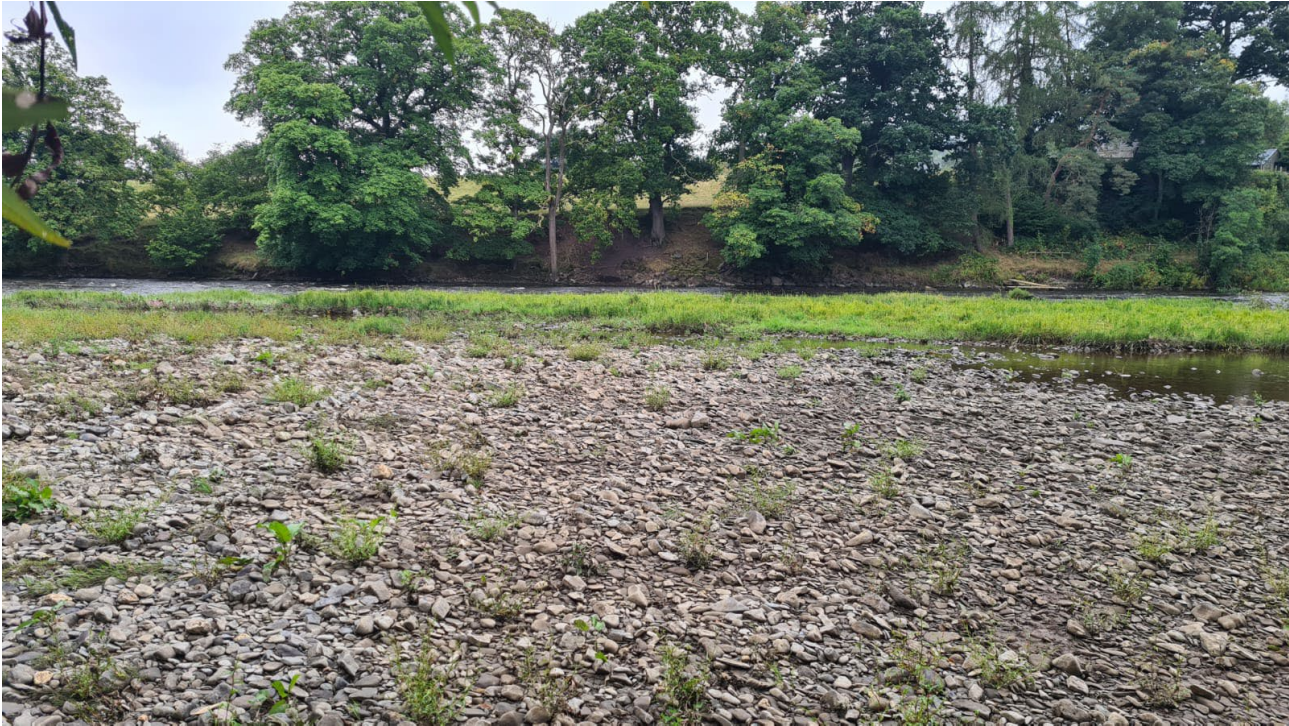
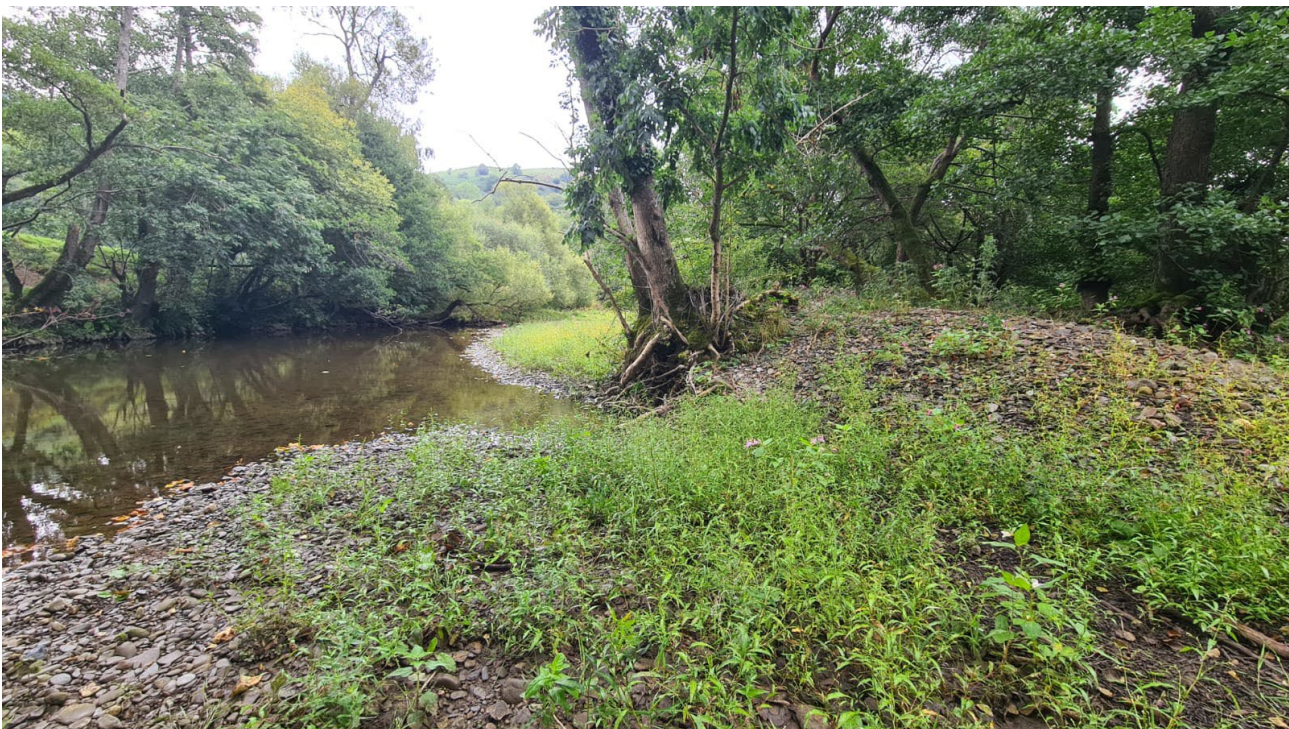
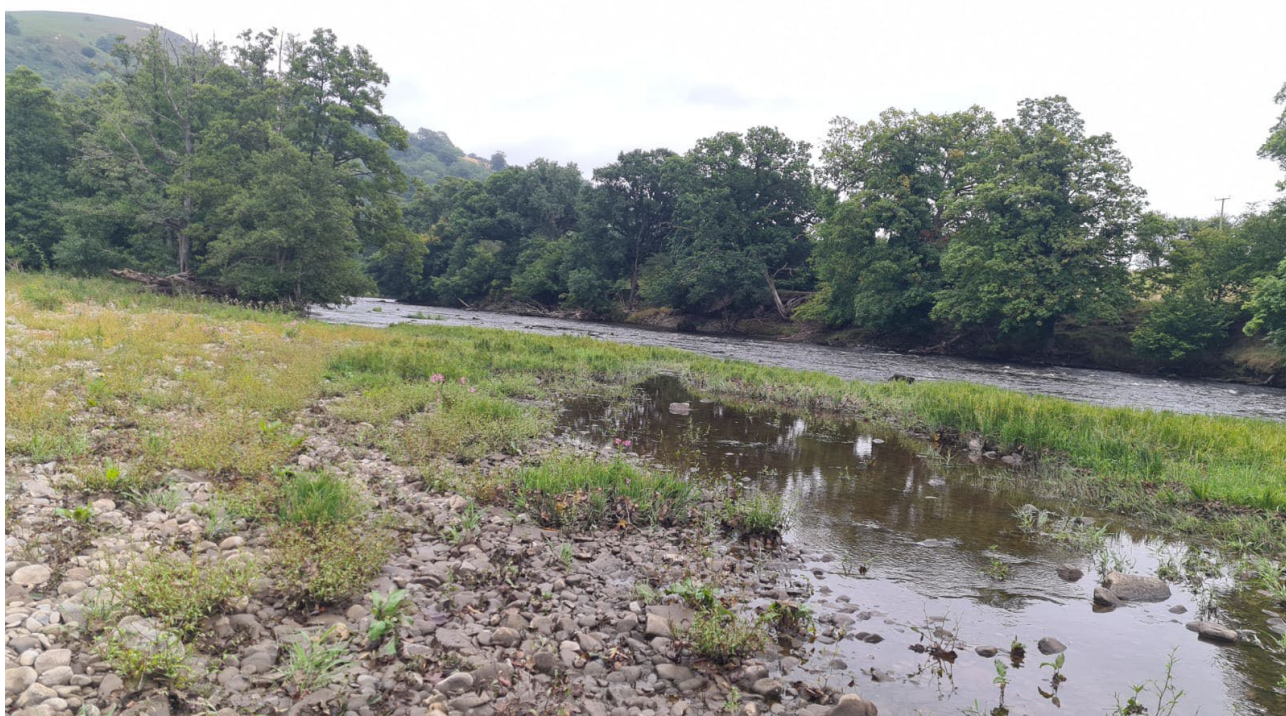
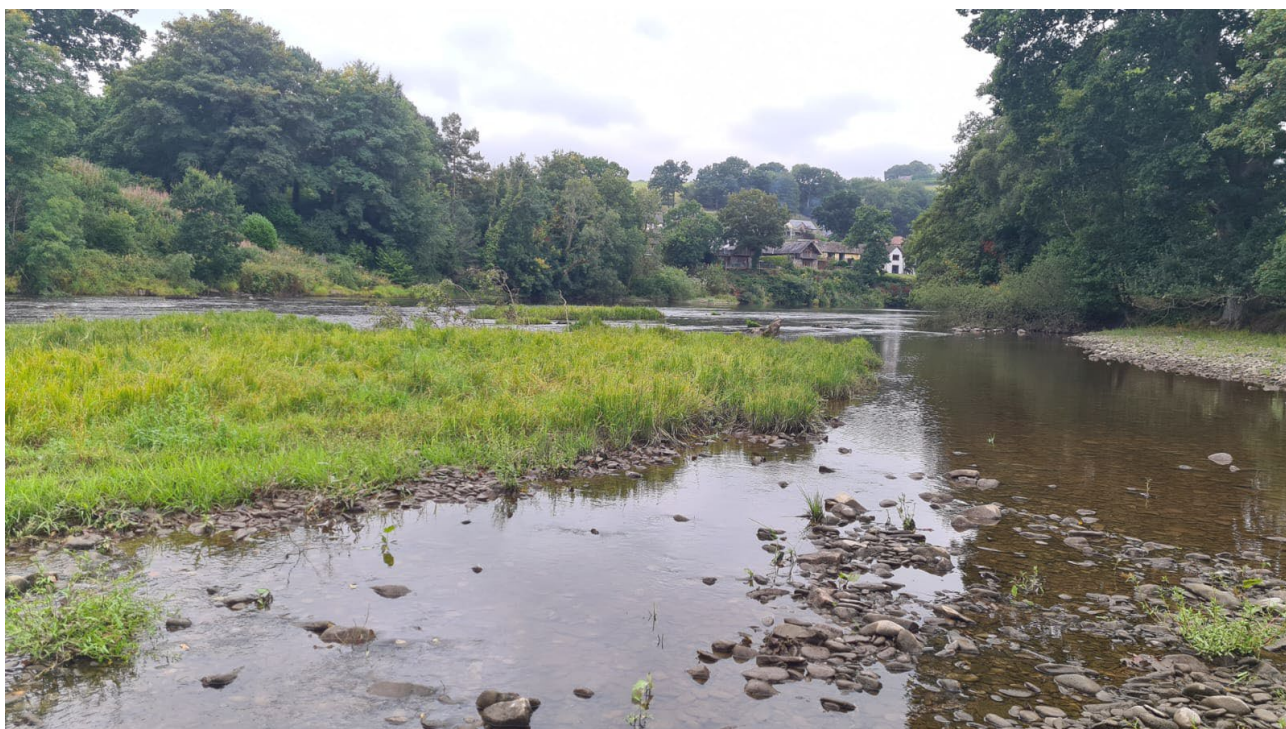
Figure 77. Photo of Wye, Erwood, at the midpoint across the channel (1)

The monitoring site midpoint was at Erwood on the River Wye, approximately 12 km downstream of Builth Wells at grid reference SO0980043300. This section of the River Wye lies in a valley with numerous small tributaries flowing down from the steep hills either side of the valley, including the Cletwr Brook which flows through a wooded valley and has its confluence at Erwood. Broadleaved woodland and grazing pasture were present along the banks. Beyond this, was agricultural use and suburban development, sometimes up to the edge of the bank top, on the right bank. Two photographs taken at the midpoint are presented in figures 77, 78, one of the areas behind the sidebar in figure 79, and photographs facing upstream and downstream are presented in figures 80 and 81 respectively.

The non-native invasive species Japanese knotweed seen in 2024 was not recorded on this visit, but Himalayan balsam was present on the bank face. Agriculture and bank poaching were noted as major impacts.

Control of the invasive species Himalayan balsam is recommended at this site. It is also recommended that the historic resectioning is allowed to continue to degrade and become more naturalised, a process which is already happening at this site. Fencing, set away from the bank top if possible, is also recommended to protect the bank from the poaching observed.

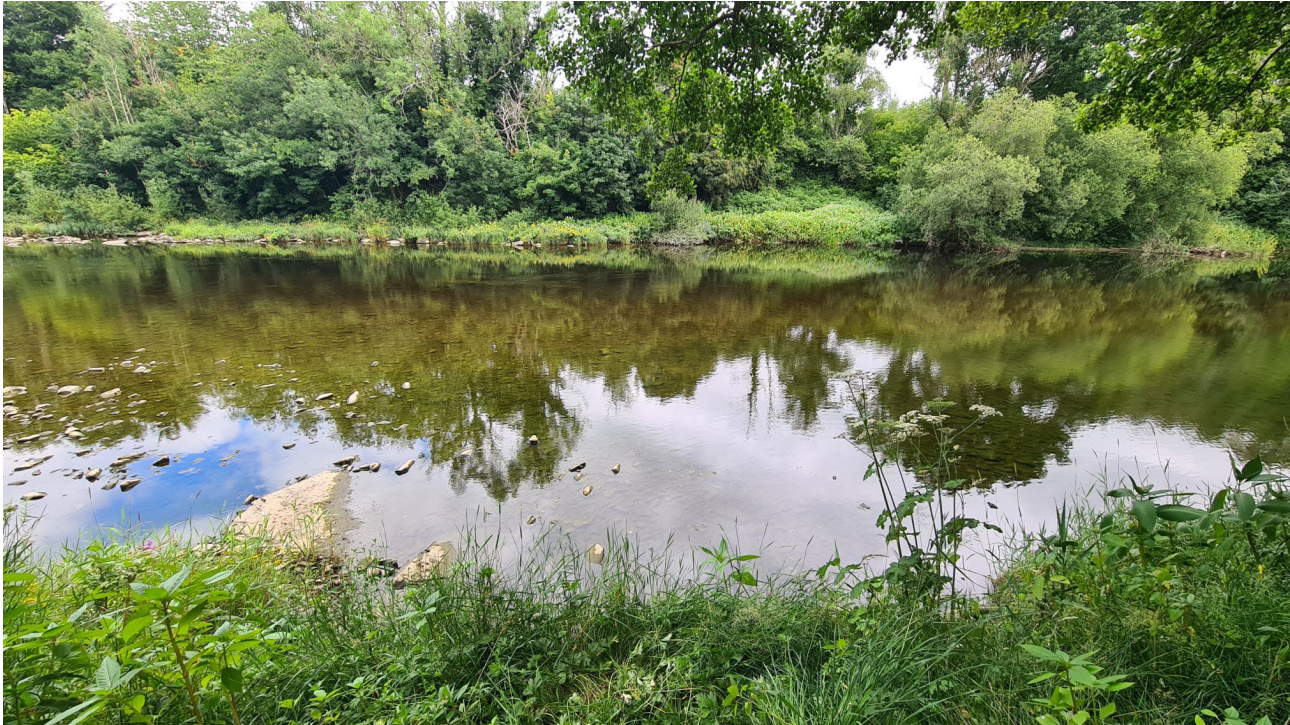
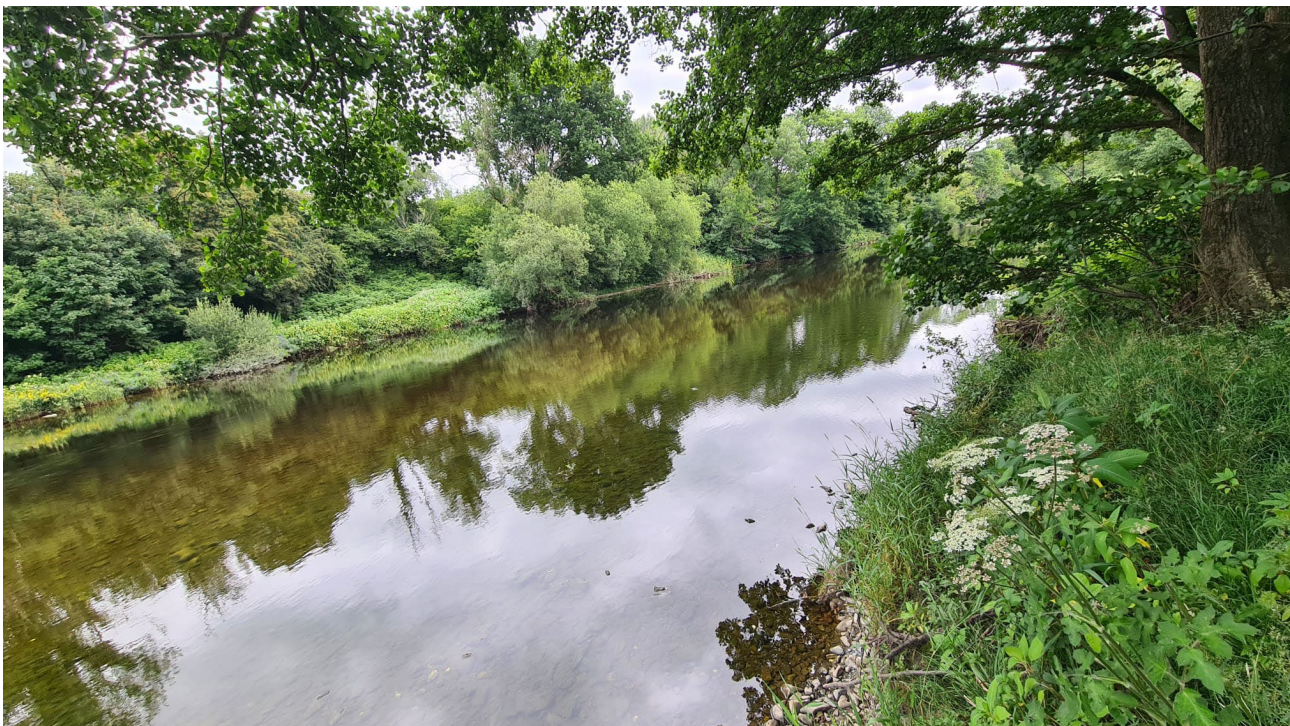
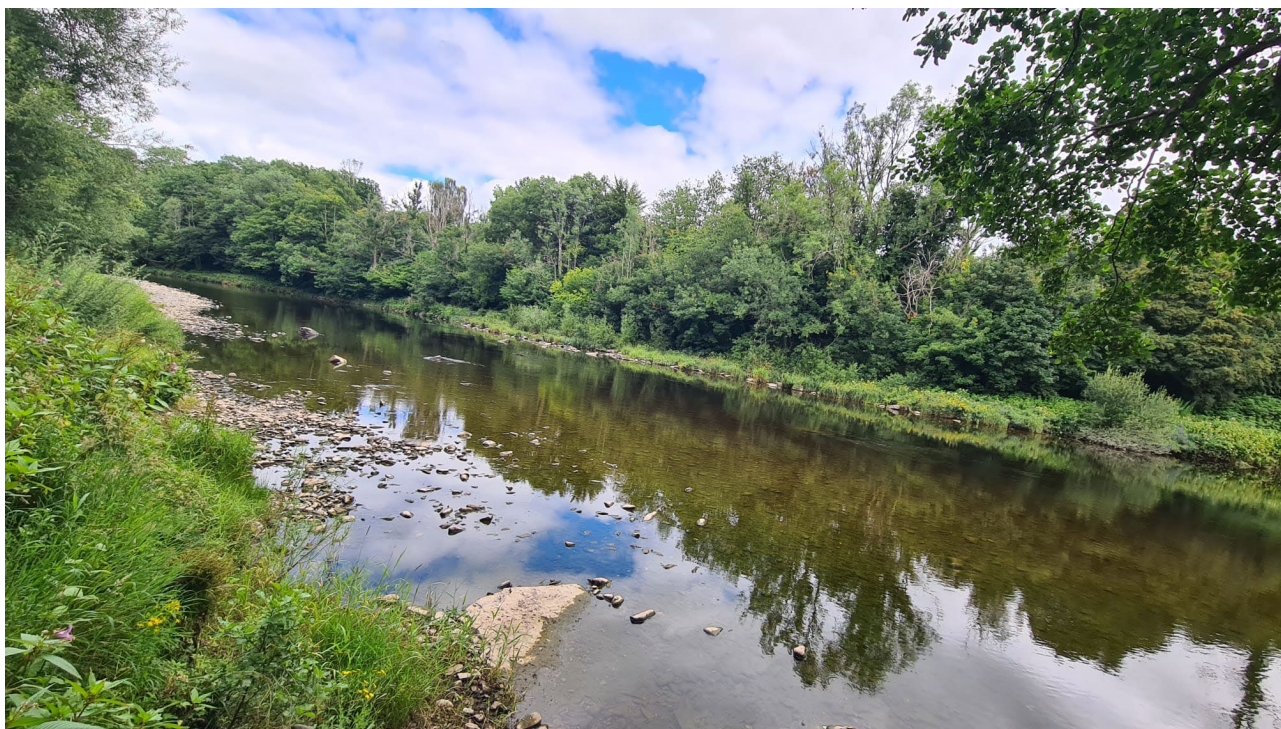
Figure 82. Photo of Wye, Llanstephan, at the midpoint across the channel

This site was located on the River Wye approximately halfway between the towns of Erwood and Boughrood, with the midpoint at grid reference SO1188641144. The channel is gently curving in this reach with some long straight sections, in a wide open valley with the A470 on the right bank, in close proximity in places. The river is mostly tree lined with fields either side and areas of woodland. Photographs taken at the midpoint facing across the channel, upstream and downstream are presented in figures 82, 83 and 84 respectively.

The simplified Phase 1 Habitat Survey score for this site was 5, the highest category due to the dominance of broadleaved woodland along the banks, despite the presence of improved and amenity grassland along the right bank in the downstream section. The mean ECS Score for SAC Unit 7729 (including four other sites at Wye Builth Wells, Wye Erwood, Wye Boughrood and Wye Glasbury) was 3, the middle category. This unit therefore failed the target for bank vegetation naturalness.

Recommendations at this site are to management of nutrient inputs which may be contributing to the high extent of filamentous algae cover at this site, and to control the invasive species Japanese Knotweed and Himalayan balsam. Increasing the buffer strip in this location to reduce management of the bank top is also recommended. As this section of the Wye has low energy flow, installation of features to diversify flow may be appropriate.

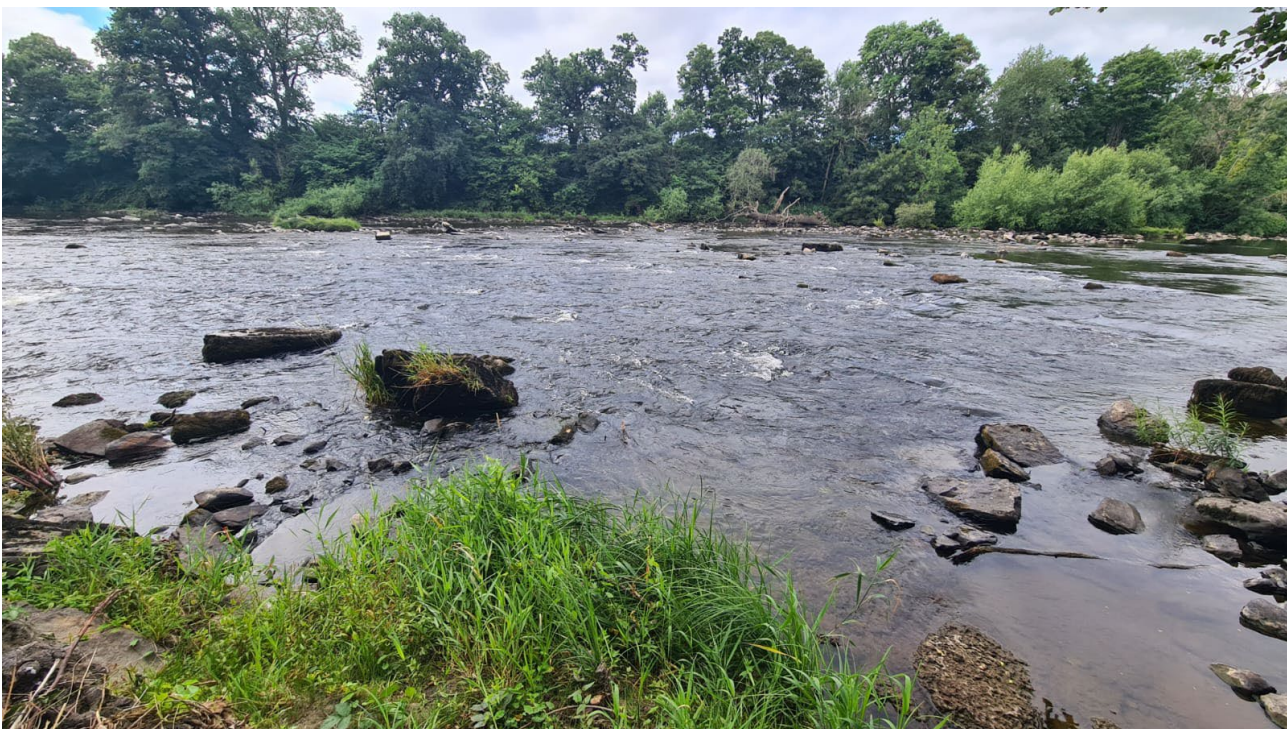
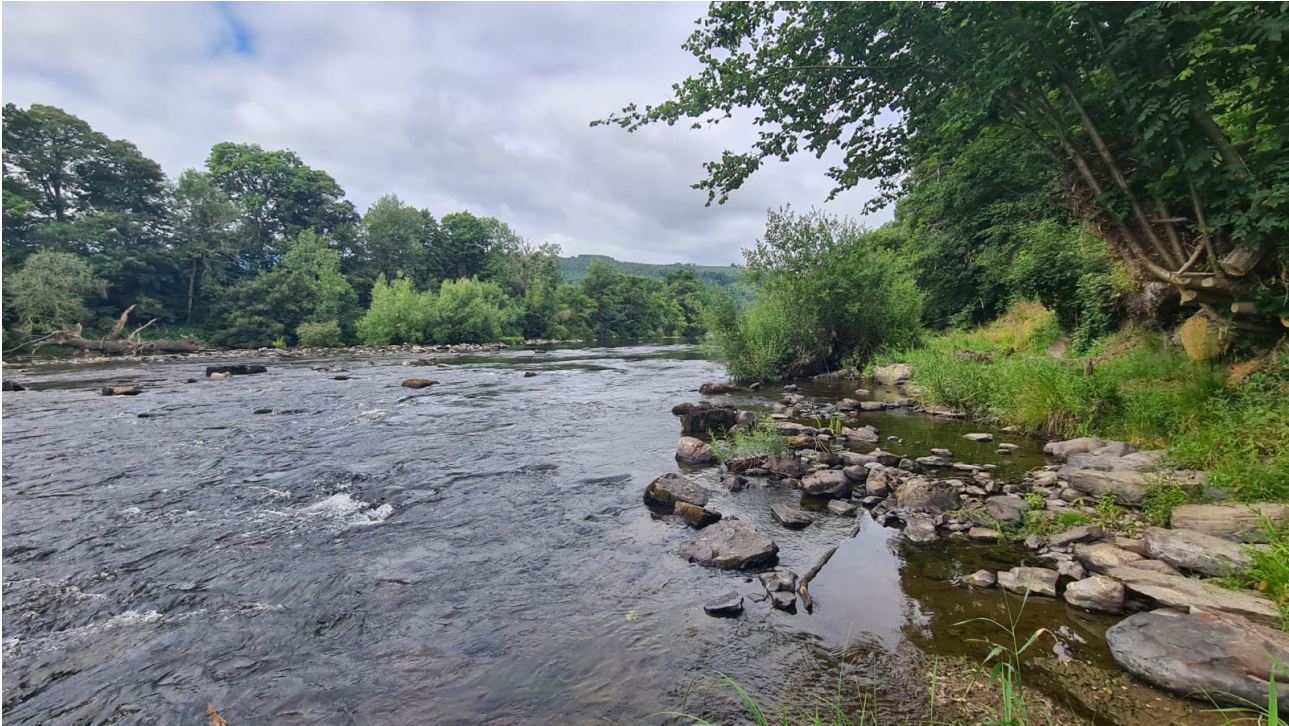
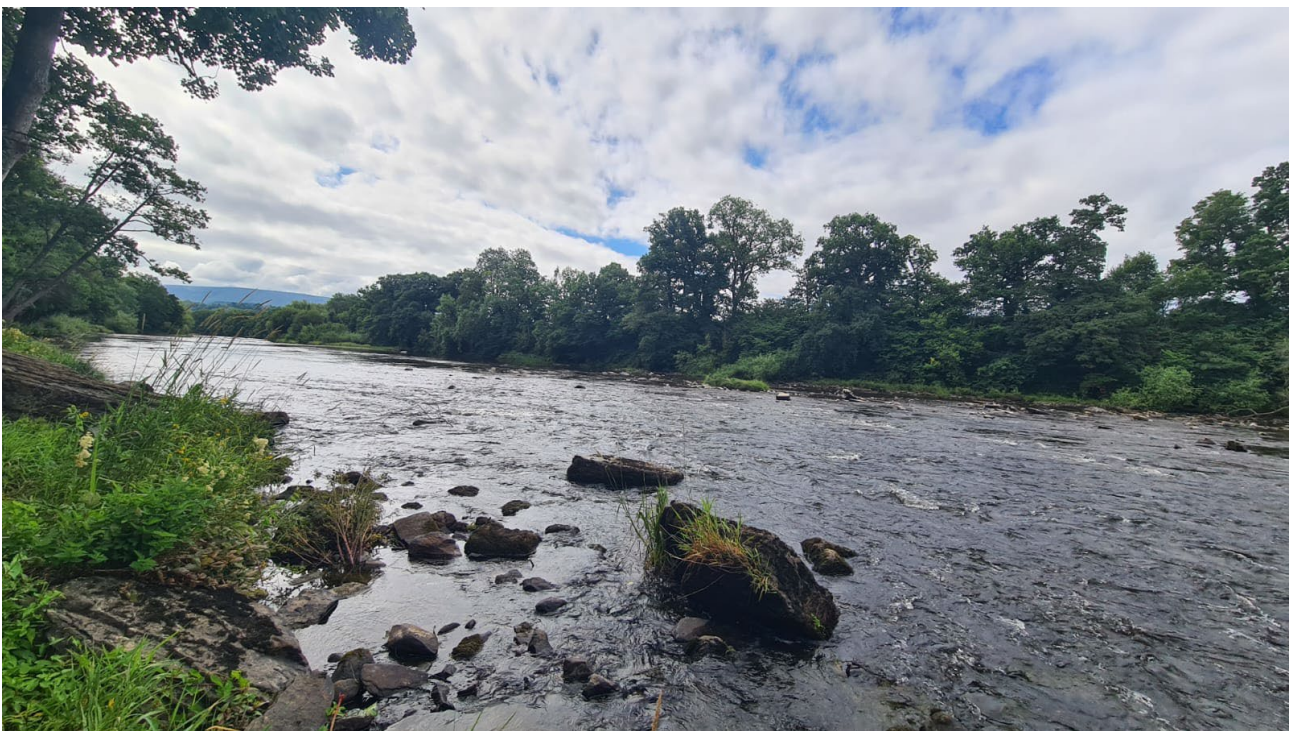
Figure 85. Photo of Wye, Boughrood, at the midpoint across the channel

Broadleaved woodland which scores highly was recorded at all but one spot check of the RHS survey, where scrub and bracken was recorded, so the simplified Phase 1 score for this site was 5, the highest category of the simplified phase one habitat survey. However, beyond this, was agricultural use with sheep grazing on improved grassland. The mean ECS Score for SAC Unit 7729 (including four other sites at Wye Built Wells, Wye Erwood, Wye Llanstephan and Wye Glasbury) was 3, the middle category. This unit therefore failed the target for bank vegetation naturalness.

Control of the invasive species Japanese Knotweed and Himalayan balsam is recommended at this site, along with management of nutrient inputs which may be contributing to the high extent of filamentous algae cover at this site.

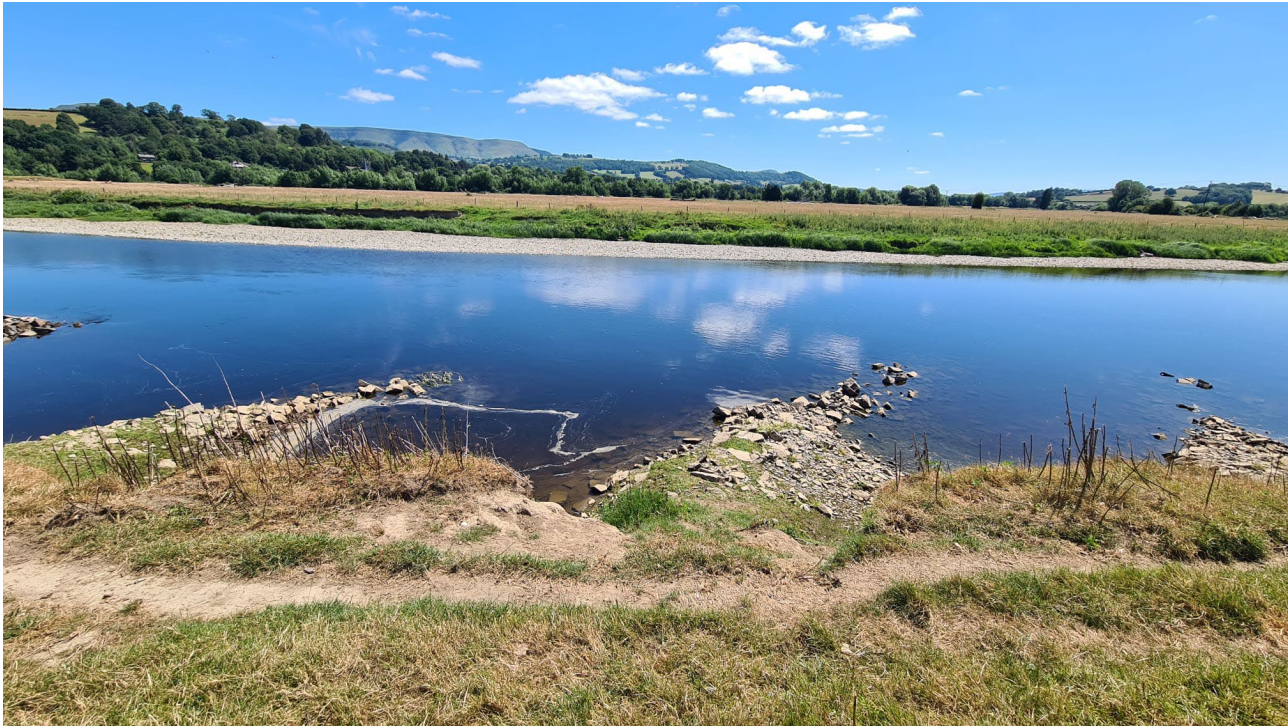
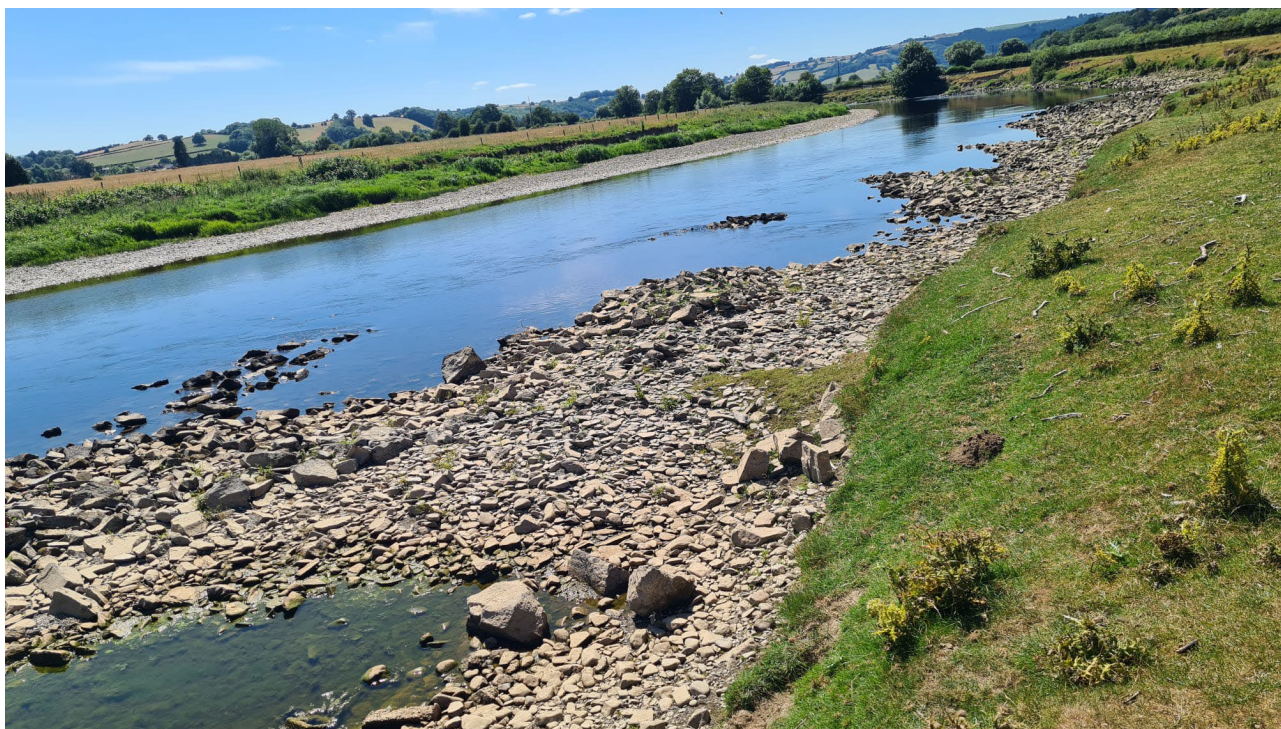
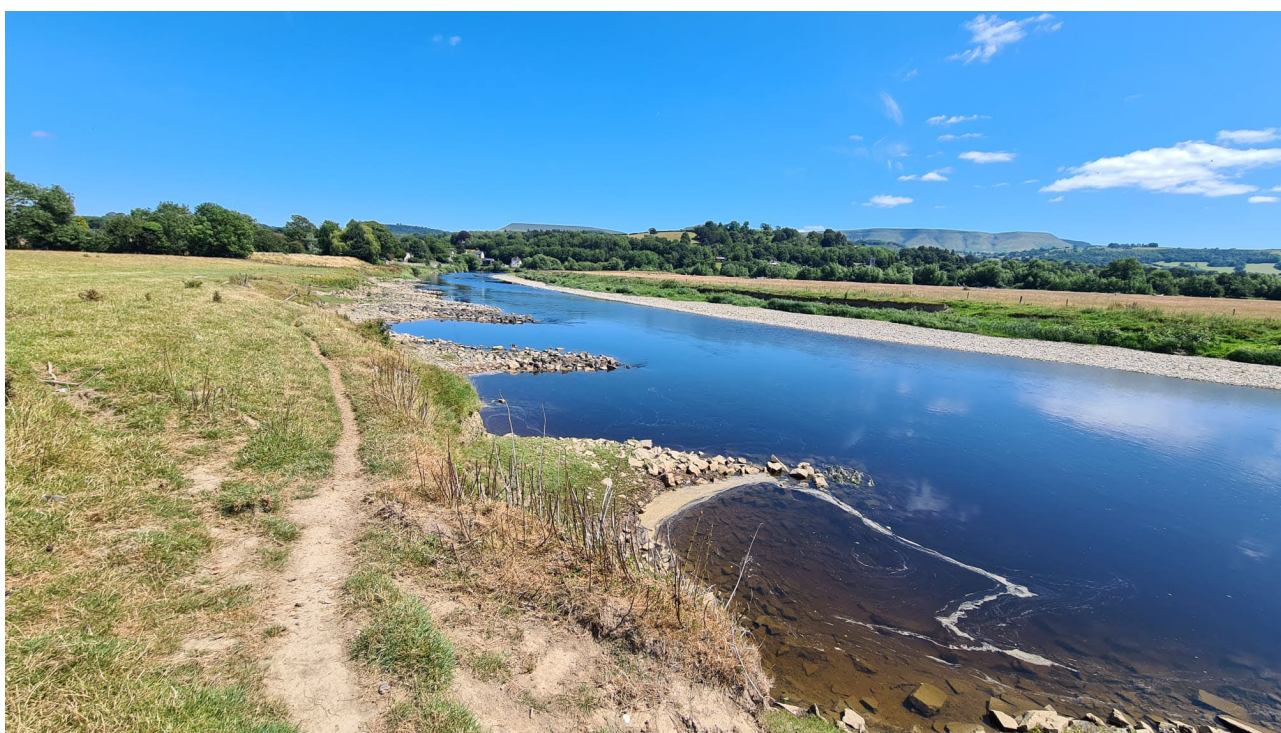
Figure 88. Photo of Wye, Glasbury, across the channel

The surrounding land was used for sheep grazing and scored 0 in the simplified Phase 1 habitat survey, the land use being mainly in the improved and amenity grassland category. The mean ECS Score for SAC Unit 7729 (including four other sites at Wye Builtth Wells, Wye Erwood, Wye Llanstephan and Wye Boughrood) was 3, the middle category. This unit therefore failed the target for bank vegetation naturalness.

This site has been impacted by channel modification and loss of bank top habitat, so restoration of the habitat is recommended. Removing the sheep from the left bank top would also reduce the impact of poaching on the bank which is already eroding being sited on the outside of a large bend in the river. The extent of filamentous algae cover indicated enrichment at this site, so control of nutrient input upstream should be considered.

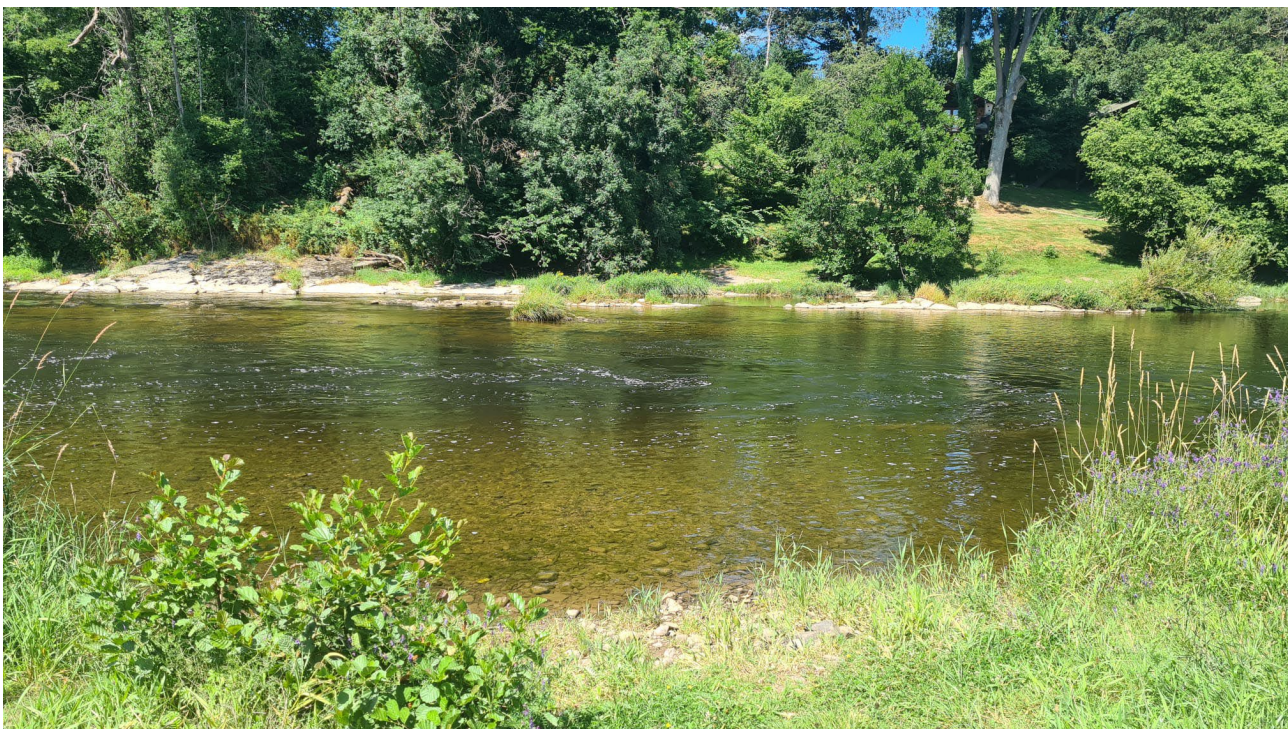
Figure 91. Photo of Wye, d/s Hay, at the midpoint across the channel

Photographs taken at the midpoint facing across the channel, upstream and downstream are presented in figures 91, 92 and 93 respectively.

Despite the broadleaved woodland which scores highly present on the left bank, the score for SAC Unit 1801 was 3, the middle category of the simplified Phase 1 habitat survey, mainly due to the presence of poor semi-improved grassland on the right bank and the carpark at the upstream limit. The surrounding land use was agricultural with sheep grazing on improved grassland. There was urban development 100 m from the water's edge on the right bank, and upstream of the survey site, and a small sewage treatment works downstream. As this site was the only survey in the SAC Unit 1801, the mean ECS Score was also 2. This unit therefore failed the target for bank vegetation naturalness. This is a cross-border unit so assessment applies to the Welsh section only.

Control of the extensive invasive species of Himalayan balsam is recommended at this site. It is also recommended that the historic resectioning is allowed to continue to degrade and become more naturalised, a process which is already happening at this site.

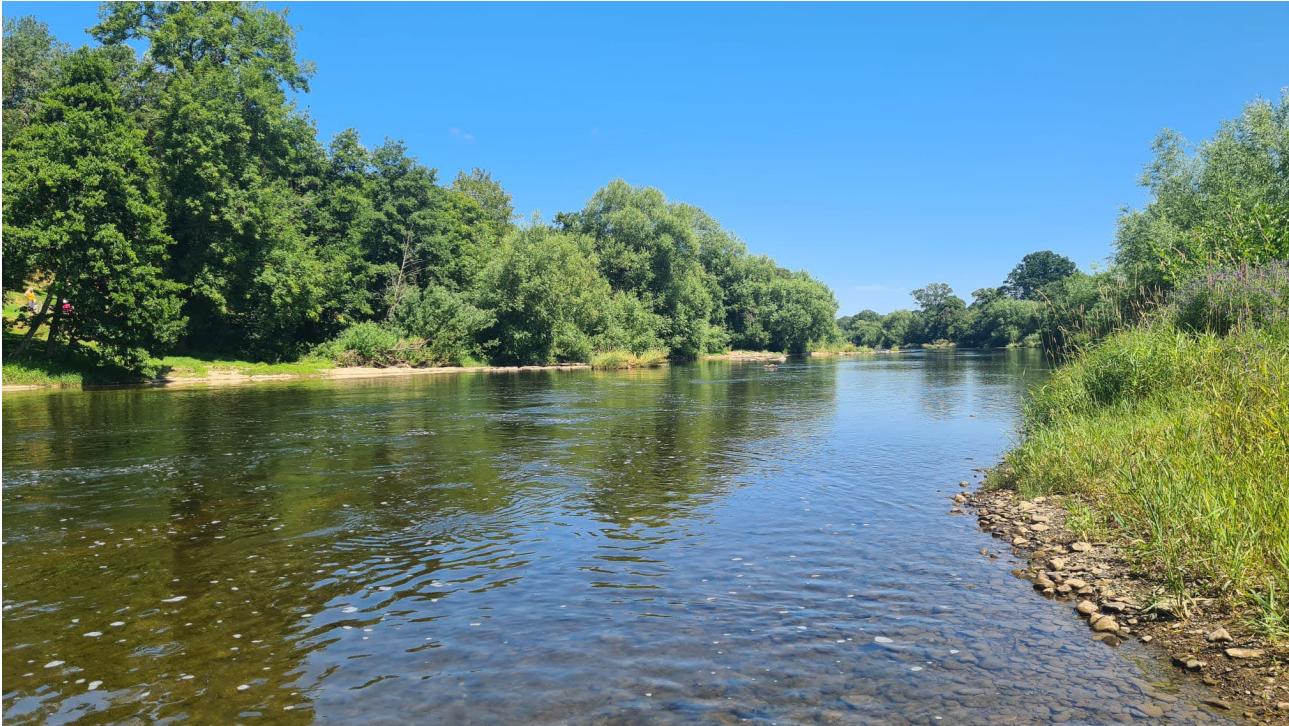
Figure 92. Photo of Wye, d/s Hay, at the midpoint facing upstream

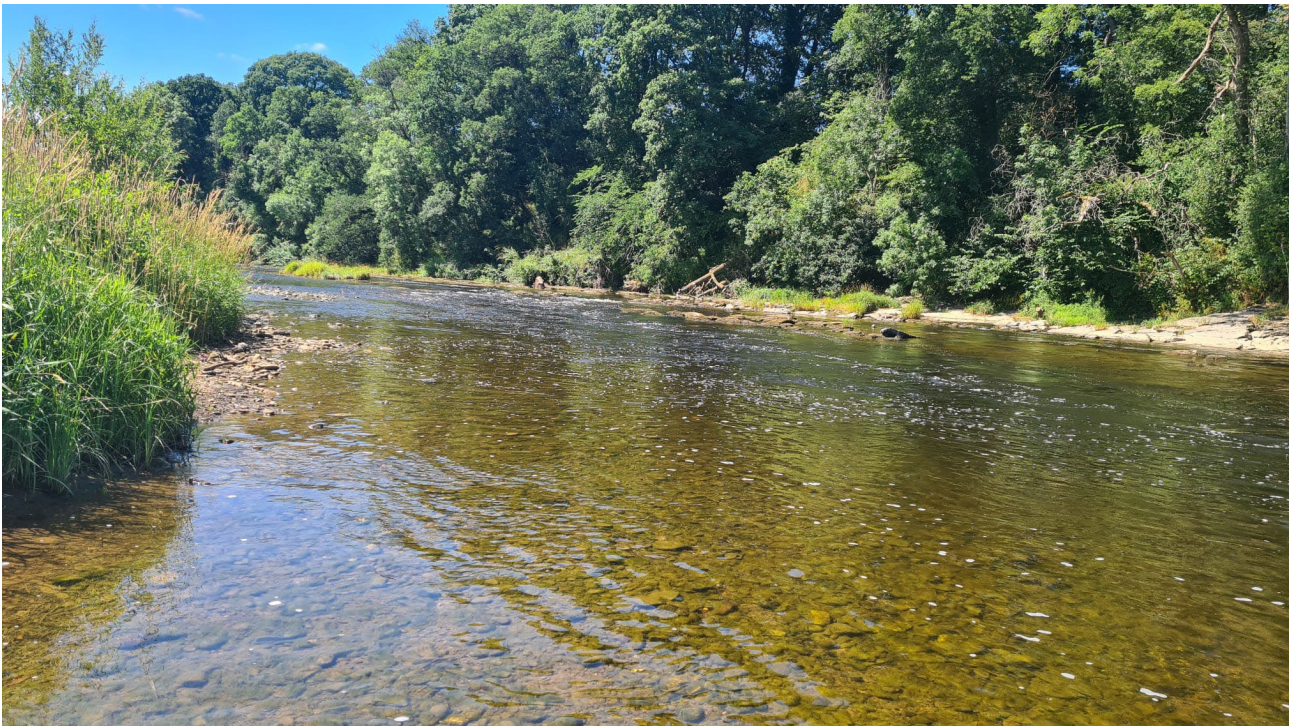
Figure 93. Photo of Wye, d/s Hay, at the midpoint facing downstream

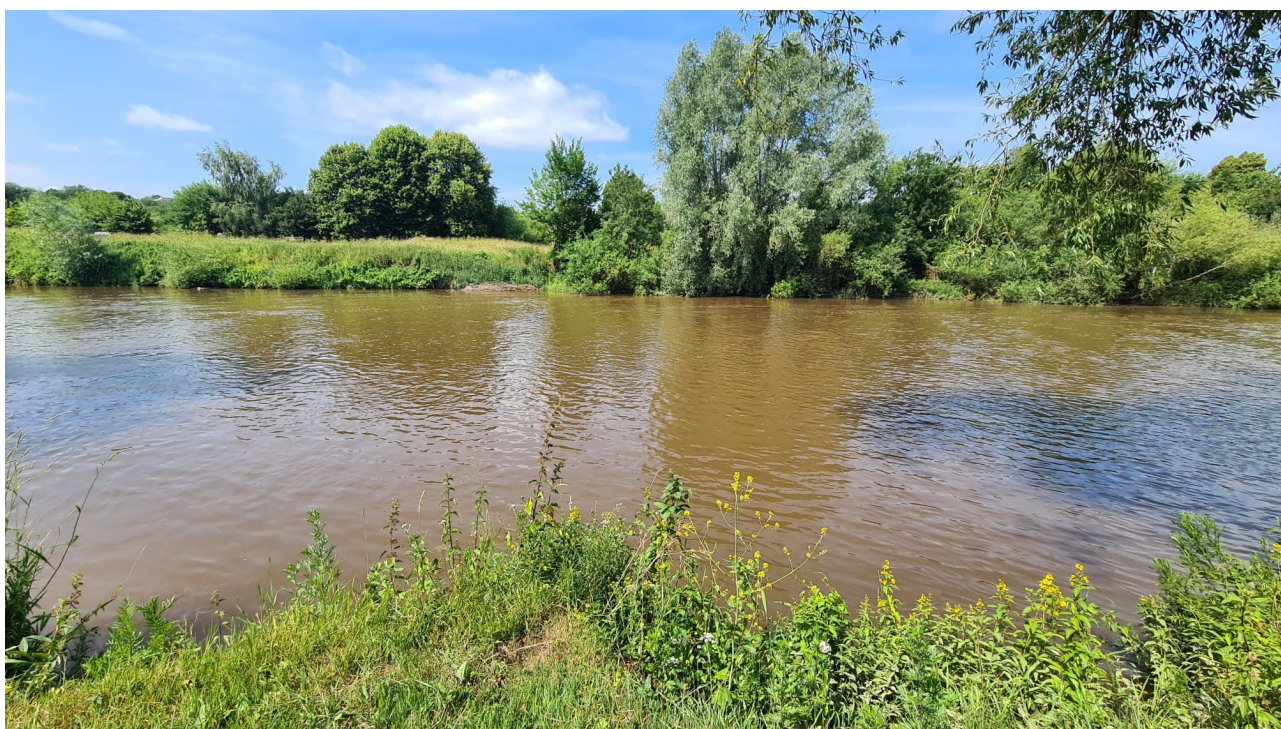
Despite the presence of a sign saying that dogs were not allowed, there was poaching where dog walkers were allowing access to the river for their pets from an informal footpath at the top of the bank.

Figure 94. Photo of Wye, Monmouth, at the midpoint across the channel

Control of the invasive Himalayan balsam is recommended for this site. The right bank was uniform so considered to be historically re-sectioned. Creating variety in this bank profile would improve the habitat quality. There are silt pollution issues to investigate with silt creating turbidity in the river at times of heavy rainfall, and means to control this should be investigated as it will undoubtedly have a detrimental effect on the submerged aquatic plants, including water crowfoot species. Controlling run-off by slowing the flow in the catchment upstream may also be of benefit to reduce the impact of fast flow events which may also have a negative effect on the water crowfoot by scouring it out. Adding deflectors may create varied flow that would allow it to re-establish.

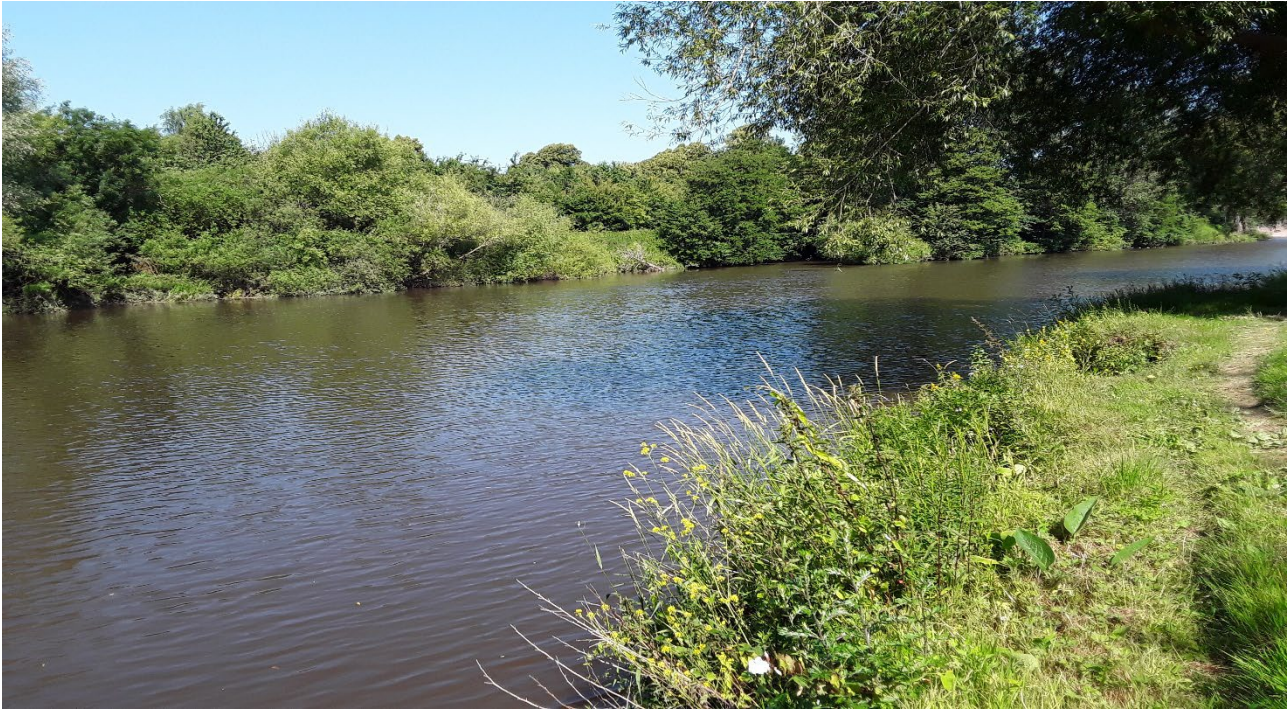
Figure 95. Photo of Wye, Monmouth, at the midpoint facing upstream

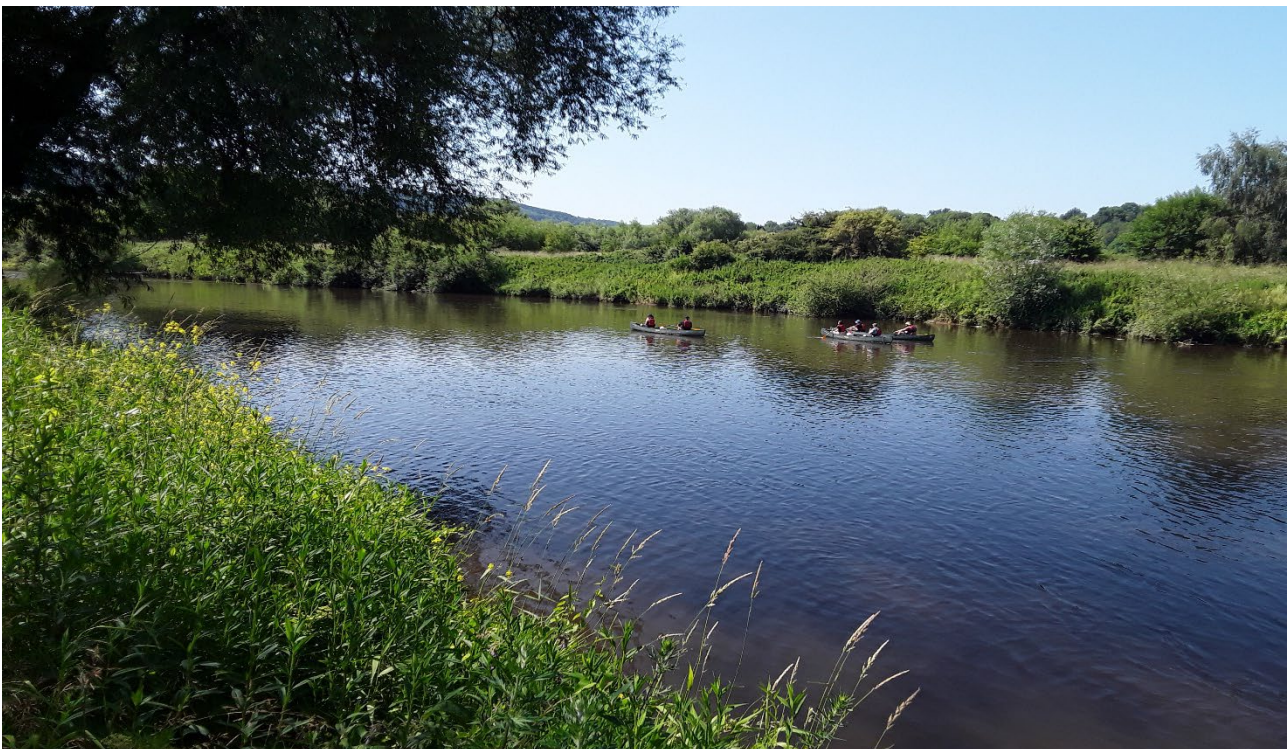
Figure 96. Photo of Wye, Monmouth, at the midpoint facing downstream
