February 2020 Floods in Wales: Natural Resources Wales Land Estate Management Review

Issued 22 October 2020

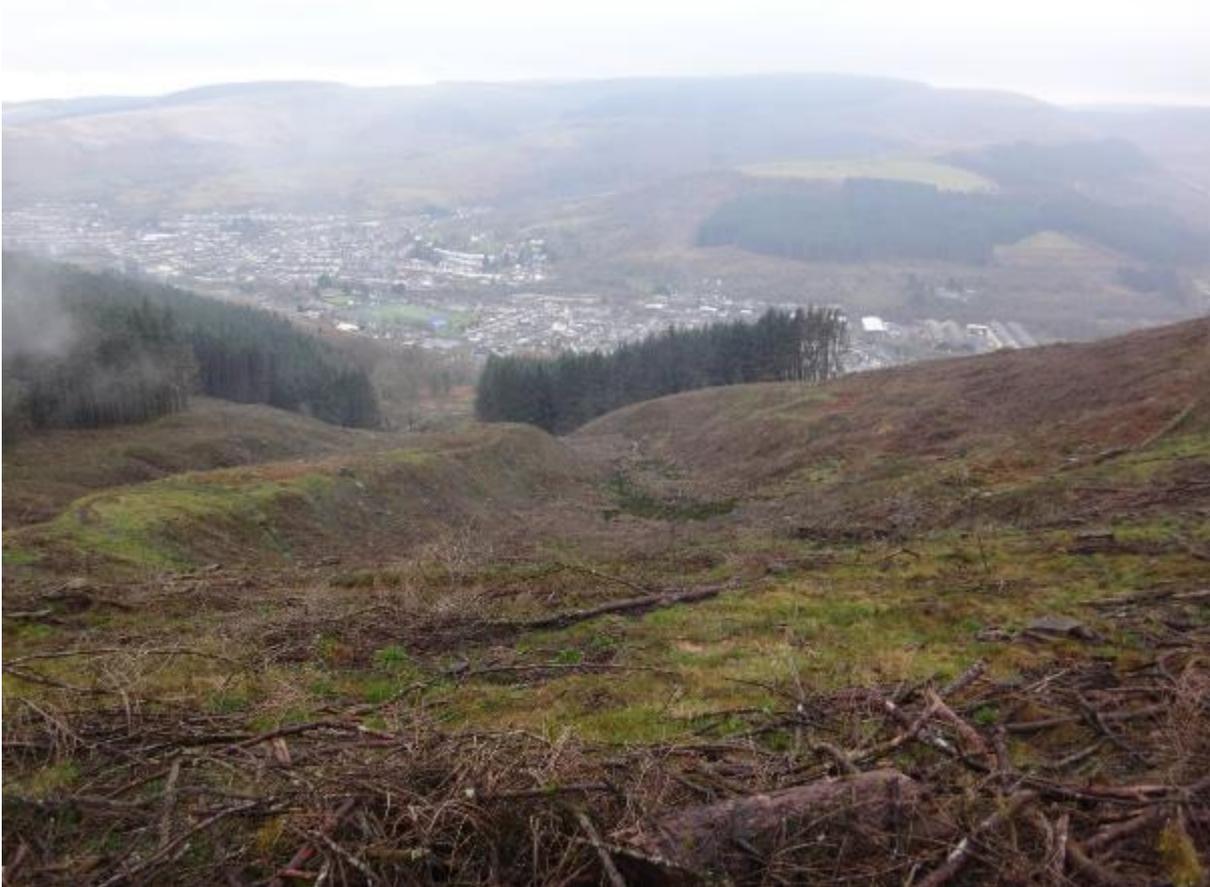
Fig 4 – View over main of the site and catchment of Stream 2

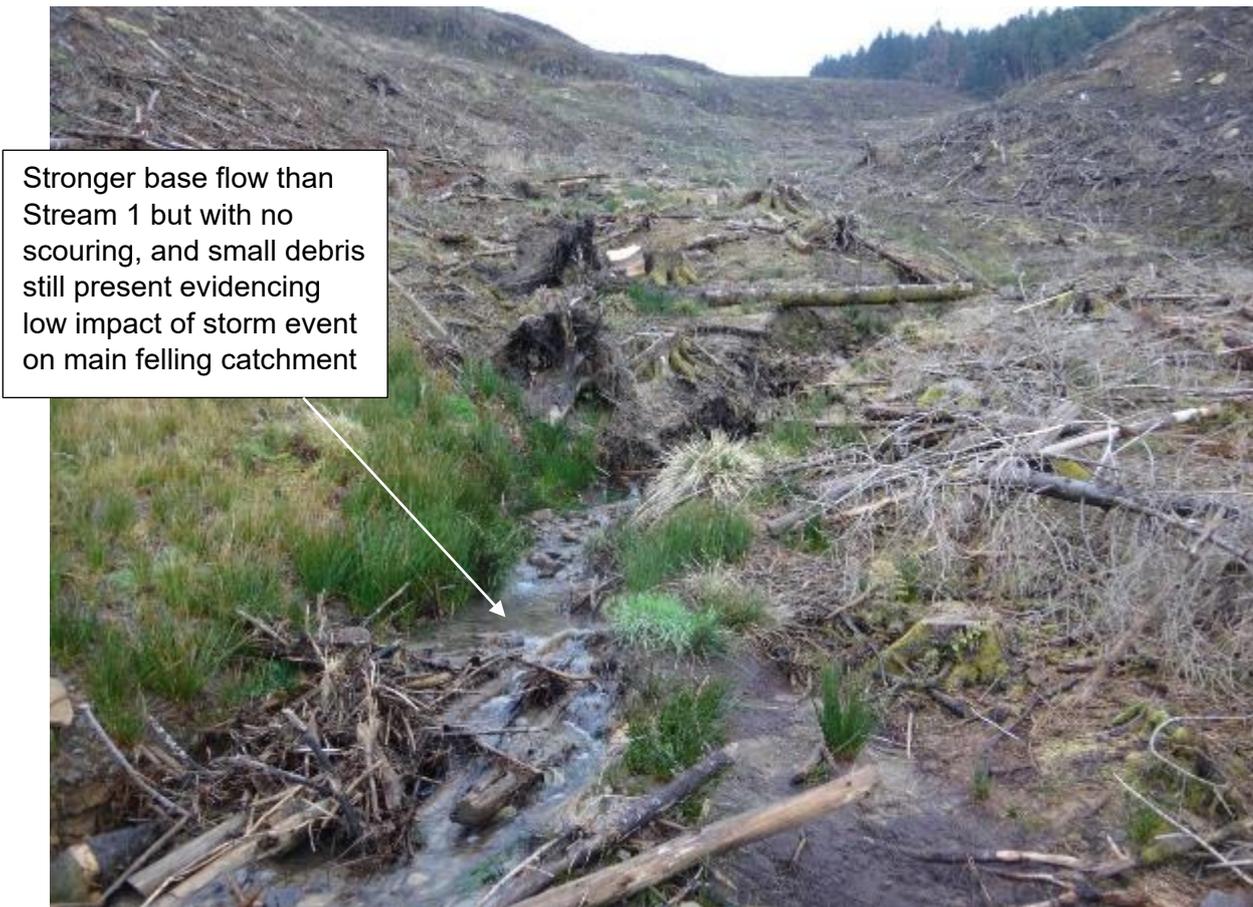
Fig 5 – View Looking back up Stream 2 and its catchment from close to confluence with Stream 1
