# **Flood Investigation Report**

## **St Asaph and Elwy Communities**

Storm Ciara  
9<sup>th</sup> February 2020

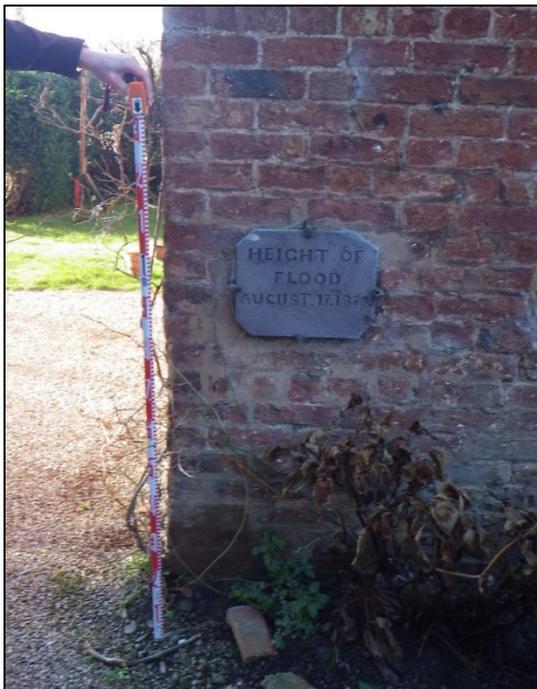
*Figure 4: Plaque on Laundry Cottage, St Asaph*

There is a long history of flood events, of varying magnitude, observed within the Elwy catchment, many of which have occurred in recent history. A plaque on the Laundry Cottage St Asaph states 'Height of Flood August 17<sup>th</sup> 1879', positioned approximately 700mm from ground levels

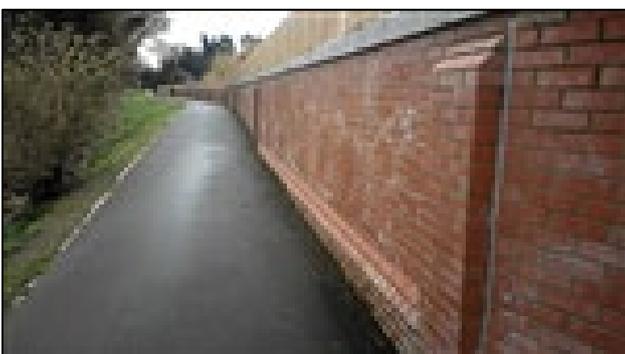
*Figure 24: Roe Parc Wall (NRW, 2019)*

The Roe Parc section of raised defence (Figure 24) was formally a grass covered earth embankment. In 2012 extensive overtopping was observed along this section. The 2018 scheme significantly improved the standard of protection along this section by construction of a steel sheet pile wall with brick cladding. A vertical wall was favoured to the original earth embankment due to space availability. The wall was designed to contain the 0.5% AEP event.

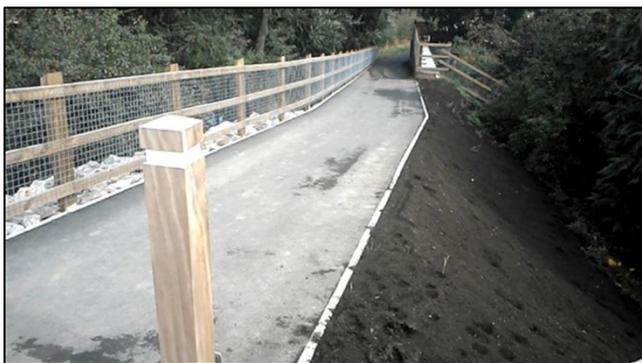
Figure 25: Roe Parc wall& embankment transition post-construction (NRW, 2018)

Post-event topographic survey completed by NRW confirmed that the as-built levels for Elwy left bank Roe Parc defences were within engineering tolerances for hard and soft defences (Figure 26).

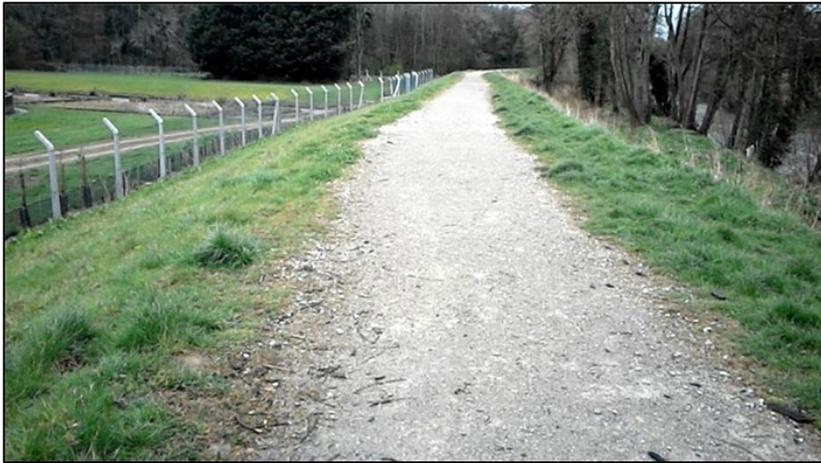
Figure 27: St Asaph STW Embankment Visual Inspection 2019 (NRW)

During the 2018 St Asaph scheme the right bank of the Elwy at St Asaph sewage treatment works was raised by up to 400mm over its 175m length of original embankment. The landward face of the embankment was widened to accommodate the increased height and to facilitate future raising if required. The full length was surfaced with a 2.4m wide gravel path along the crest, although this does not form part of the FDL. The upstream end of the embankment ties into high ground at the A55 flyover with a finished ground level of 14.06m AOD which forms FDL for the 0.5% AEP event.

Post-event topographic survey completed by NRW confirmed that the as-built levels for Elwy right bank sewage treatment works defences were within engineering tolerances for hard and soft defences (Figure 28). There was a short length, less than 5m which was approximately 100mm lower than the design crest level.

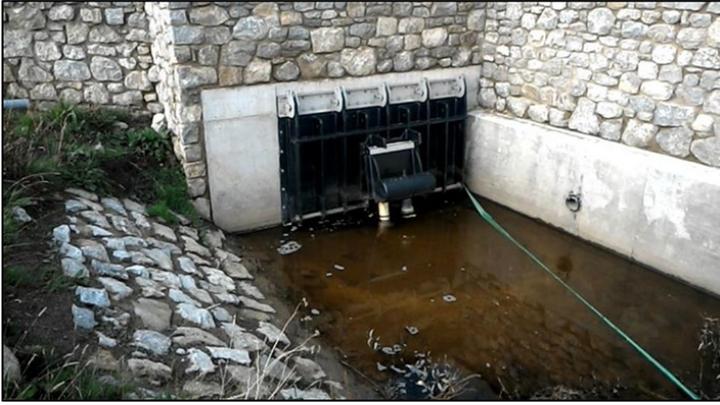
Figure 29: Glascoed Stream non-return flap (NRW, 2019)

The Glascoed Stream upstream of the Lower Denbigh Road bridge is an ordinary watercourse, downstream of the road bridge is designated main river and within the Afon Elwy floodplain. As part of the 2018 St Asaph scheme the first section of concrete culvert was placed, and a concrete headwall was cast into the wall to hold a non-return flap (Figure 29). The non-return flap stops water from the Afon Elwy flowing up the Glascoed Stream which otherwise would potentially causing flooding to properties along Glascoed Road. At a later date, circa autumn October 2019, Denbighshire County Council undertook refurbishment of the road bridge by continuing placement of concrete culvert sections.

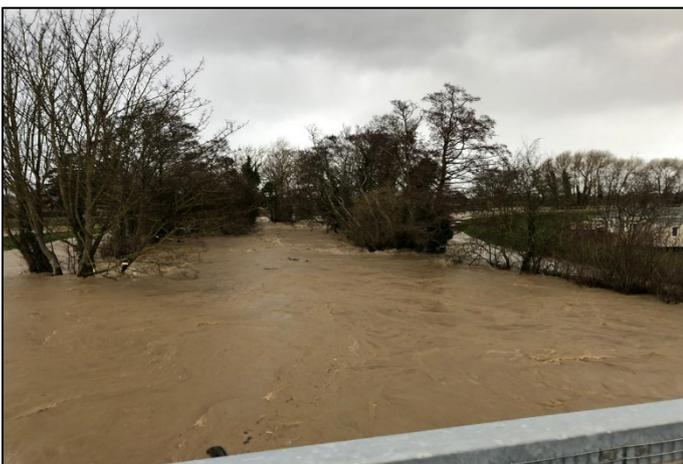
Initial reports from NRW operatives on site stated that flooding began to occur just downstream of Spring Gardens Bridge on the left bank (See Figure 34, Figure 35& Figure 36), but based on observed water levels (Figure 31) it is possible other areas of raised defence in the lower reaches (downstream of Spring Gardens Caravan Park) of the Elwy started to overtop before this. Multiple sources later confirmed that during the event significant lengths of the Elwy Fishermans Bridge Embankment (EMB1500412) experienced overtopping, >200mm for approximately 1.5 hours (see Figure 32 & Figure 33 below).

Figure 31: Afon Elwy levels looking D/S from SGB (NRW, 2020)

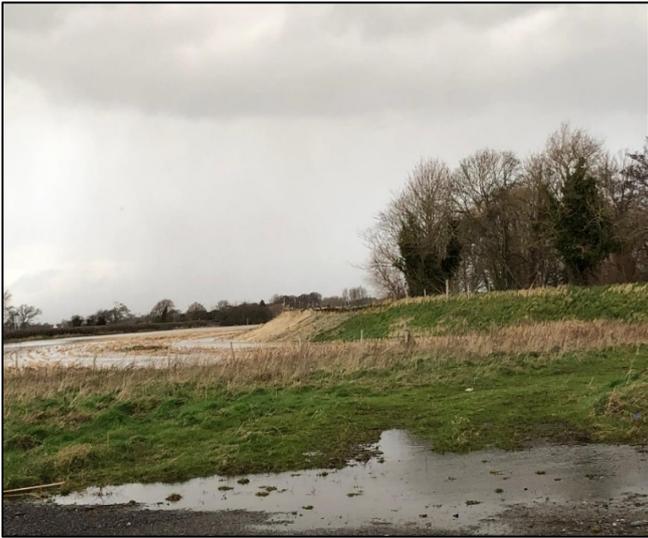
Figure 34: Phase 2 - Reducing overtopping at EMB1500412 (NRW 2020)

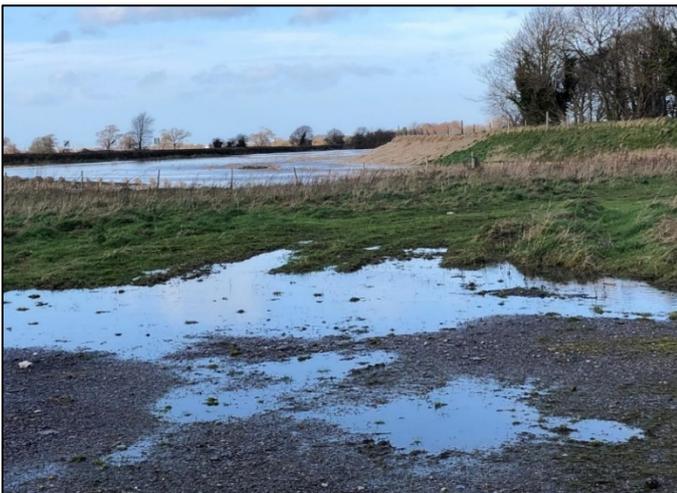
Figure 35: Phase 1 - Extensive overtopping at EMB1500412 (NRW 2020)

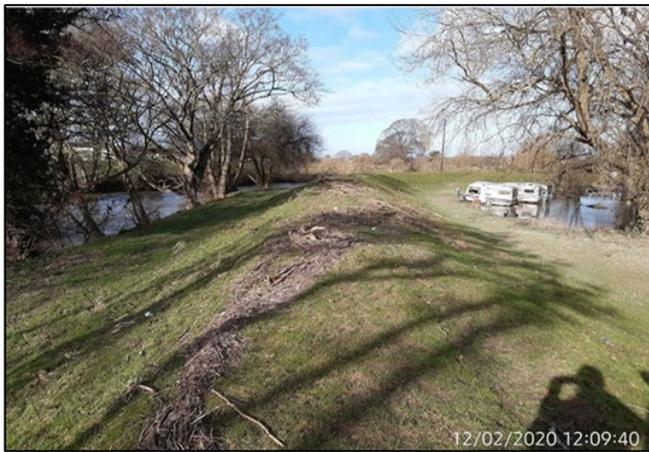
The right embankment, Elwy Mount Embankment (EMB1501406) was also overtopped (see Figure 38, Figure 37 & Figure 39) but it is unclear to what extent and for what time period this occurred. The property known as “The Retreat” was reported as flooded internally. Other residential properties were not reported as flooded internally but all residents of the Mount would have experienced significant impacts due to the single access road flooding to a significant depth.

Figure 38: Wrack & debris deposits showing line of overtopping (NRW, 2020)

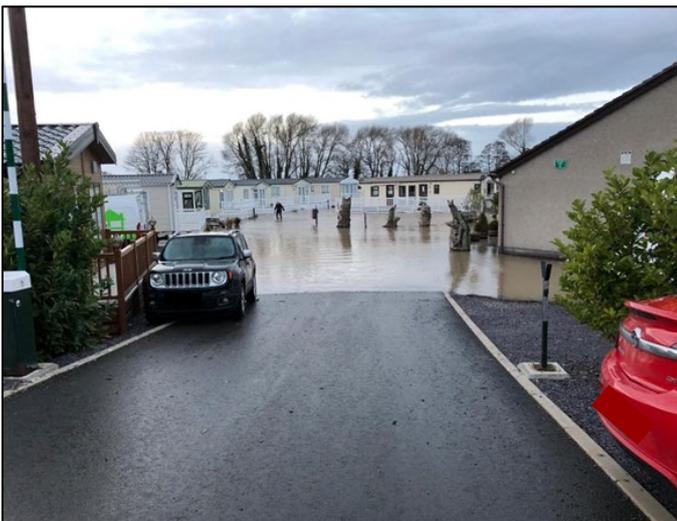
Figure 43: Spring Gardens Caravan Park flooding (NRW, 2020)

Significant overtopping, between 100-150mm over 150m for approximately 1.0 hour was observed on the right bank St Asaph STW Embankment (EMB1800067). A private residential dwelling (Figure 41) and 3 static caravans were inundated by flood water in the Spring Gardens Caravan Park (Figure 42). Significant amounts of water which overtopped the right bank flowed through the sewage treatment works, following the topography and filling the land of Spring Gardens Caravan Park. As the overtopping water could not exit the caravan park because of downstream embankments, depths within the park rose considerably. Although there is a small, privately owned pumping station on-site to drain surface water, there is no permanent infrastructure on site to evacuate the volume of water observed.

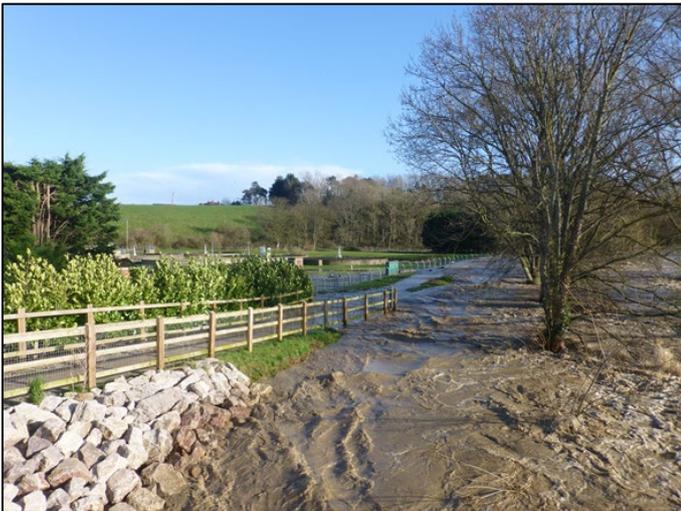
*Figure 45: Water levels looking u/s from SGB (Resident photo)*

Overtopping of the St Asaph STW Embankment started after the defences in Lower St Asaph had been overtopping for a period of time (Figure 45). During the post-event topographic survey, a low spot (approx. 100mm) was identified over a short length, less than 5m, of the right bank. Information and photographs obtained through the subsequent investigation have found evidence to show that overtopping occurred along a significant length of the right bank (Figure 46). Although observed to be extensive and prolonged, the overtopping was not deemed to pose a significant risk of defence failure during the event based on age, build quality and current condition. Post-event asset inspections (Figure 49) confirmed that the embankment structure had performed well under considerable hydraulic and debris loading.

## **Recommendation 2.2 – NRW – Using the hydraulic model, investigate the flow mechanisms and sensitivity of various parameters which may be impacting water levels at St Asaph STW Embankment.**

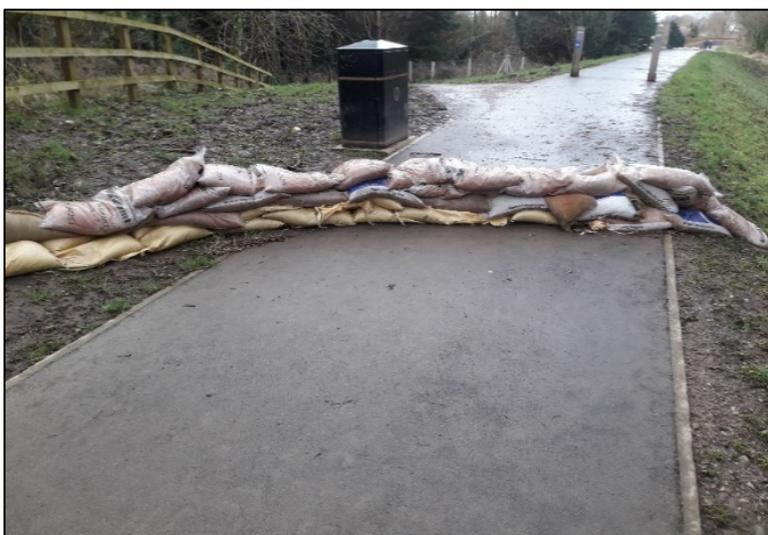
Figure 53: Sandbags placed at Roe Parc by residents looking downstream (NRW, 2020)

Water levels on the left bank (Figure 56) just downstream of the A55 flyover reached 13.978m AOD as the velocity of water pushed up the smooth surface of the tarmac footpath. Water levels on the left bank at the upstream end of Roe Parc Wall reached 13.886m AOD. Residents deployed sandbags (Figure 53) to stop water being pushed up the tarmac path and over the bank towards Roe Parc. Based on evidence provided by residents and flood wardens and validated by post-event survey, it is unlikely that river levels (Figure 54) would have overtopped the Roe Parc embankment just downstream of the A55 bridge.

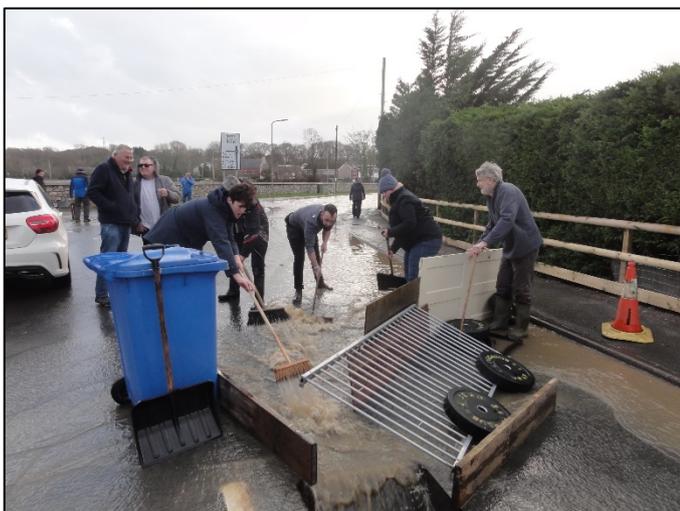
Post event inspection of the Glascoed Stream by representatives of NRW and DCC highlighted the high-water levels (Figure 63). During the event residents utilised available material to divert flood water away from property and into road gulleys and surface water systems (Figure 61 & Figure 62).

*Figure 61: Residents diverting flood waters from Llwyn Elwy during Storm Ciara (Resident Photo, 2020)*

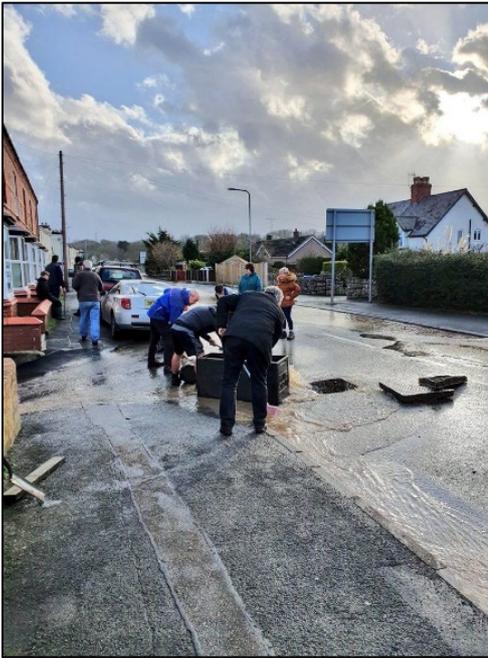
Figure 62: Residents diverting flood waters on Lower Denbigh Road during Storm Ciara (Resident Photo, 2020)

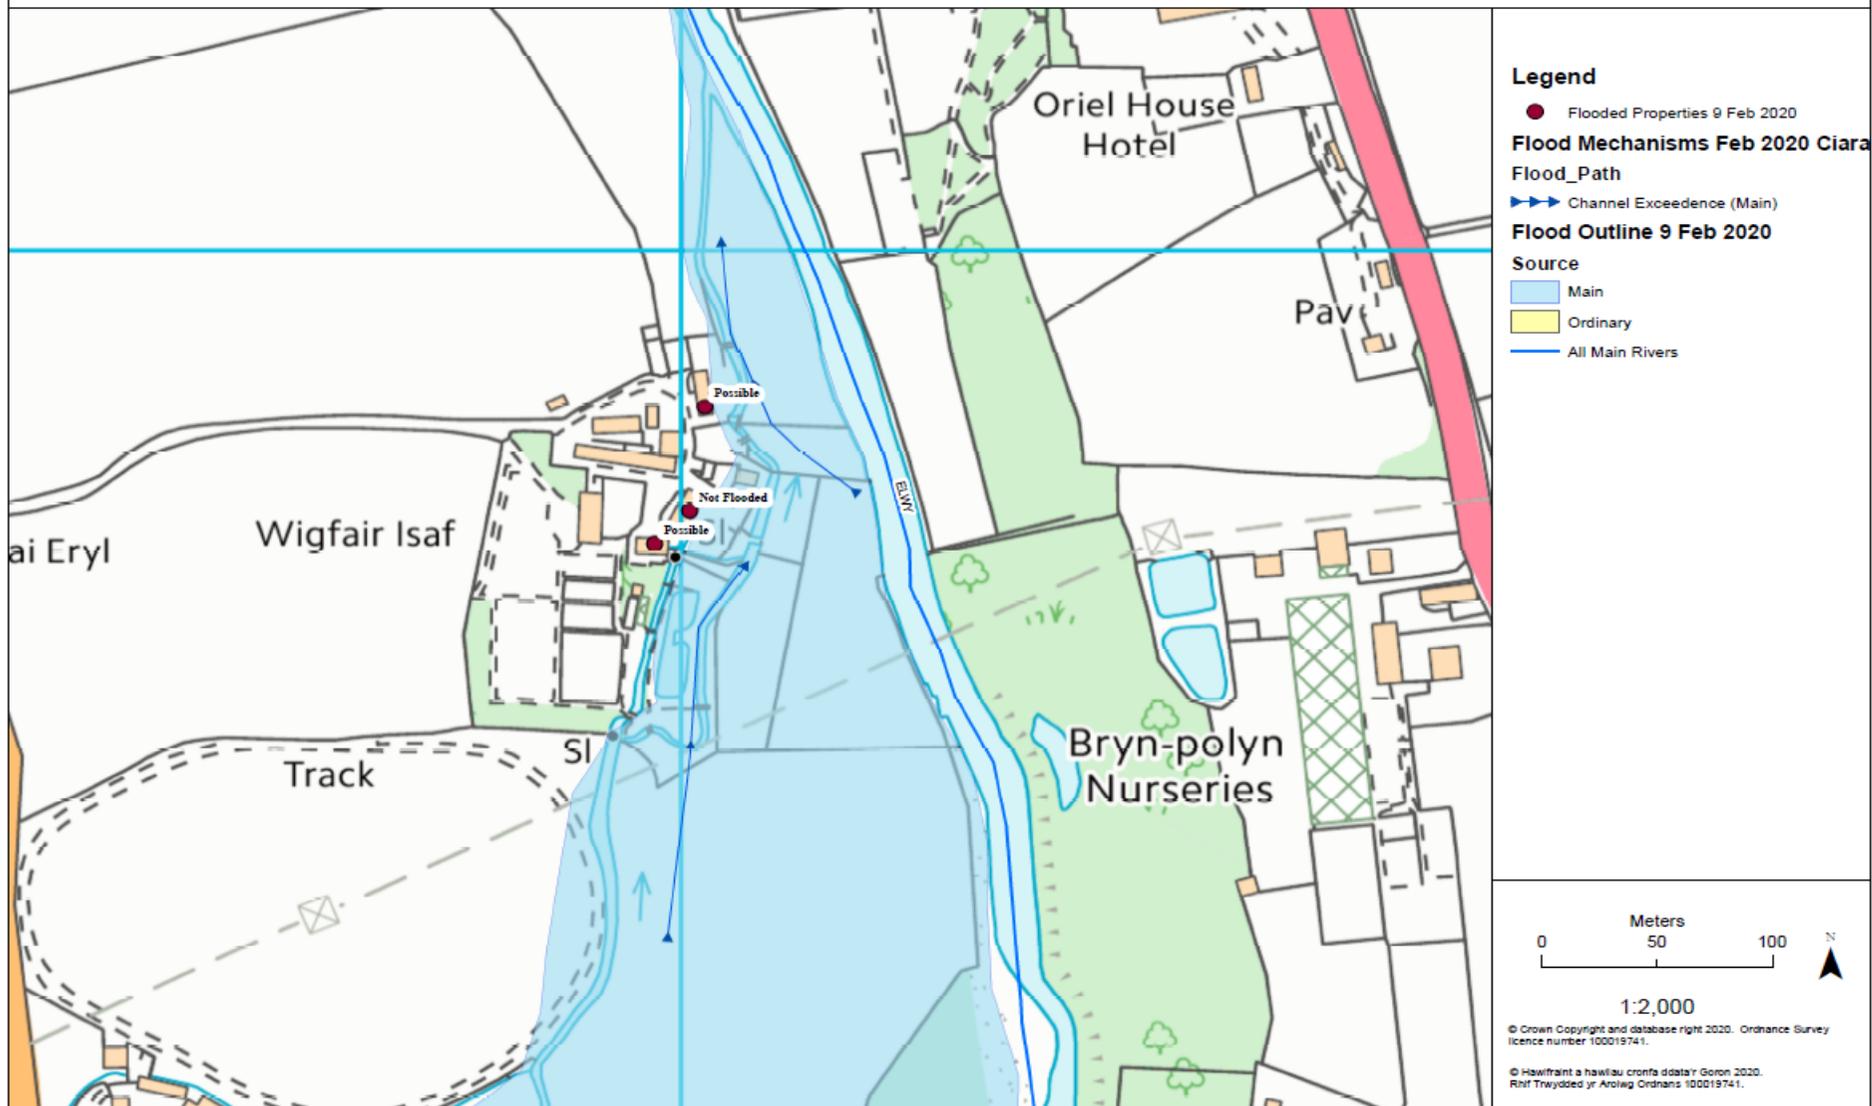
Figure 67: Wigfair Isaf community flood mechanisms - Feb 2020

**The primary mechanism of flooding in Wigfair Isaf Community is deemed to be main river inundation of the floodplain as a result of river levels exceeding the level of natural riverbanks in the area.**

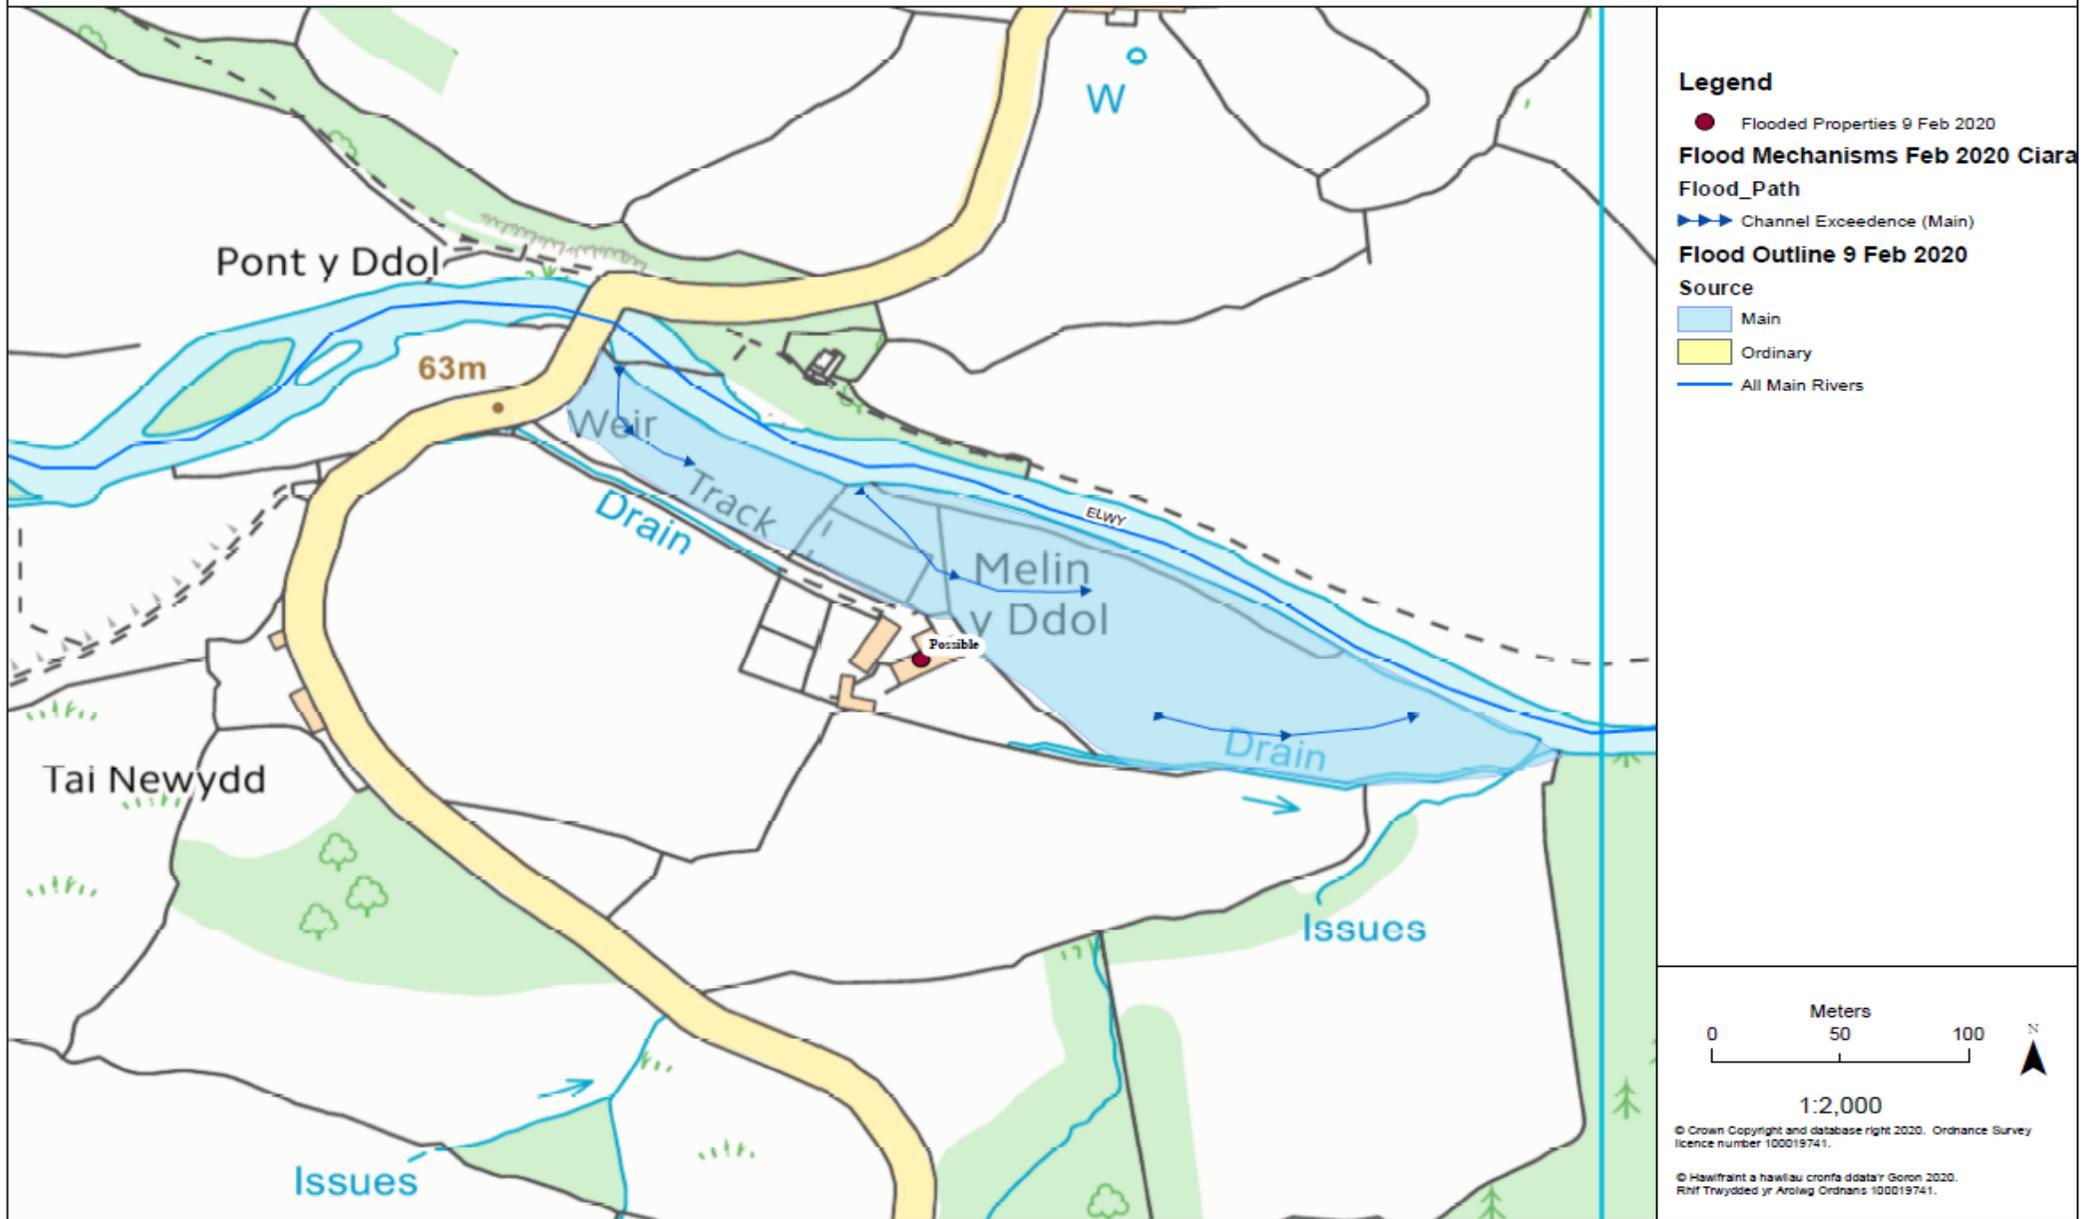
Figure 73: Pont Y Ddol community flood mechanisms - Feb 2020

The impacts on Pont Y Ddol Wood Community are deemed to be main river inundation of the natural floodplain caused by a significant rainfall event centred over the catchment.

**Recommendation 6.1 is also applicable to this community.**

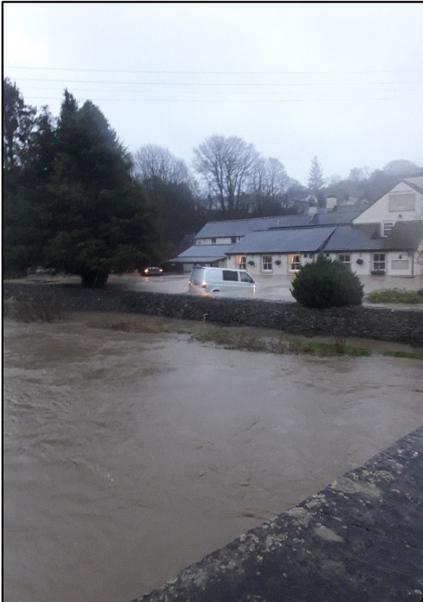
The river levels on the Elwy recorded downstream at Pont Y Gwyddel were the highest ever observed, along with significant rainfall totals recorded at Gwytherin rain gauge upstream of Llanfair TH, point to a significant event on the Afon Elwy (Figure 77) which exacerbated flood water levels in lower areas of the Llanfair community. During the 2012 flood event, anecdotal evidence highlighted a flow route from the Afon Elwy crossing agricultural land (natural floodplain) and entering Llanfair community along School Lane from west to east. This same flow route was observed by a Llanfair resident and flood warden during the 2020 event. Based on this information and the location and height of flood defences, it is surmised that this flow route is only initiated during flow events significantly greater than 1 in 100 year (1% AEP) on the Afon Elwy. Flood levels in the lower village were significant, greater than 1m in areas, as a result of culvert exceedance of the Nant Barrog and natural channel exceedance of the Afon Elwy. The significant flood levels are demonstrated by Figure 76 which shows flood water in lower Llanfair overtopping the Elwy embankments back into the Elwy floodplain. The wall in front of the Black Lion Hotel was also overtopped by flood water back into the Elwy.

Figure 77: Flooding in Llanfair TH (Resident photo)

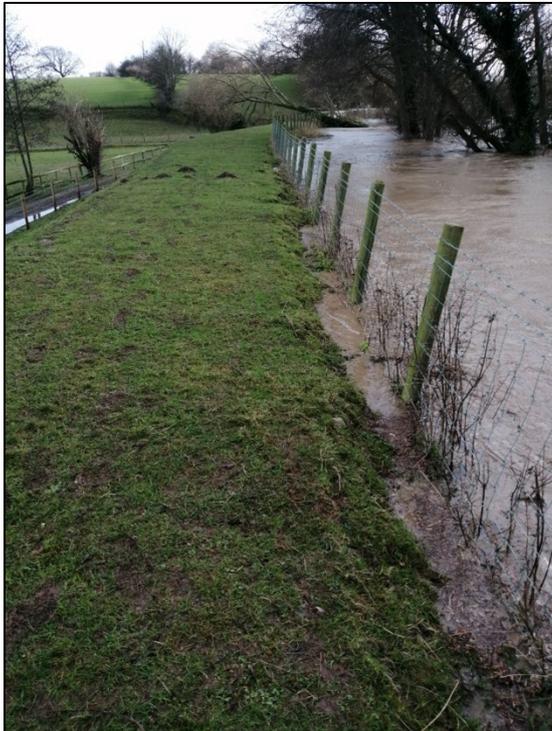
*Figure 89: River levels d/s of fishermans bridge (NRW, 2020)*

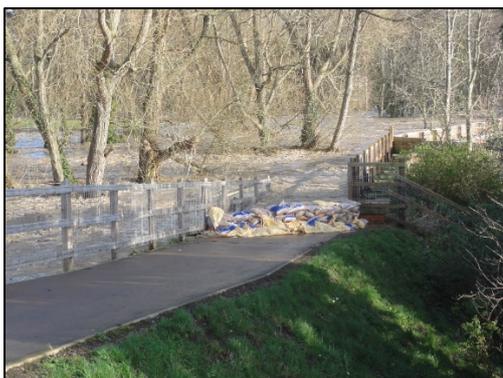
*Figure 90: Sandbags deployed at Roe Parc Wall (Resident photo, 2020)*

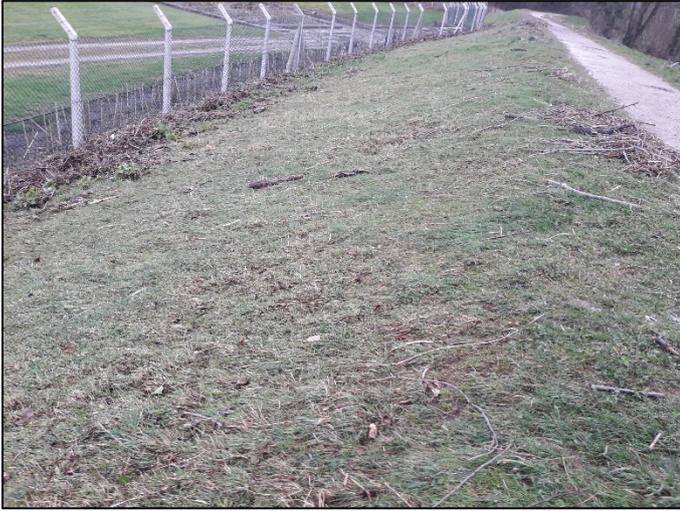
Figure 92: Overtopping location RB STW emb (NRW, 2020)

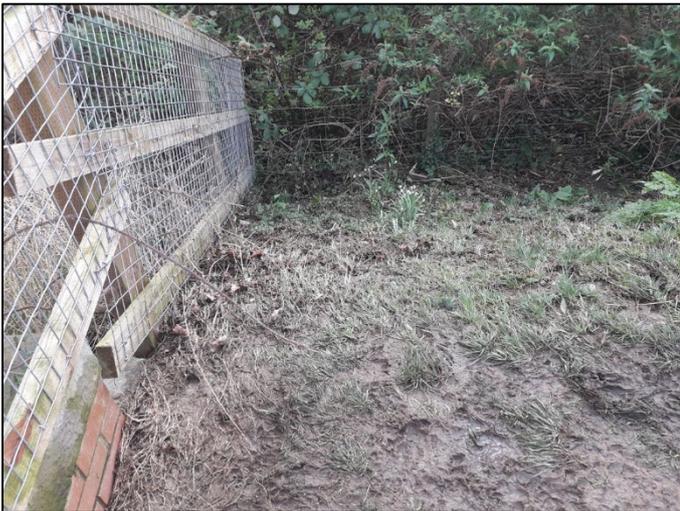
Figure 93: Location of overtopping Roe Parc Wall (NRW, 2020)

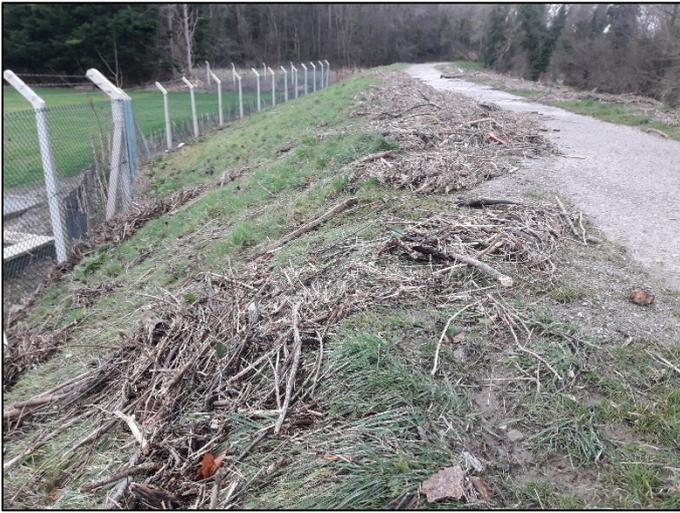
Figure 95: Overtopping location RB STW emb (NRW, 2020)

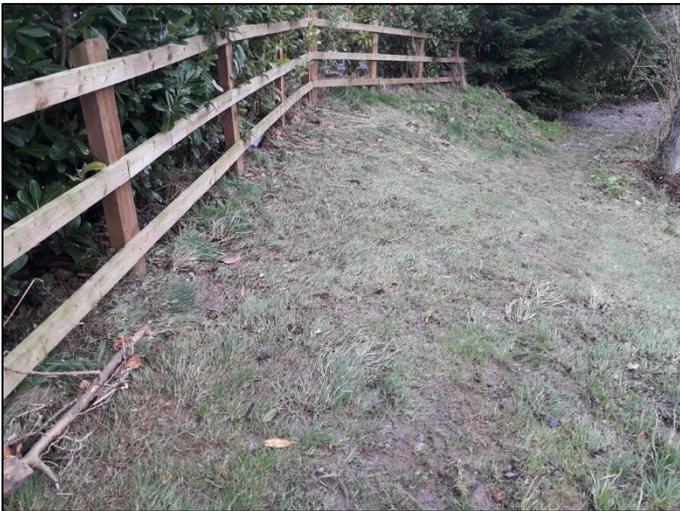
Figure 96: Overtopping location RB STW emb (NRW, 2020)

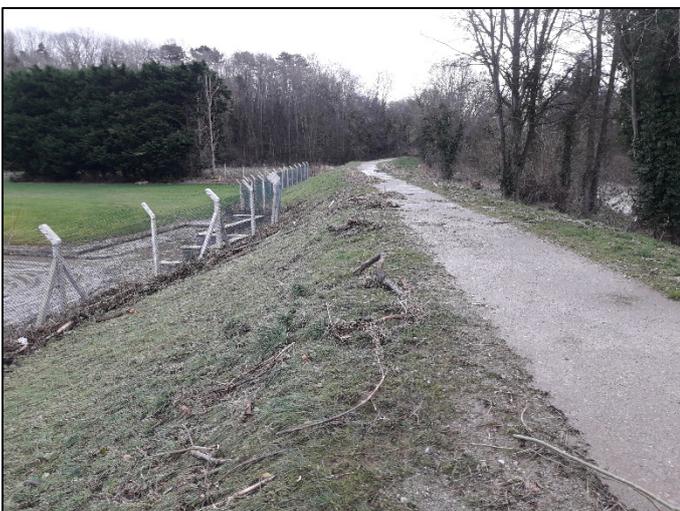
Figure 97: Progression of overtopping RB STW emb (NRW, 2020)

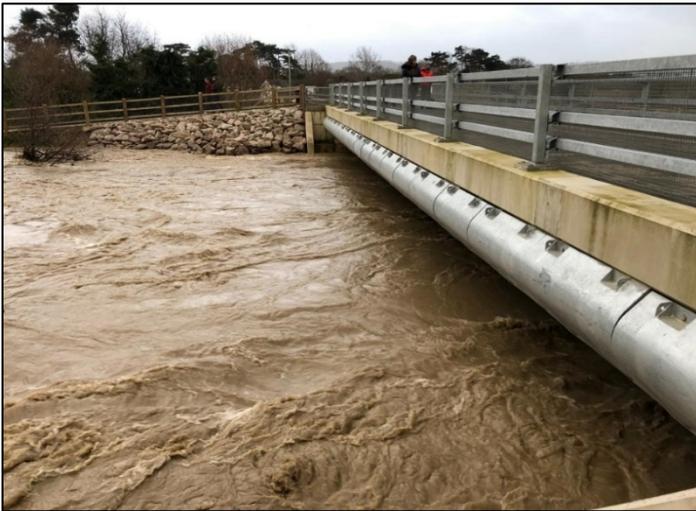
Figure 98: River levels 09-02-2020 compared to bridge deck (NRW, 2020)

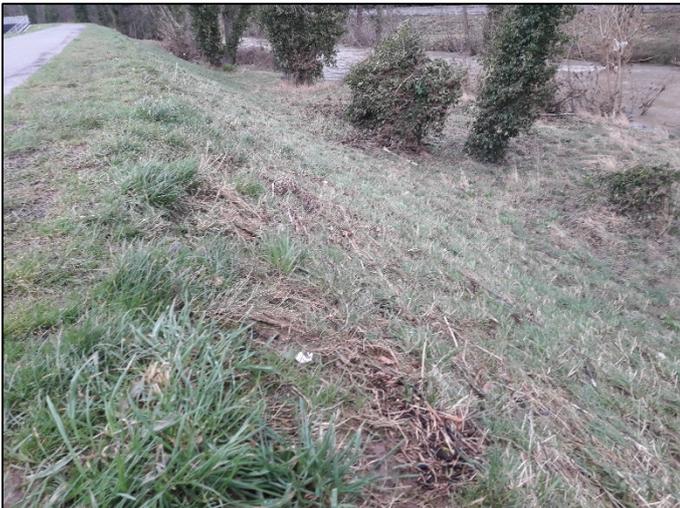
Figure 99: Wrack marks cattle market emb u/s section (NRW, 2020)

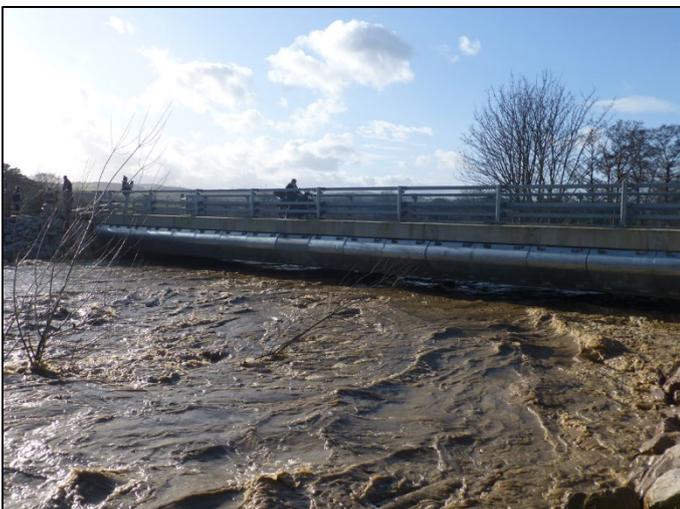
Figure 100: Water levels at SGB (Resident photo)

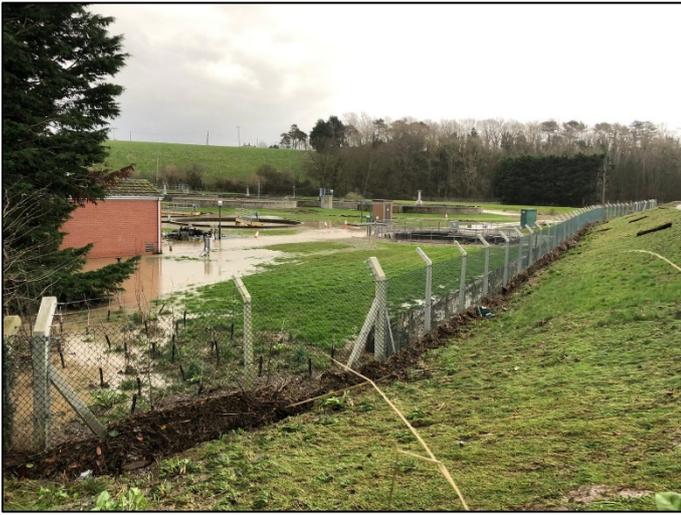
Figure 101: Post event debris (Resident photo)

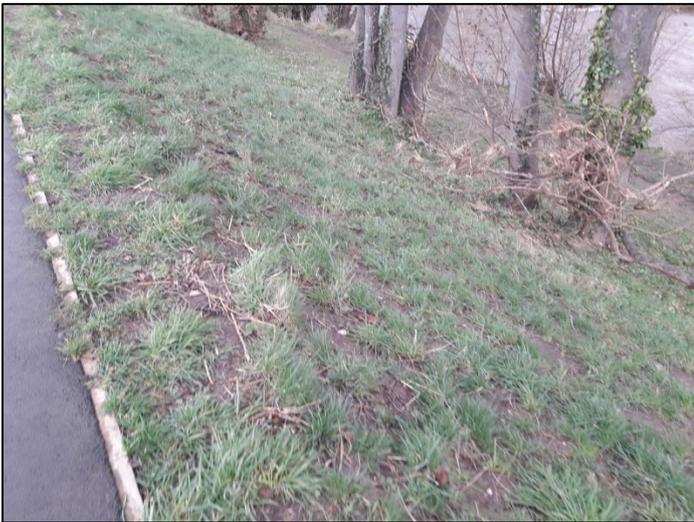
Figure 102: Wrack marks u/s library wall (NRW, 2020)

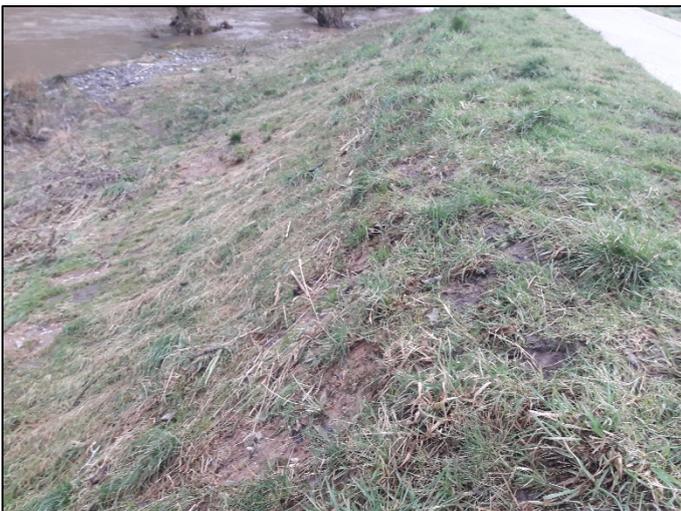
Figure 103: Wrack marks cattle market emb d/s section (NRW, 2020)

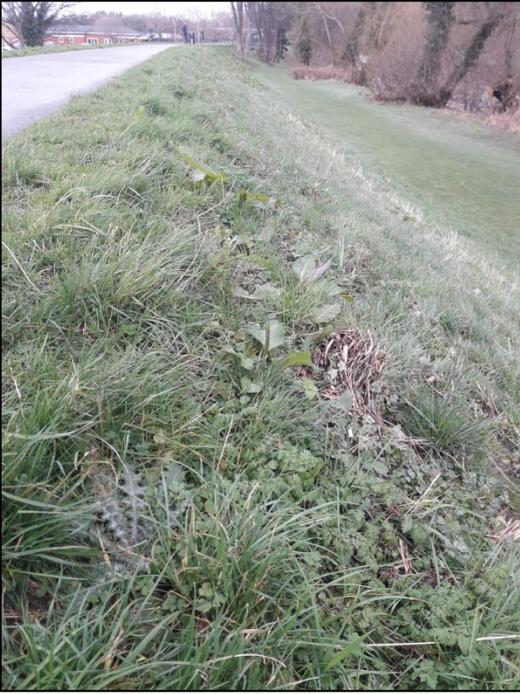
Figure 104: Wrack marks Dr Emb (NRW, 2020)

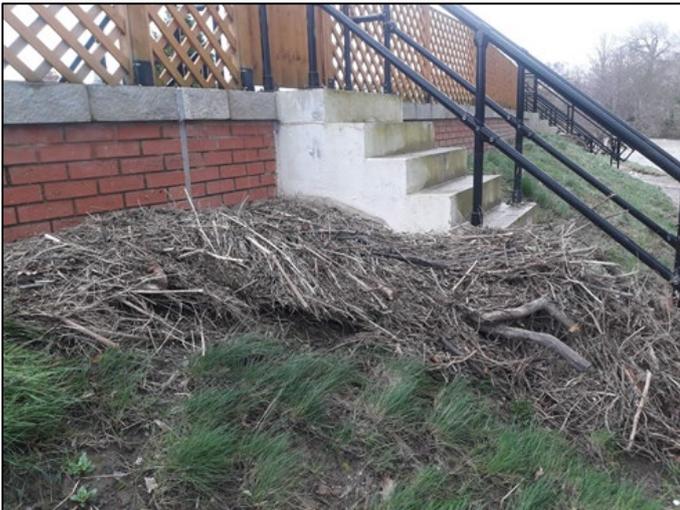
Figure 105: Flood debris at the rear of Ruby Terrace (NRW, 2020)

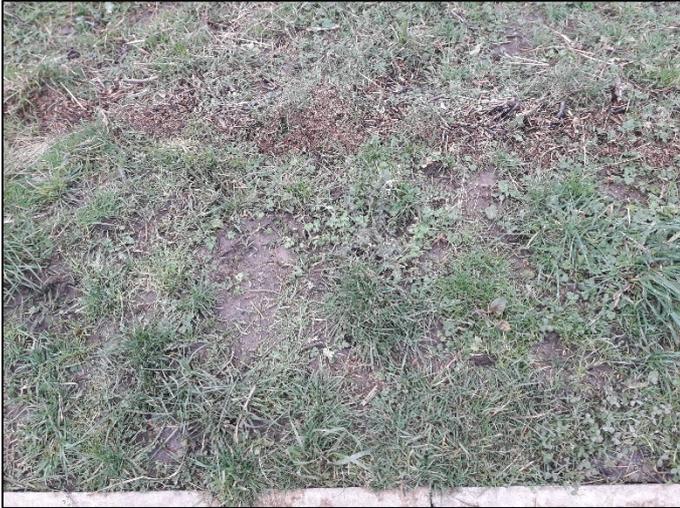
Figure 106: Wrack mark in relation to crest height common emb (NRW, 2020)

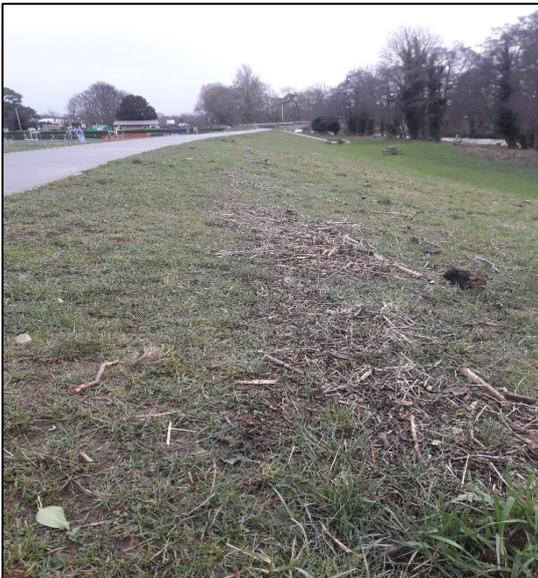
Figure 107: Wrack mark common emb (NRW, 2020)

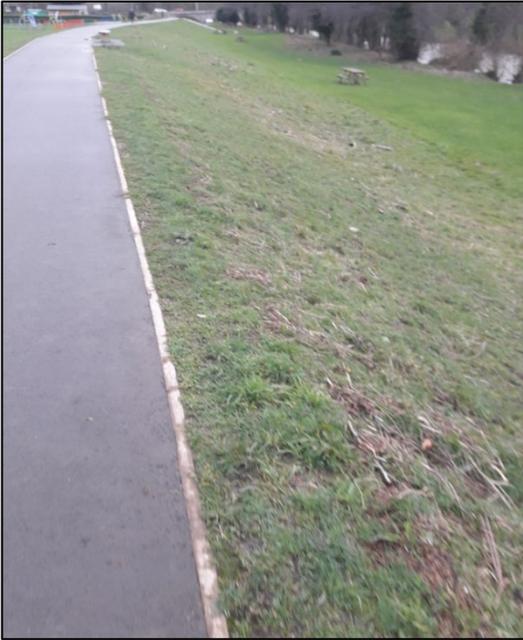
Figure 108: Wrack mark common emb (NRW, 2020)

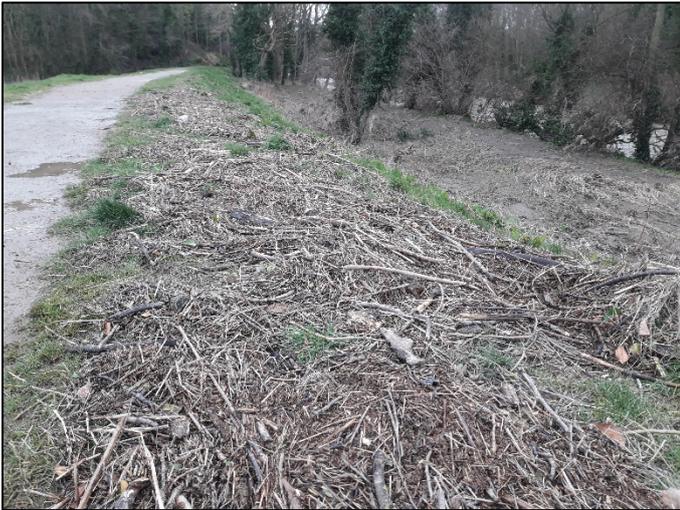
Figure 109: Overtopping location RB STW emb (NRW, 2020)

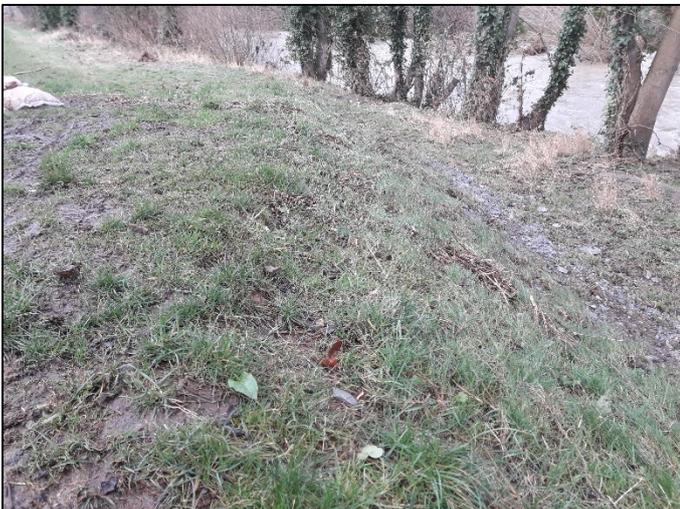
Figure 110: Wrack marks at Roe Parc emb (NRW, 2020)

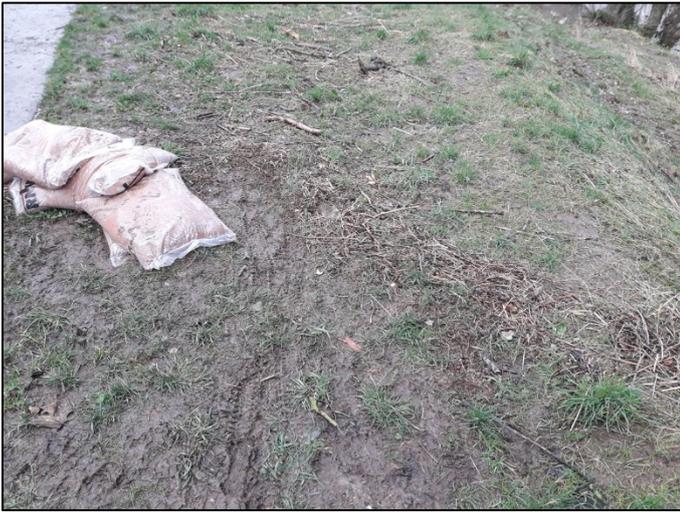
Figure 111: Wrack marks at Roe Parc emb ramp (NRW, 2020)

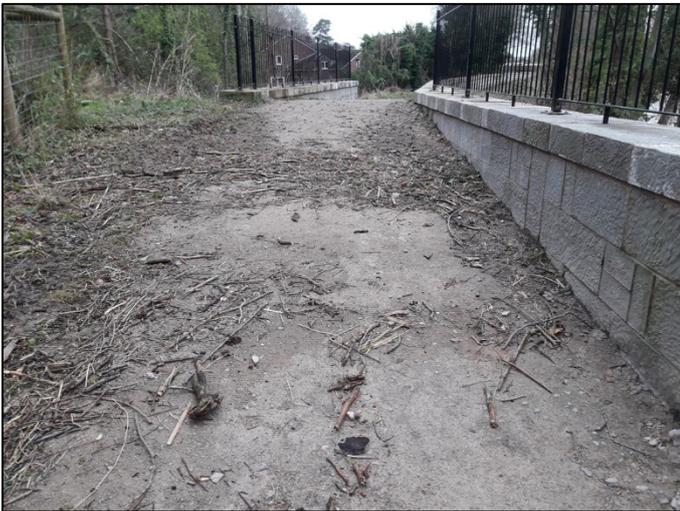
Figure 112: Wrack marks at Pont Begard wall (NRW, 2020)

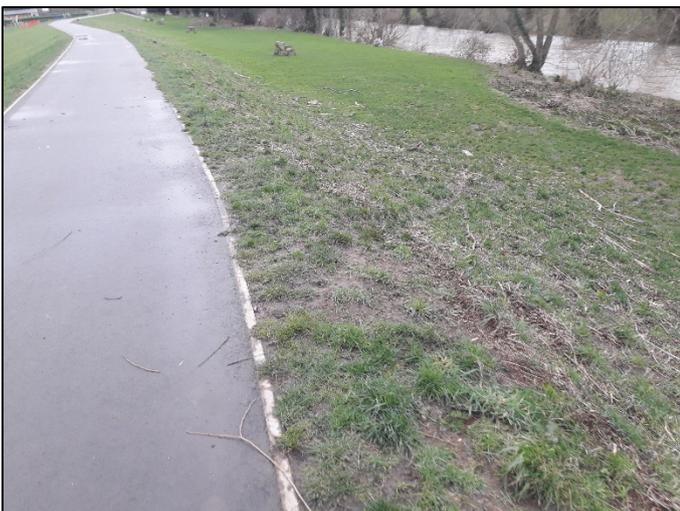
Figure 113: Wrack mark common emb (NRW, 2020)

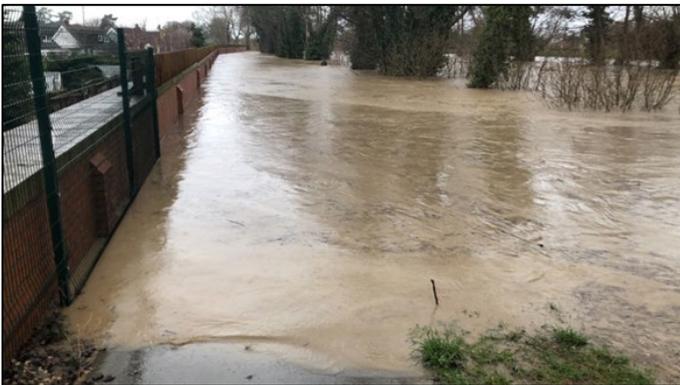
Figure 115: Prior to peak water levels at u/s end of Roe Parc Wall (Resident photo)

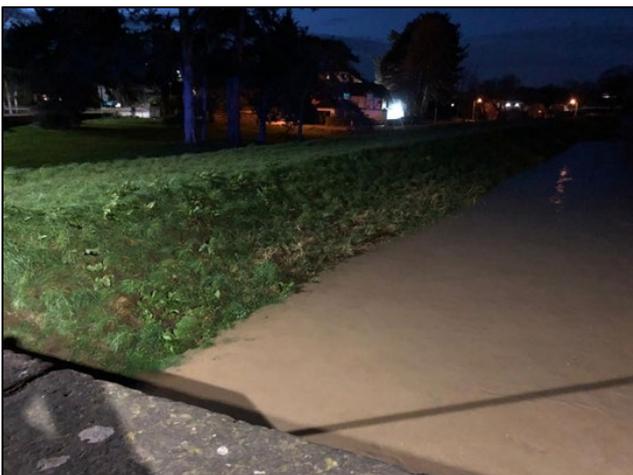
Figure 116: River levels looking d/d from city bridge (NRW, 2020)

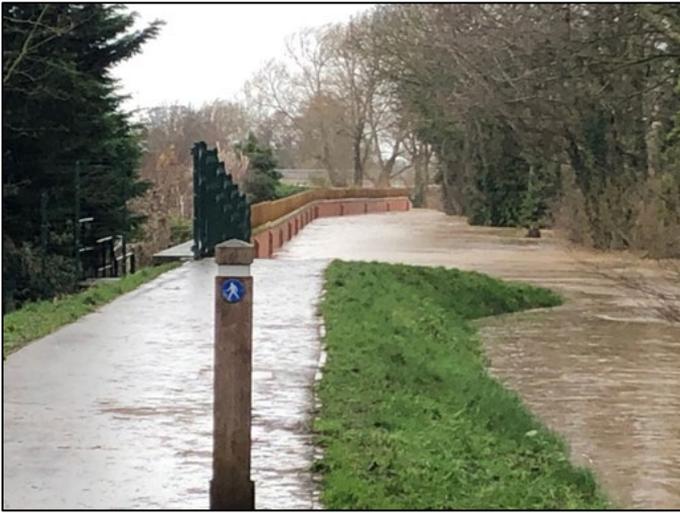
Figure 117: Prior to peak water levels at u/s end of Roe Parc Wall (Resident photo)

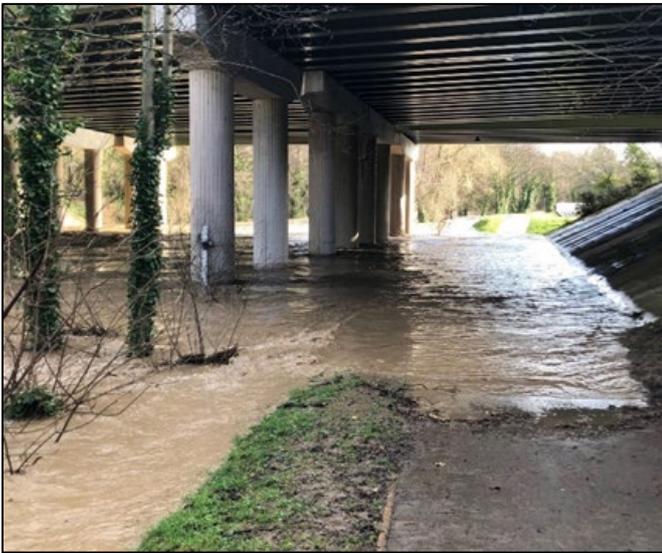
Figure 118: Prior to peak water levels at A55 bridge (Resident photo)

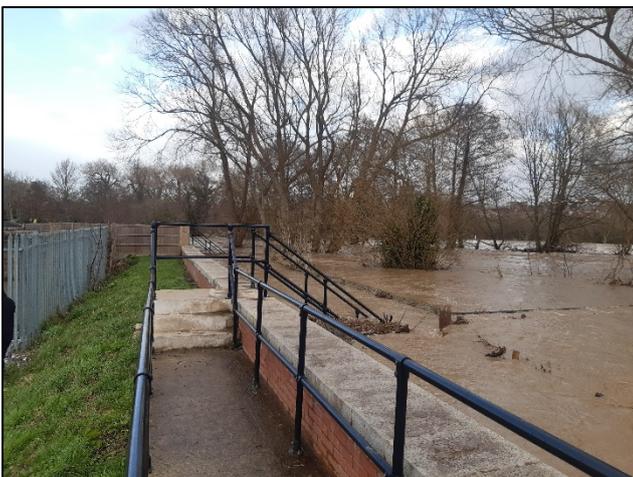
Figure 119: River levels at confluence of Glascoed & Elwy (NRW, 2020)

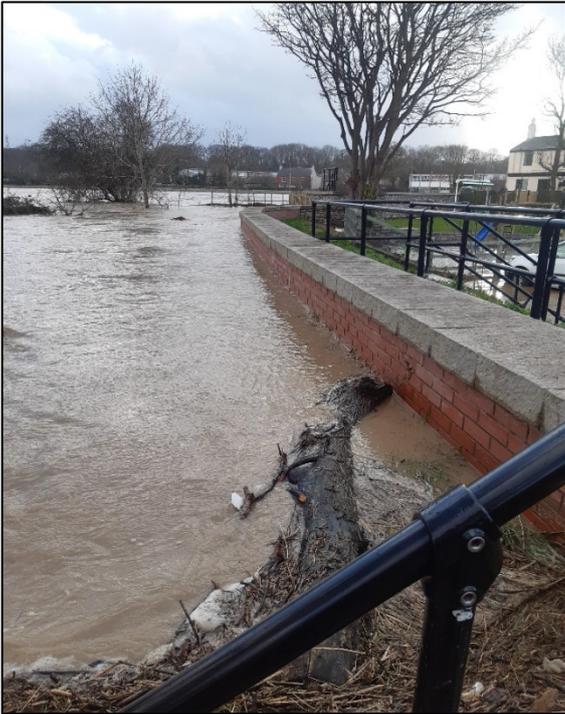
Figure 120: Water levels at the U/S end of Ruby Terrace (NRW, 2020)

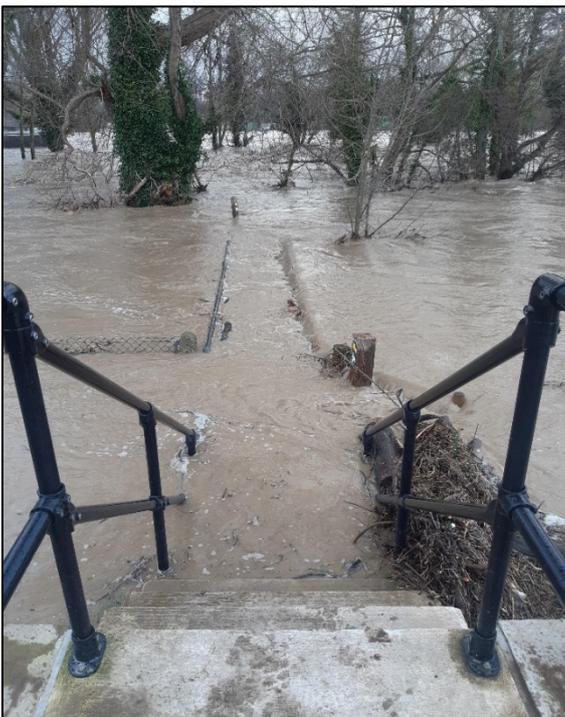
Figure 121 Water levels at the U/S end of Ruby Terrace (NRW, 2020)
